## Condo Inspection Report

**123 Sample Ave**

**Anytown, SC 29555**

Inspected on Wed, Jun 20 2018 at 12:07 PM

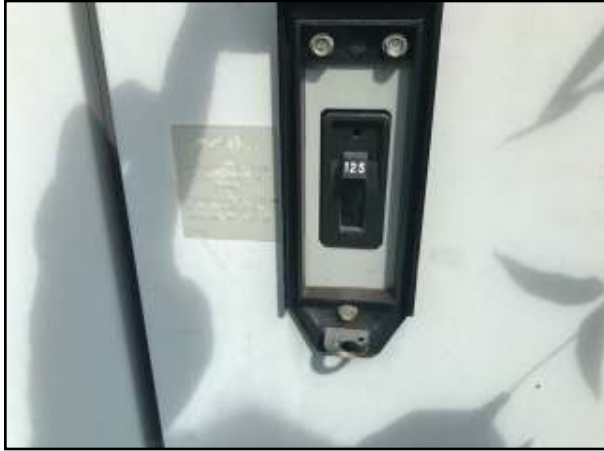
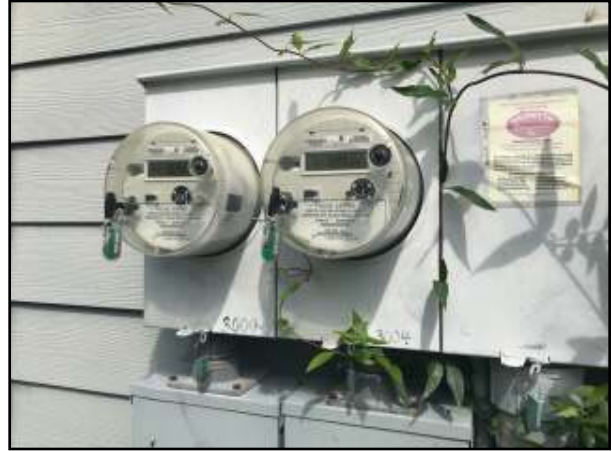
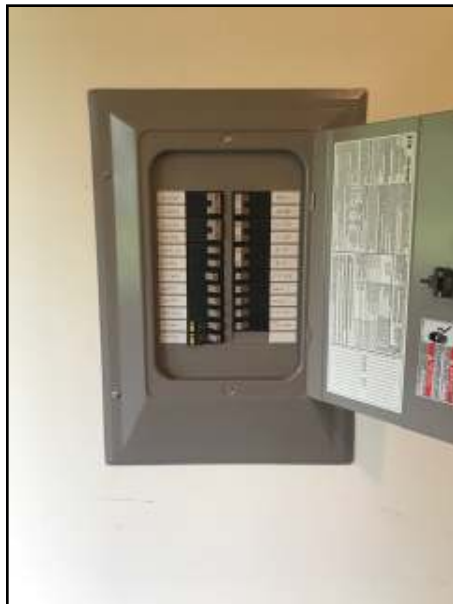
The main electrical service is sufficient for a building of the size and type. The electric is in good order with no major defects present. The distribution of electricity within the building is good. All visible wiring within the building is copper. All outlets tested are appropriately grounded. All GFCI outlets responded properly when tested. The 125amp main disconnect is located in the meter box. All AFCI breakers responded properly when tested. All breakers are appropriately sized and responded properly when tested.

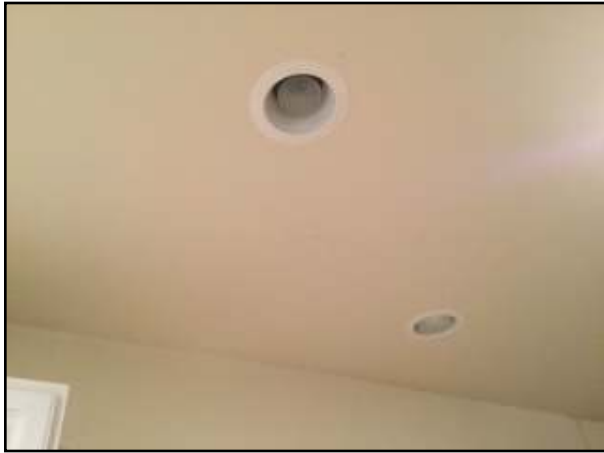
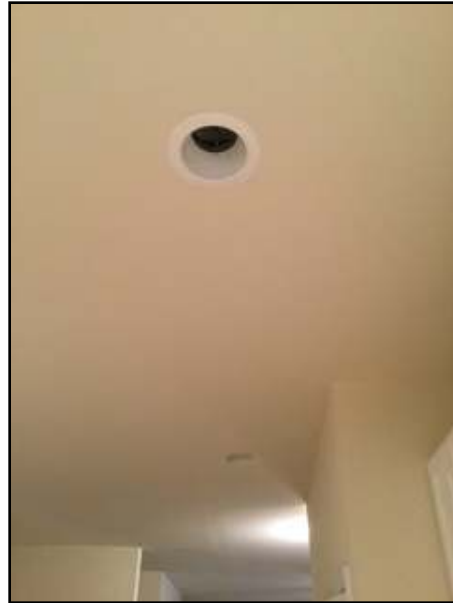
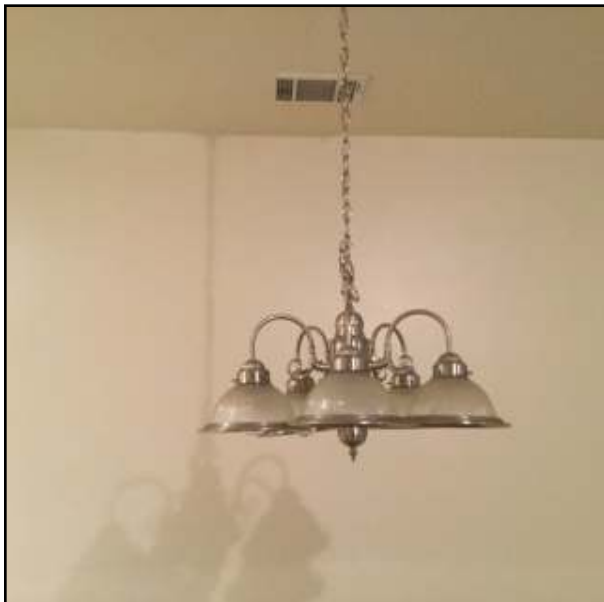
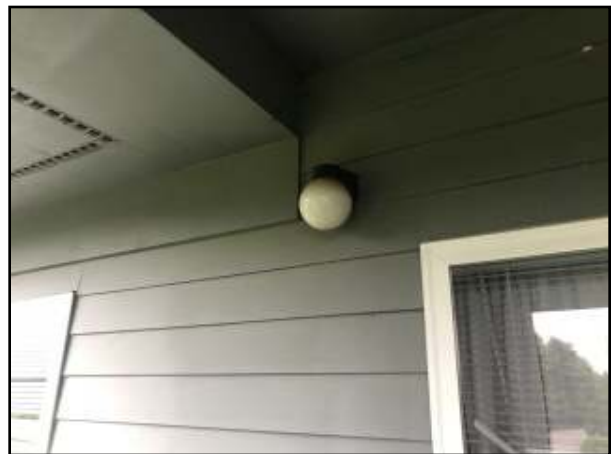
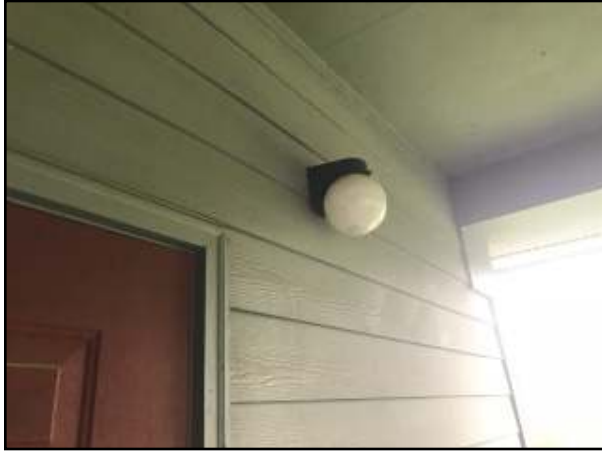
Repair: there are several inoperative lights in the unit. The bulbs are likely blown. In the event bulb replacement doing not repair the issue, the fixture may be bad and need replacement or the circuit may need to be repaired.

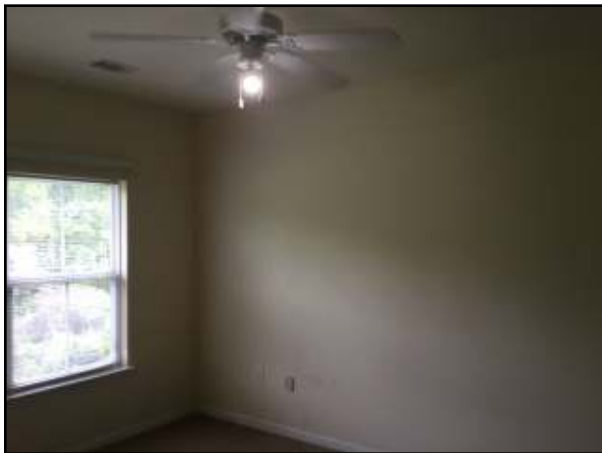
Figure 3-1

Monitor: the rear bedroom ceiling fan is not working in the high setting. Replacement may be desired.

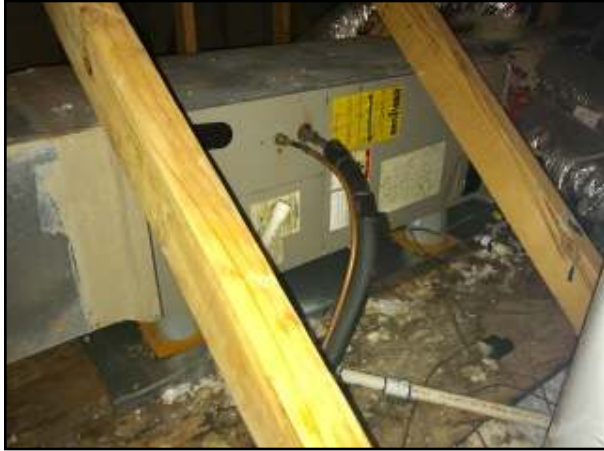
Figure 4-1

Monitor: The air handler of the heat pump system was manufactured in 2004. The system responded properly when tested. The typical lifespan of a heat pump system is 20-25 years. No one can predict when replacement will become necessary. It is recommended you obtain a home warranty for unexpected repairs.

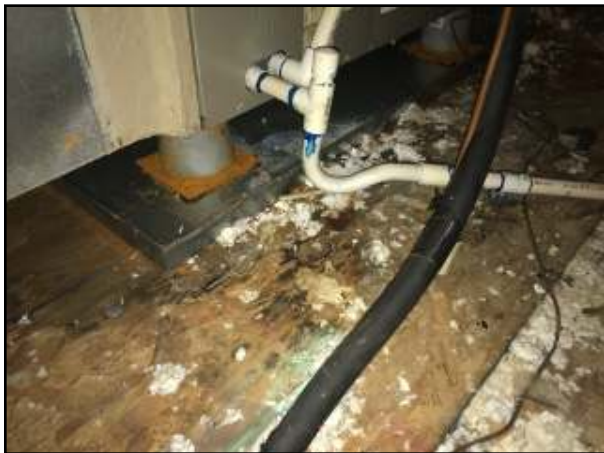
Figure 5-1

Monitor: the air handler system has leaked in the past. The pan has been replaced and there is no sign of a present leak. This condition should be monitored.

Furnaces over 10 years old should be checked, cleaned and serviced yearly by a licensed contractor.

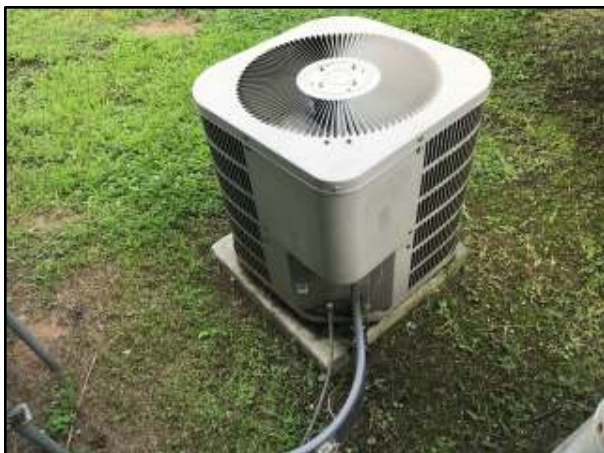
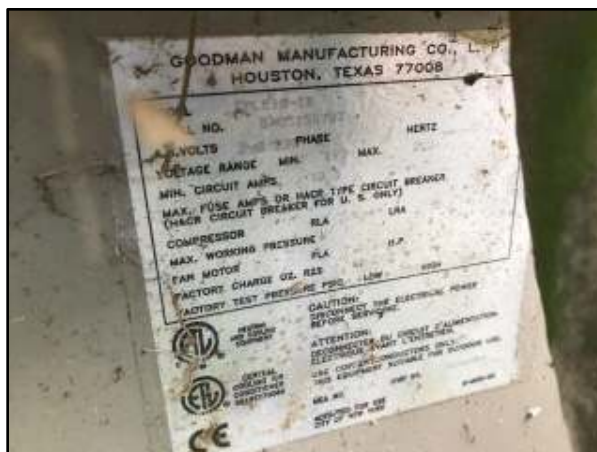
Monitor: the condensing unit was manufactured in 2004. The system responded properly when tested. The typical lifespan of a air conditioning system is 20-25 years. No one can predict when replacement will become necessary. It is recommended a home warranty be obtained to cover unexpected repairs.

Air conditioners over 10 years old and heat pumps over 5 years old should be checked, cleaned and serviced yearly by a licensed contractor.

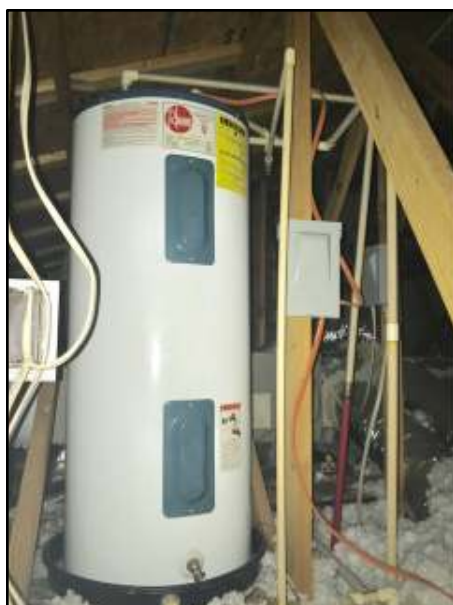
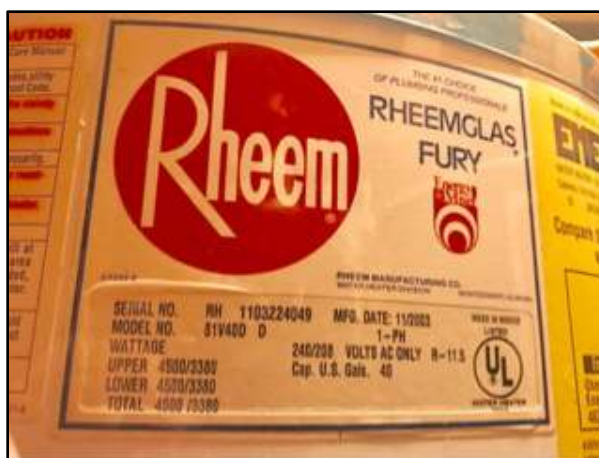
Monitor: The water heater was manufactured in 2003. The typical lifespan of a water heater is 10 to 15 years. The unit responded properly when tested. The system is beyond this age range and may require a higher level of maintenance. No one can predict when replacement will become necessary.

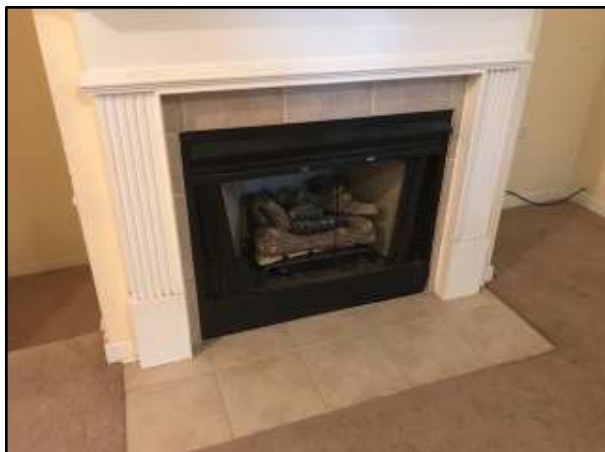
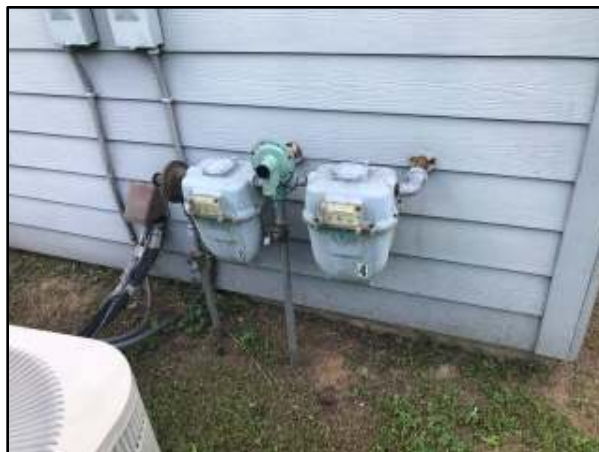
Monitor: the gas insert could not be tested due to no fuel supply.

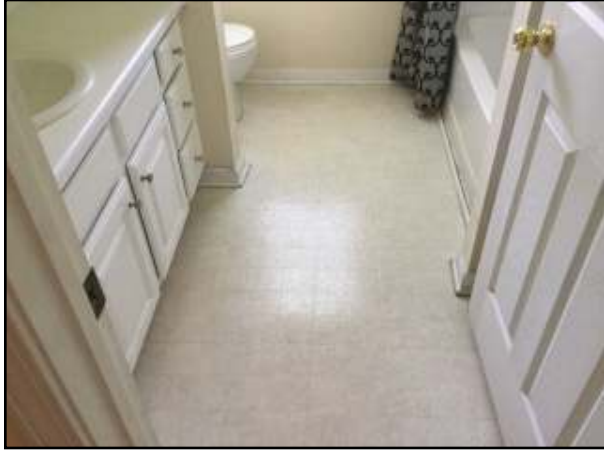
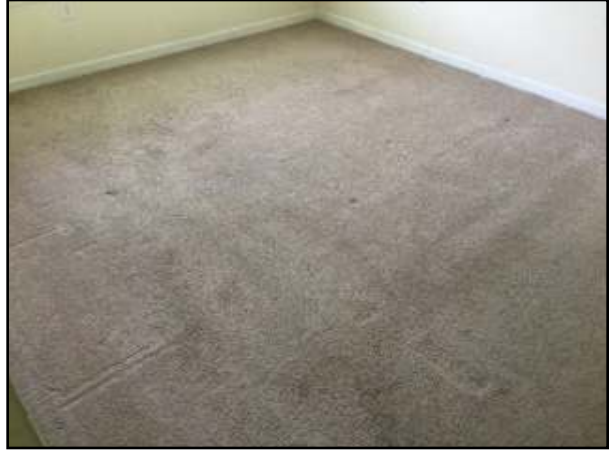
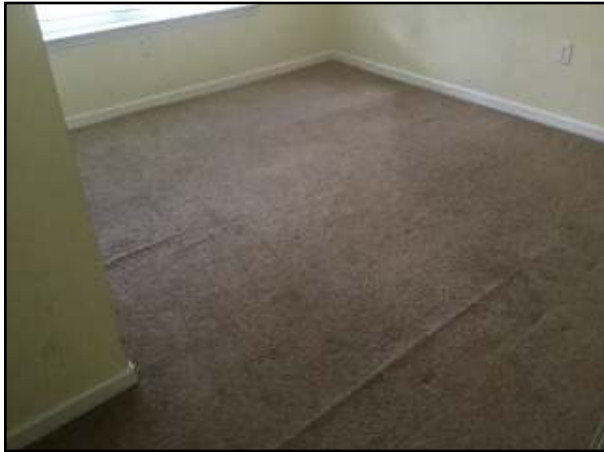
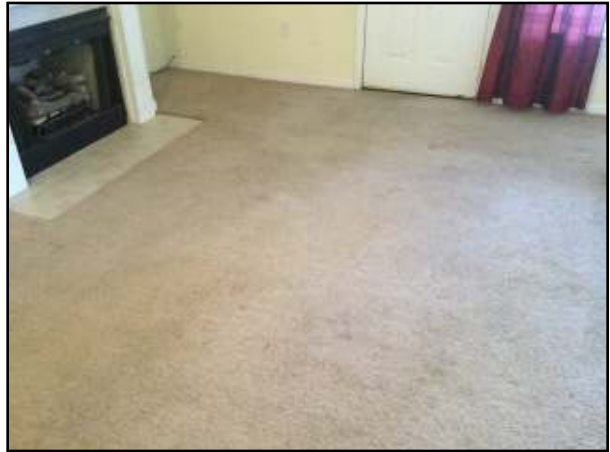
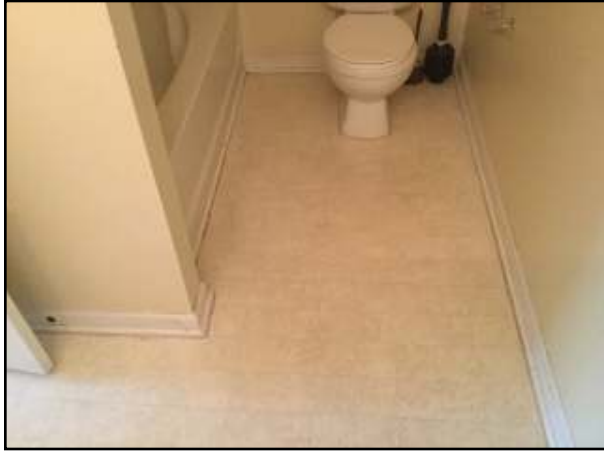
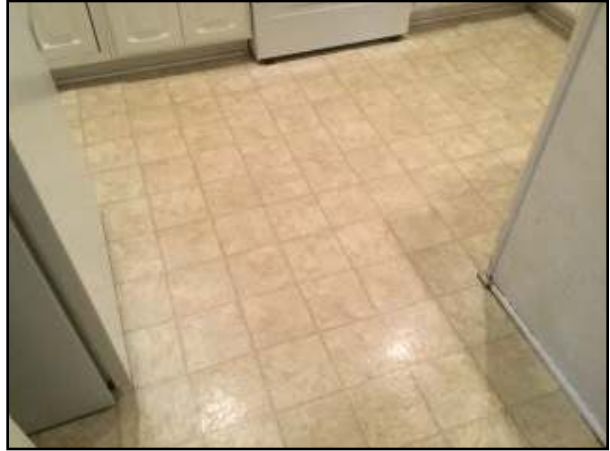
Monitor: the interior flooring is in fair condition. Replacement will likely be desired.

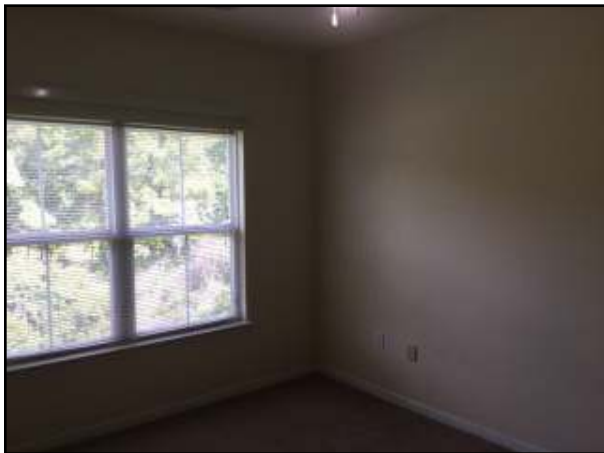
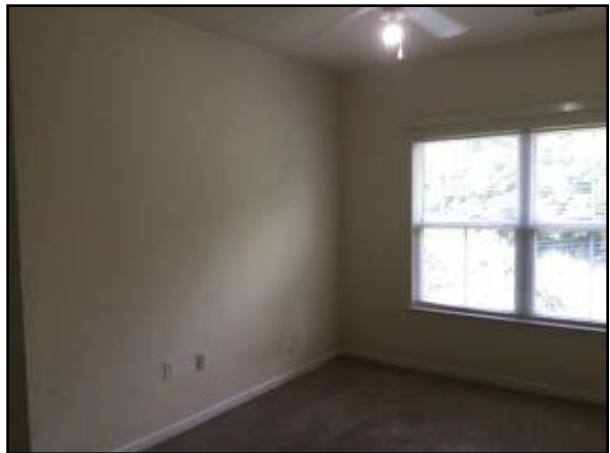
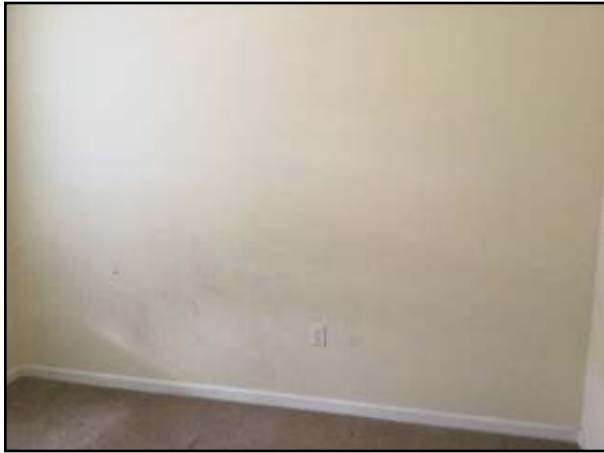
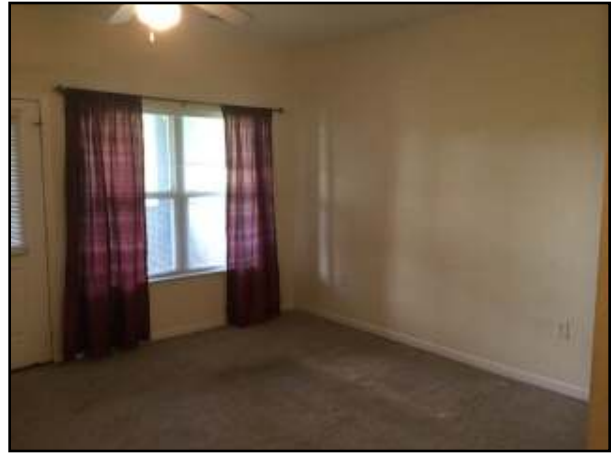
Monitor: painting the interior walls will likely be desired. There is patched area in the master bathroom ceiling the needs prepping prior to painting.

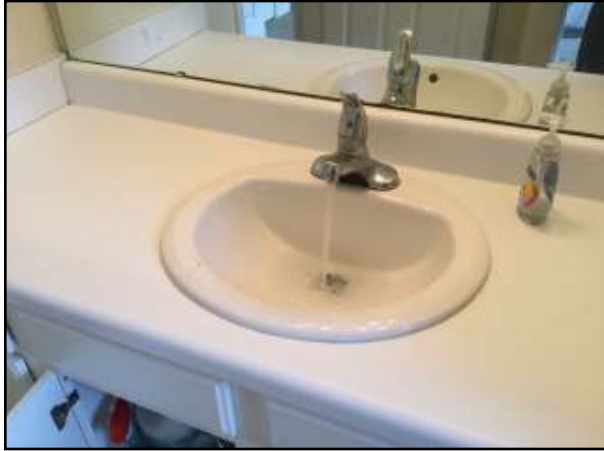
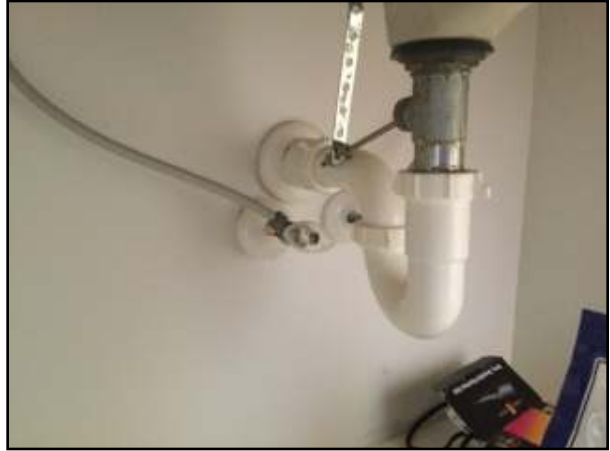
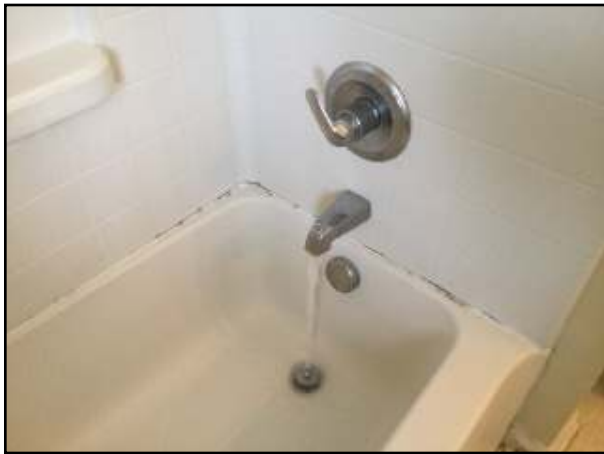
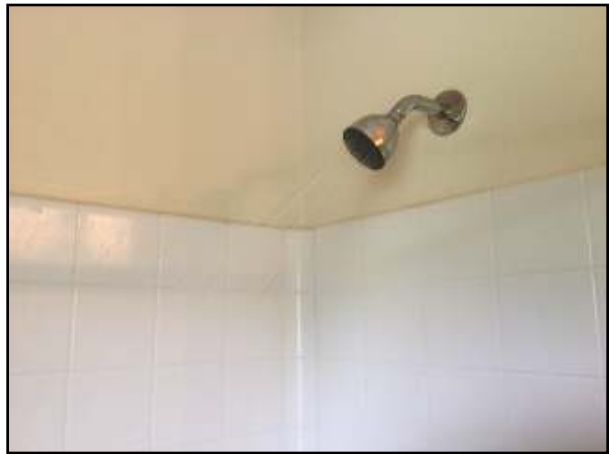
The water pressure to the fixtures is good. Only a slight decrease in pressure was observed when multiple fixtures are operated simultaneously.

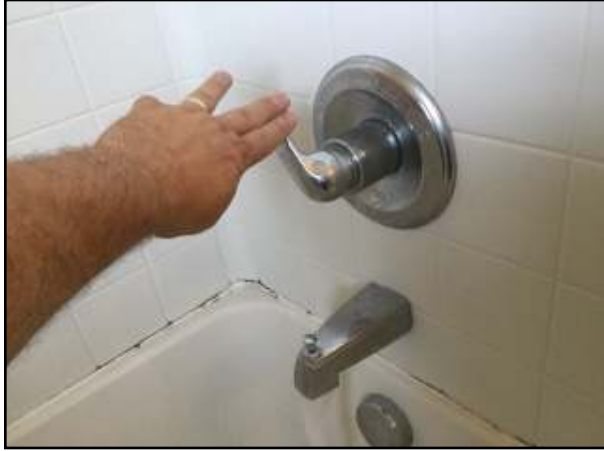
Figure 13-1

Repair: the hall bath faucet set is loose and needs to be secured.

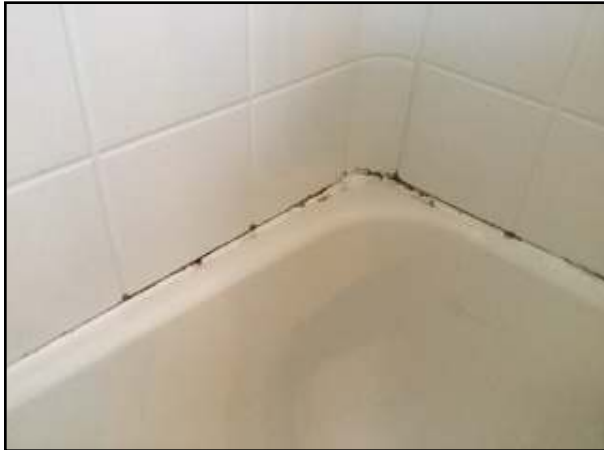
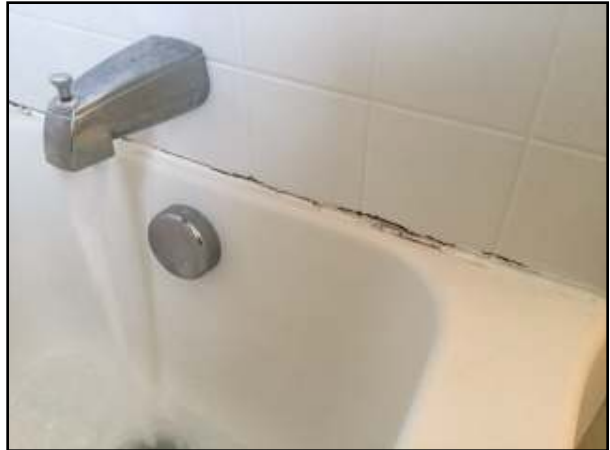
Repair: caulking is needed around the tub/shower surround.

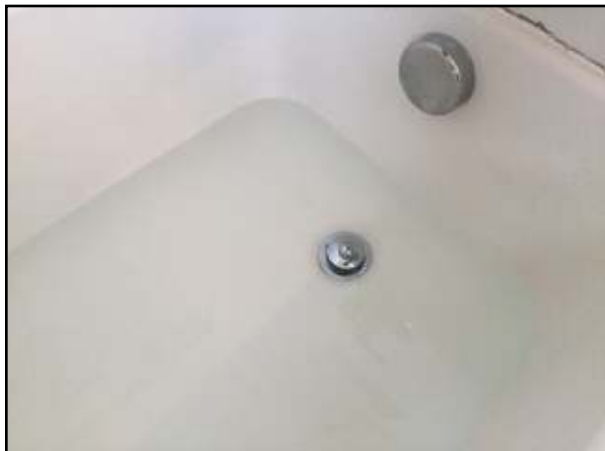
Figure 15-1

Repair: the hall bath tub s draining slowly. An obstruction likely exists in the drain pipe.

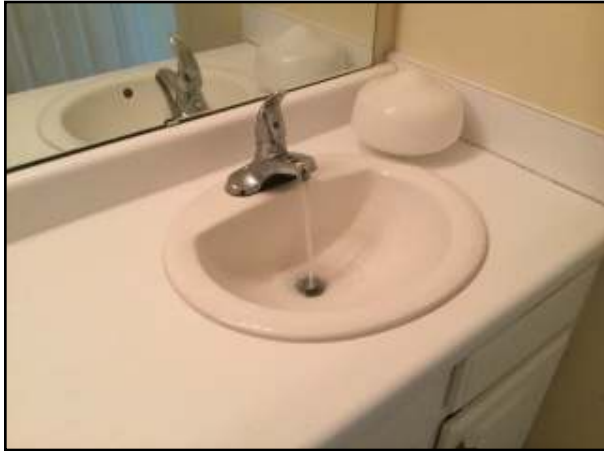
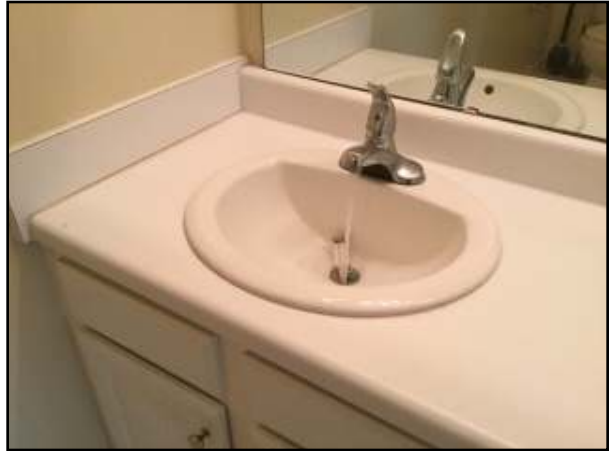
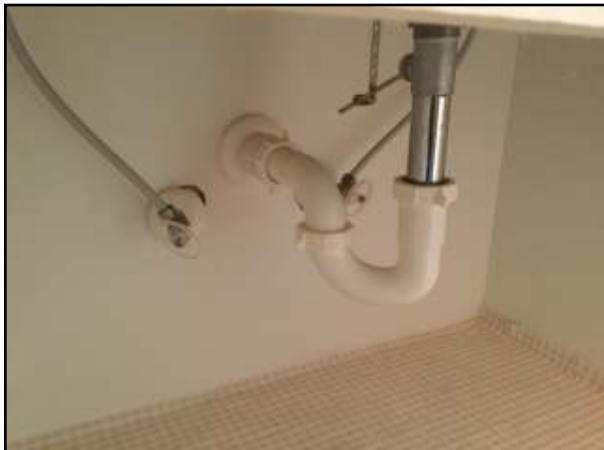
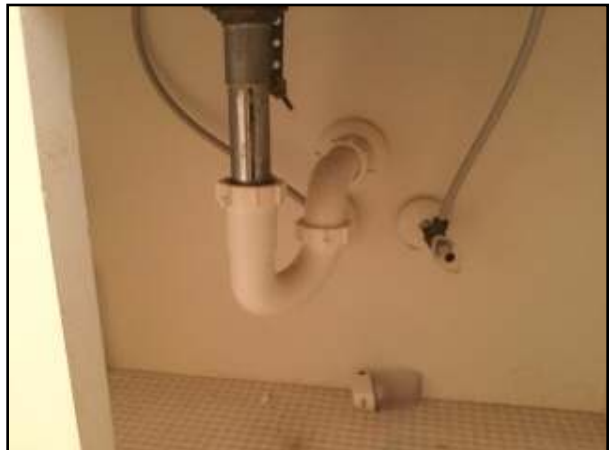
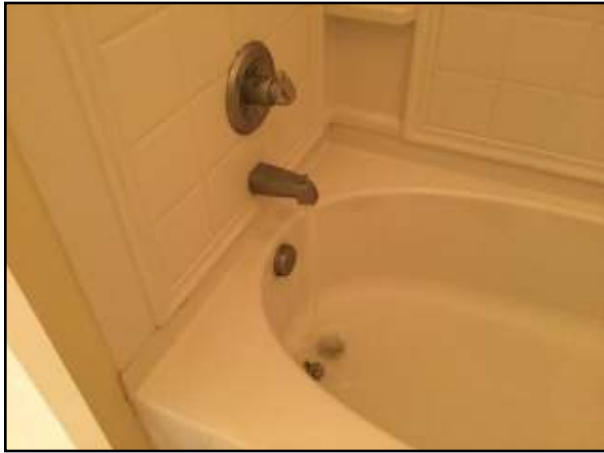
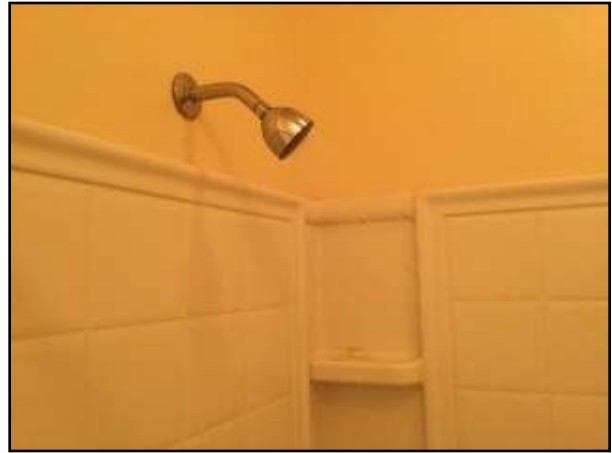
The water pressure to the fixtures is good. Only a slight decrease in pressure was observed when multiple fixtures are operated simultaneously.

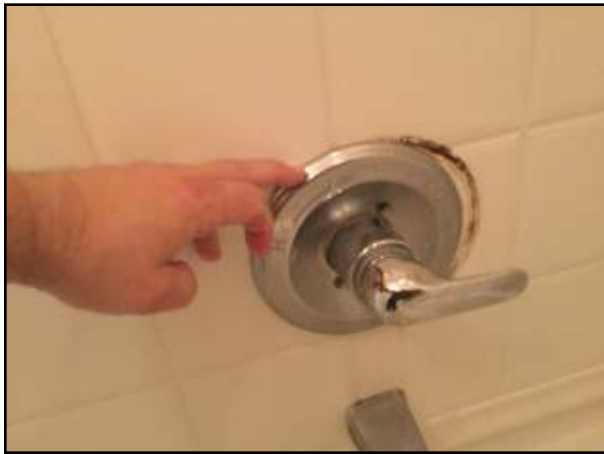
Figure 17-1

Repair: the hall bath faucet set is loose and needs to be secured.

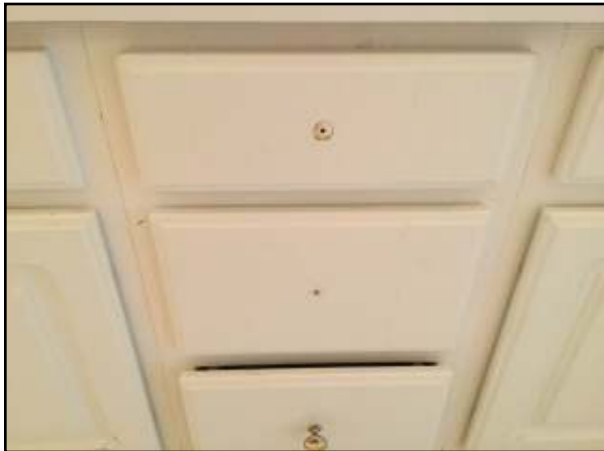
Figure 18-1

Repair: missing cabinet drawer hardware needs to be replaced. The knobs are in the drawers but the screws are missing or too short.

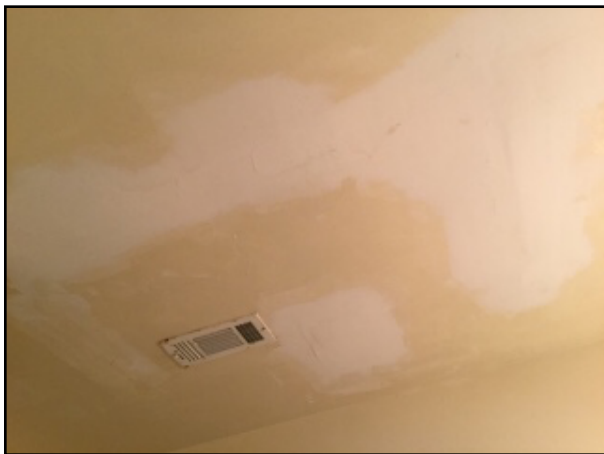
Figure 19-1

Repair: the master bathroom ceiling is not properly finished. The ceiling needs to be prepped, sanded, and painted.

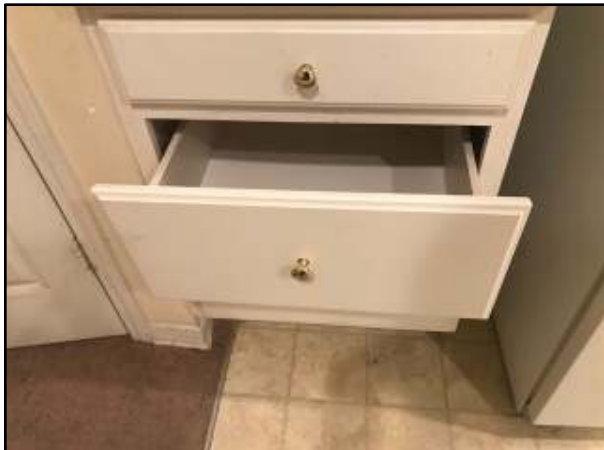
Figure 21-1

Repair: the loose cabinet drawer face needs to be repaired.

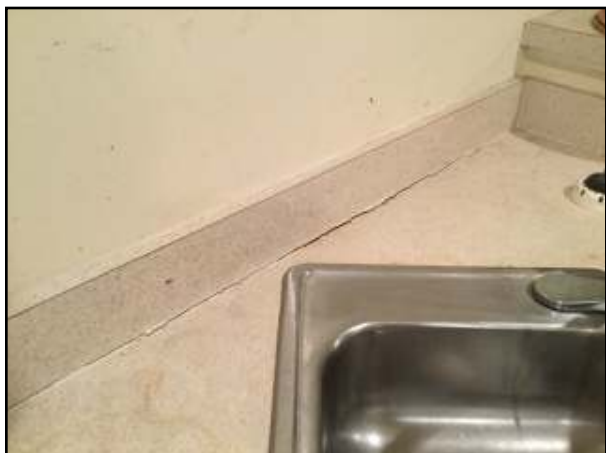
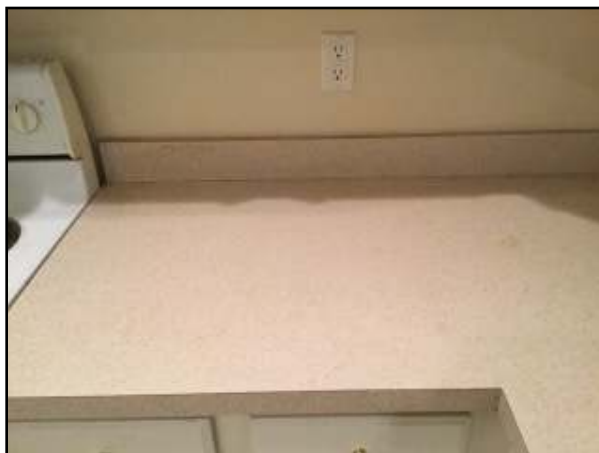
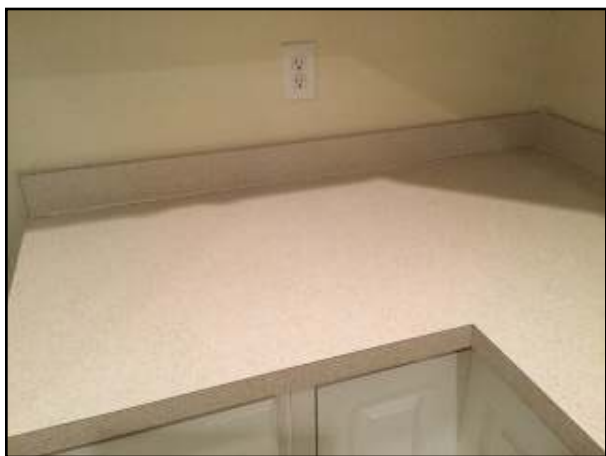
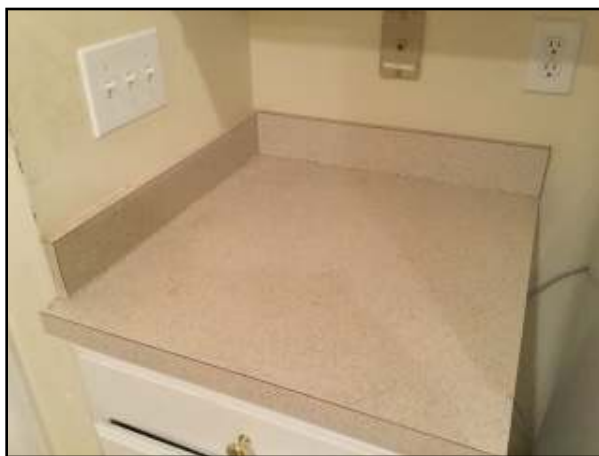
Repair: the laminated countertop needs to be caulked along the backsplash. Bracing under the counter top is needed.

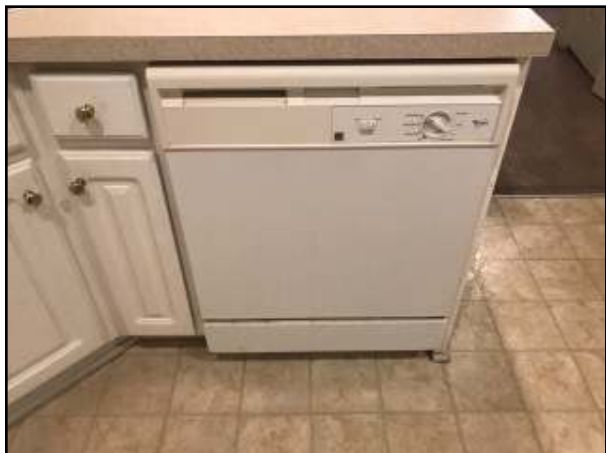
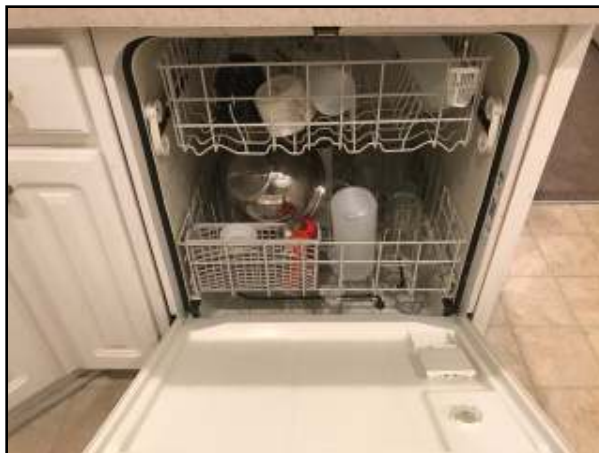
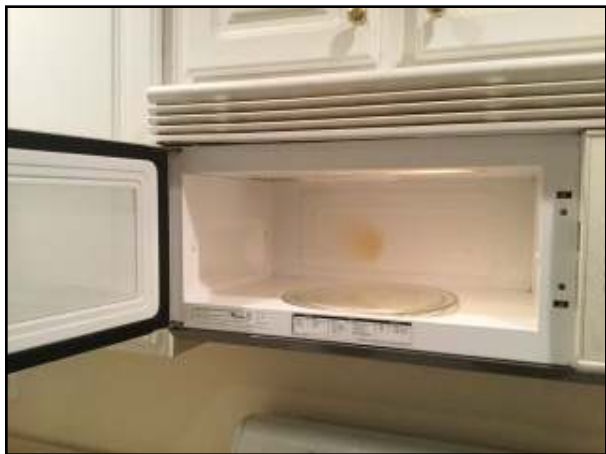
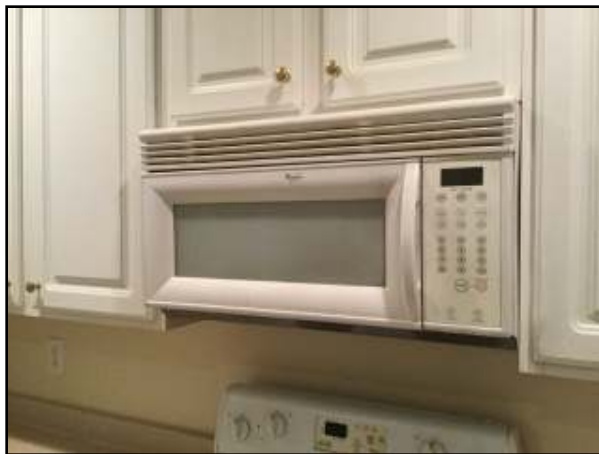
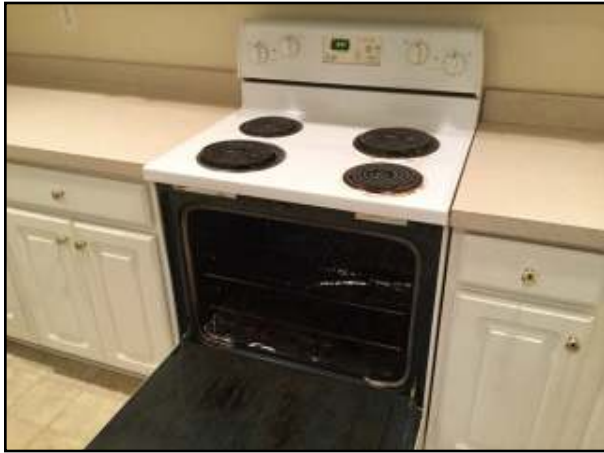
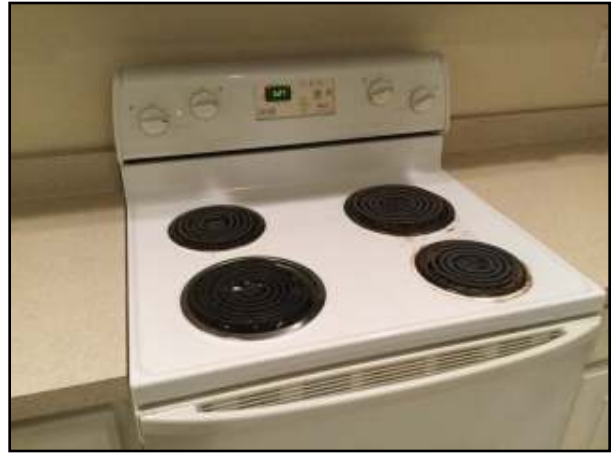
The appliances are middle aged (2004) units . The appliances responded properly when tested and there should be a few years of useful life remaining.

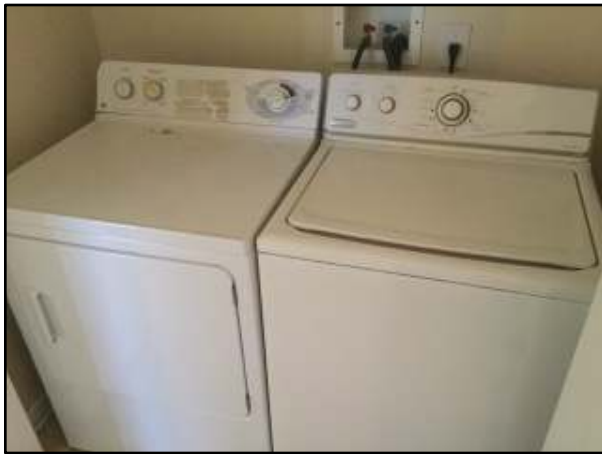
Figure 24-1

Clothes washer and dryer are relatively new units and responded properly when tested.
