Patriot Home Inspections

Home Inspection Report

**123 Sample Ave
Anytown, SC 29555**

Inspected on Wed, Jun 20 2018 at 12:12 PM

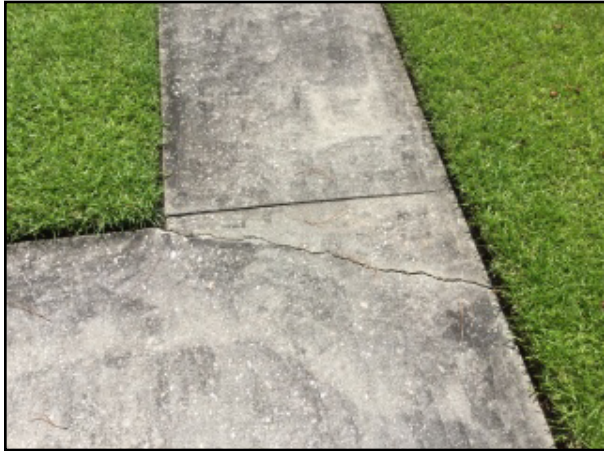
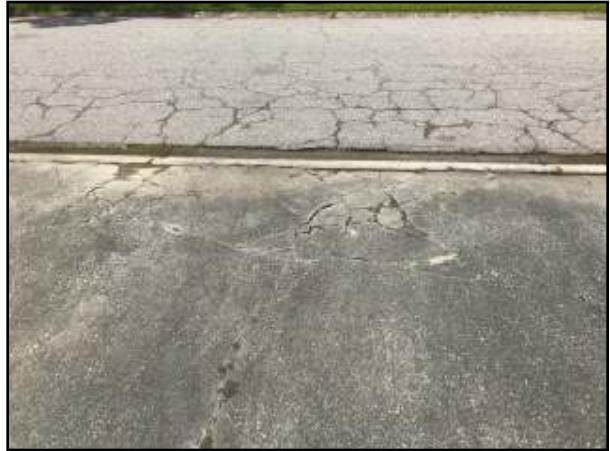
Monitor: typical cracking was observed in the concrete driveway and walkways. This condition should be monitored.

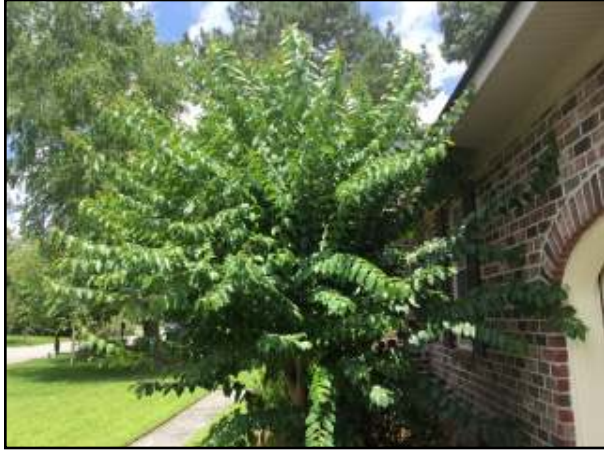
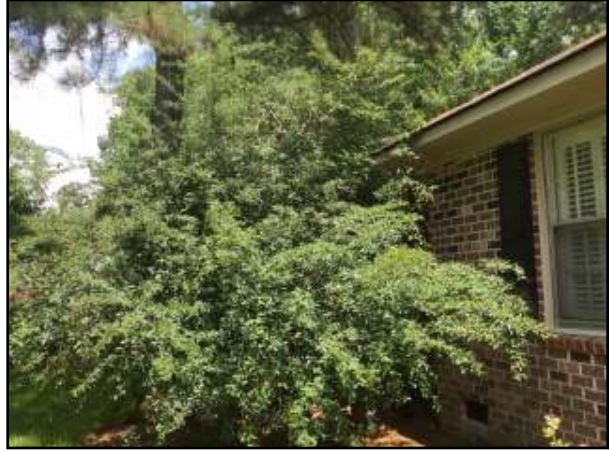
Repair: trees and tree limbs need to be trimmed away from the house.

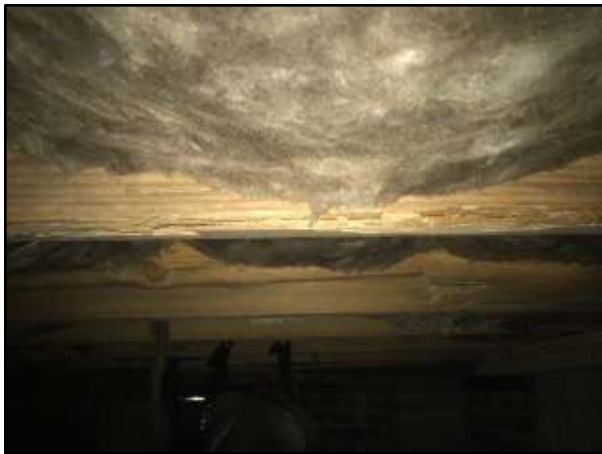
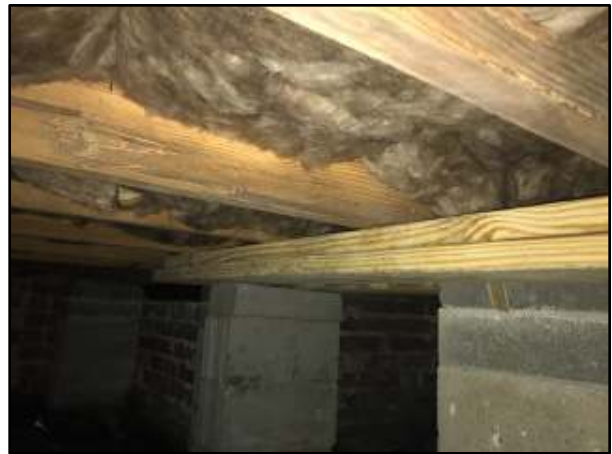
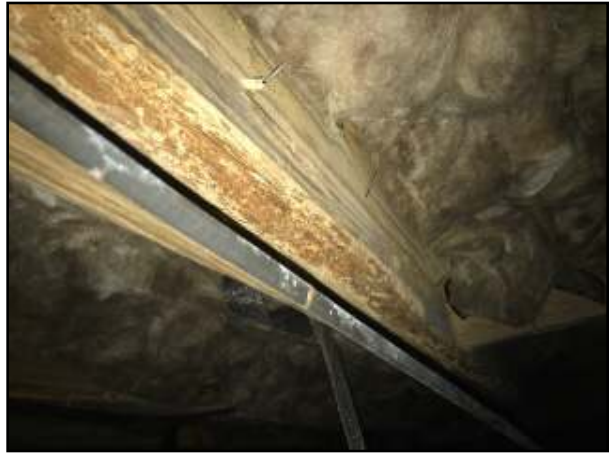
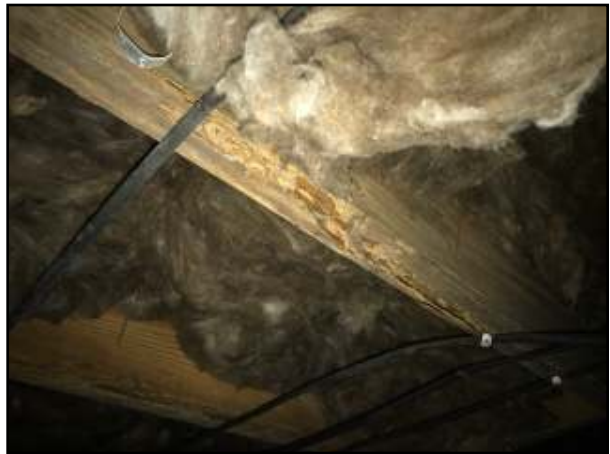
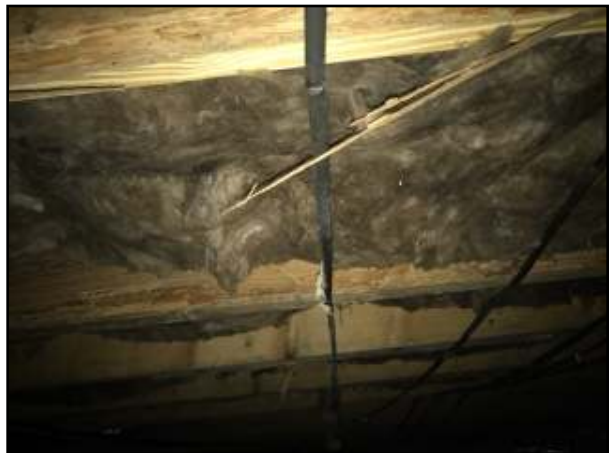
Repair: the floors in the home are sagging. Some prior termite damage was observed which has been repaired by sistering new floor joists against damaged ones. There are long spans of floor joists where they are not supported. This can cause bouncy floors which was observed. Additional support piers or foundation jack posts are needed to stabilize the floor system. A licensed building contractor should evaluate for repairs.

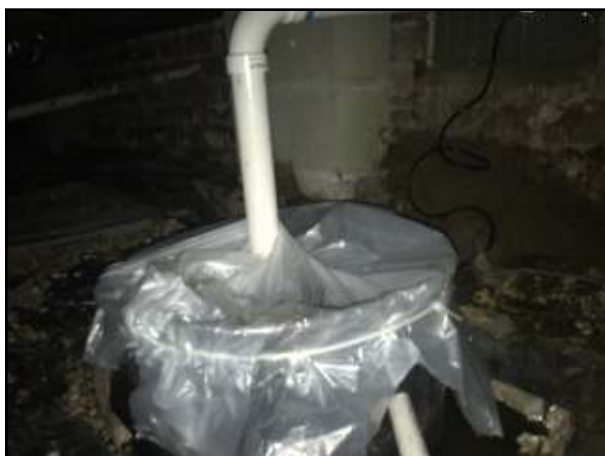
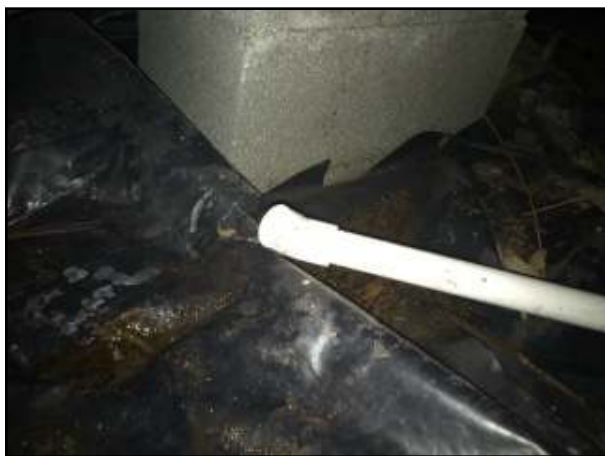
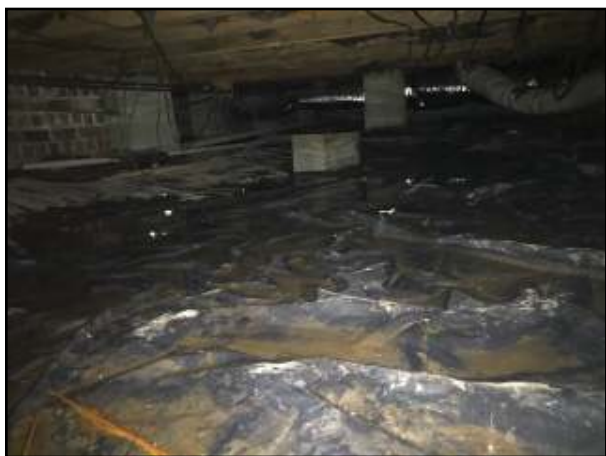
Repair: the sump pump is discharging water inside the crawl space. The discharge pipe should extend to the exterior and directing discharge away from the foundation.

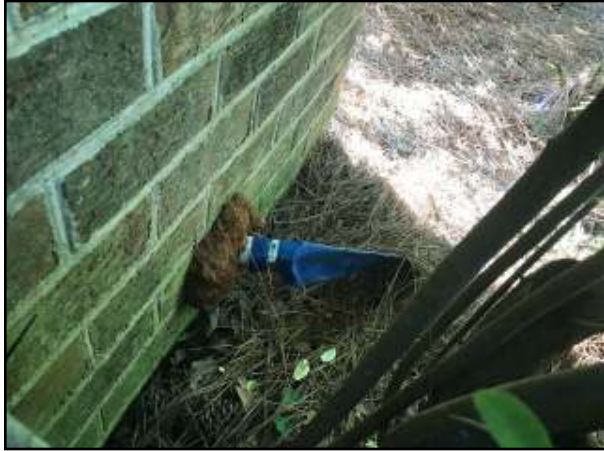
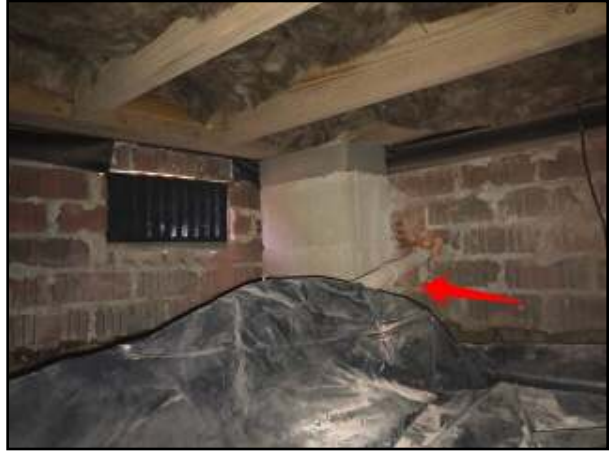
Repair: the discharge pipe for the pool pump is has a positive incline inside to crawl space. The discharge pipe needs repair so that the pipe has a negative slope and discharges away from the foundation.

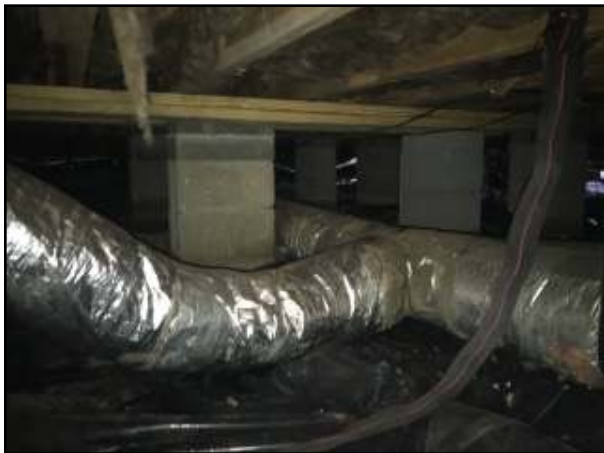
Figure 8-1

Repair: part of the main supply trunk line is lying on the ground. The supply trunk needs to be elevated and supported.

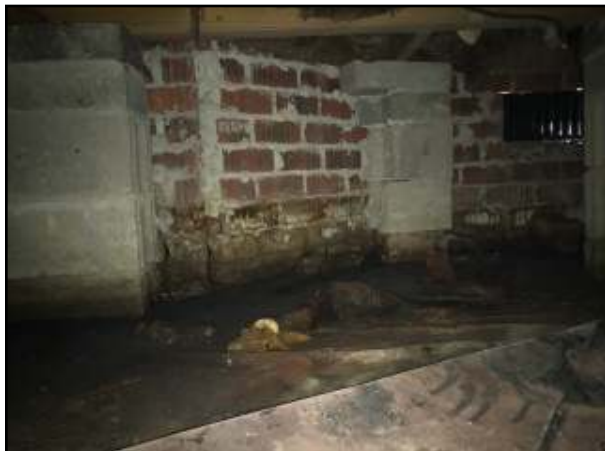
Figure 9-1

Repair: there is standing water around the foundation perimeter. A gutter system is needed to collect and discharge storm water runoff away from the foundation.

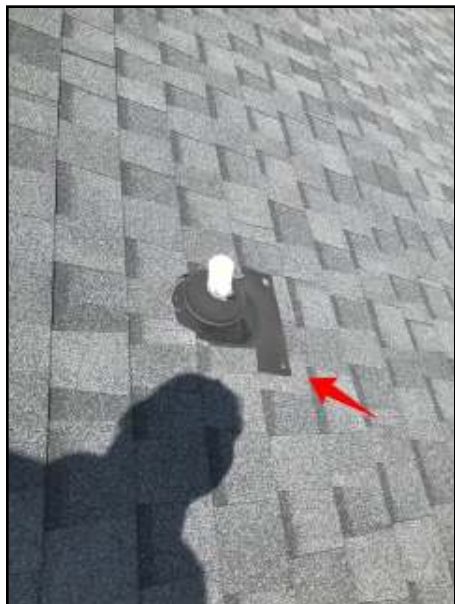
Figure 11-1

Repair: there are exposed nail heads on the plumbing vent boots. Exposed nail heads should be sealed.

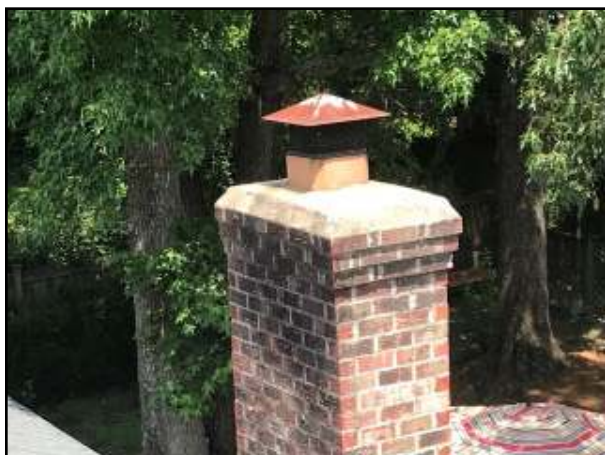
Figure 12-1

Repair: the chimney cap is rusted and need to be painted.

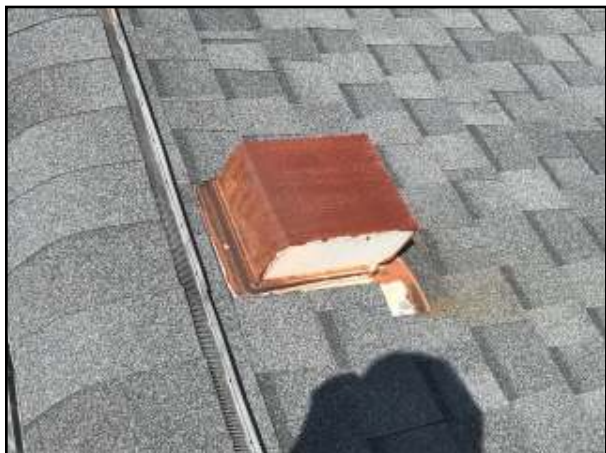
Figure 13-1

Repair: the roof vent is rusted and needs to be painted.

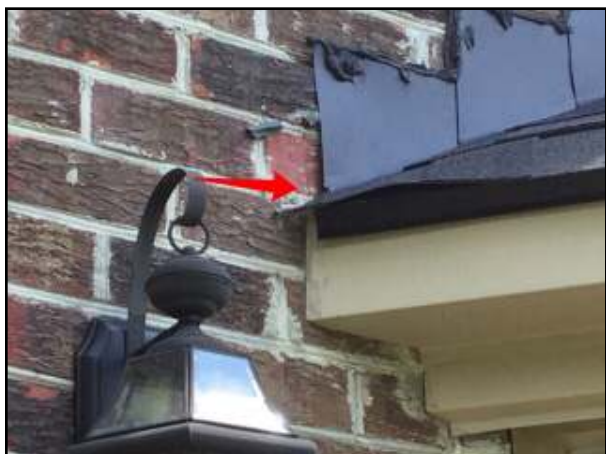
Figure 14-1

Repair: the flashing on the left side of the front bay window stops short of the roof edge creating a gap for water intrusion. This needs to be repaired.

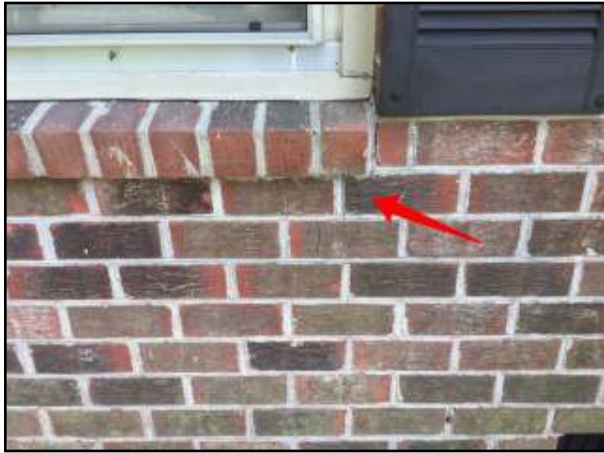
Figure 16-1

Repair: there's a crack in the brick veneer on the front of the house. This condition should be monitored. Barring persistent movement no repair should be necessary. Filling the crack and mortar joints on the brick masonry is recommended to prevent further water intrusion.

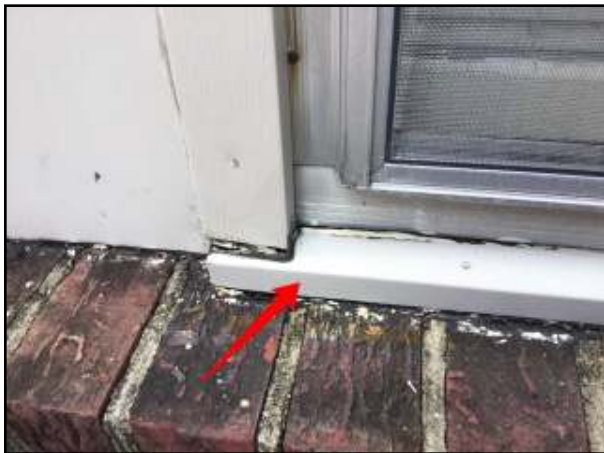
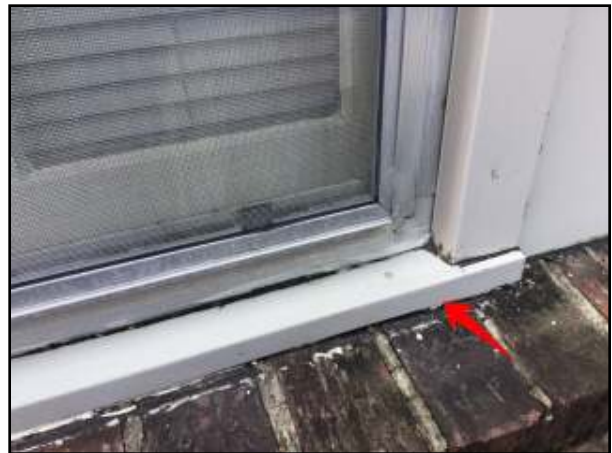
Repair: there is wood rot at the rear bay window frames underneath the aluminum cladding. There may be some additional damage concealed from view.

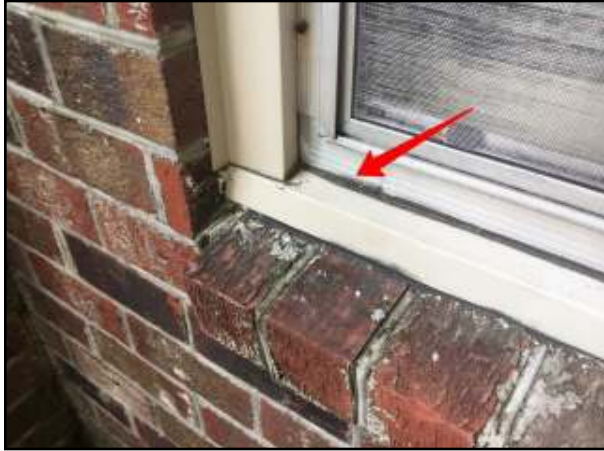
Figure 18-1

Repair: there is wood rot at the rear window frame underneath the aluminum cladding. There may be some additional damage concealed from view.

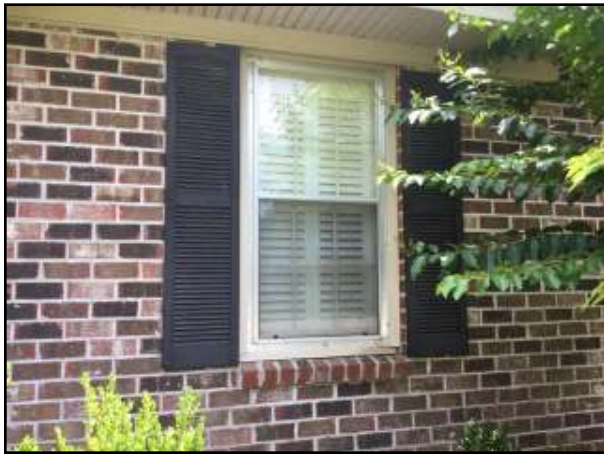
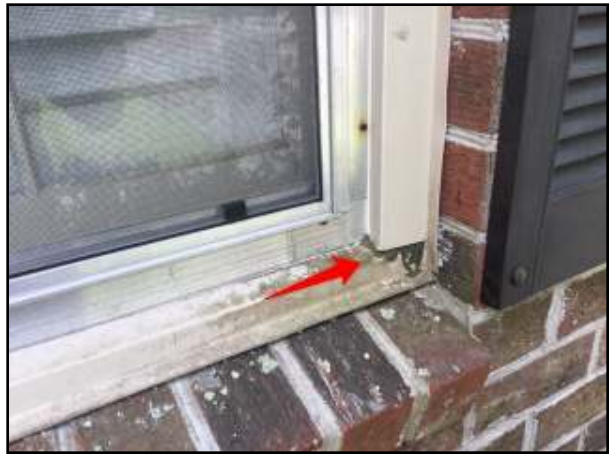
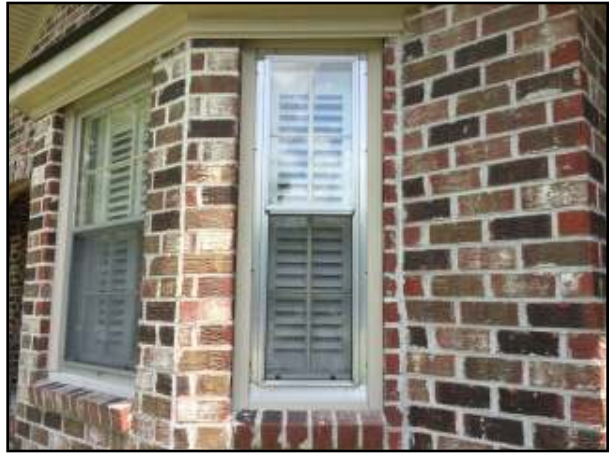
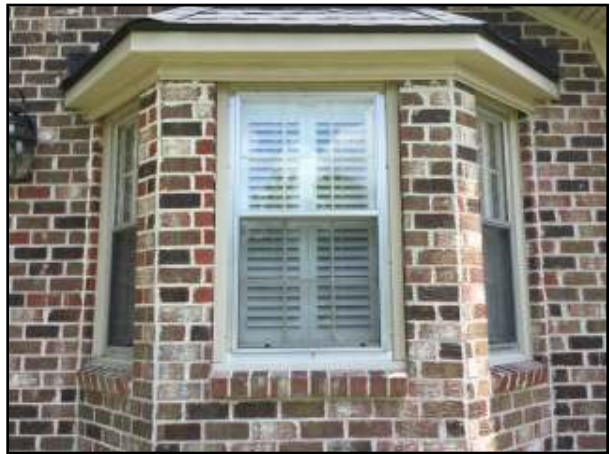
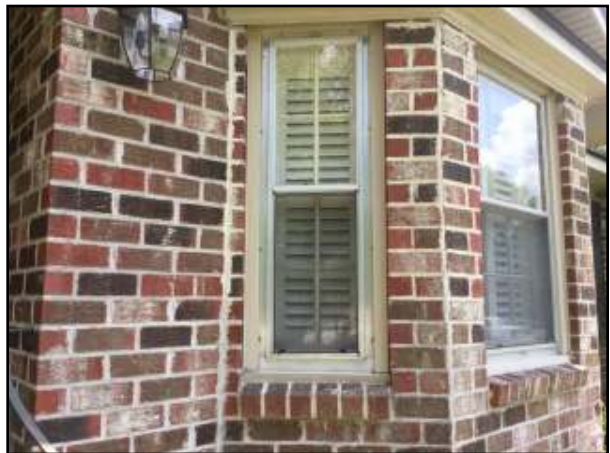
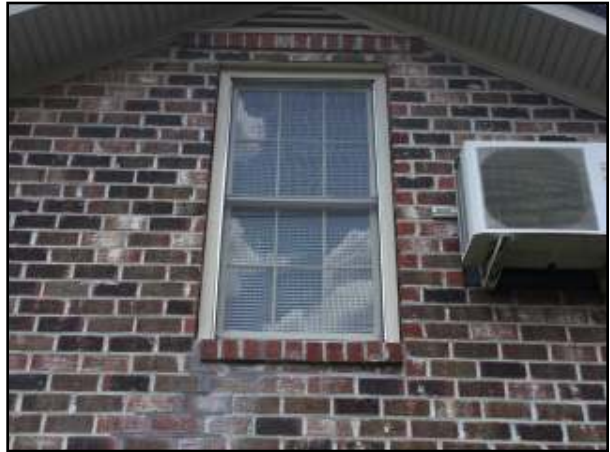
Repair: all windows cladding needs to be caulked and sealed.

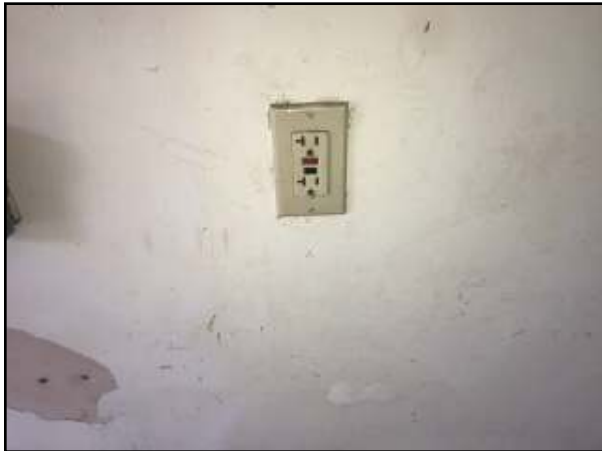
Figure 22-1

Repair: the garage GFCI outlet did not respond when tested. The outlet needs to be GFCI protected.

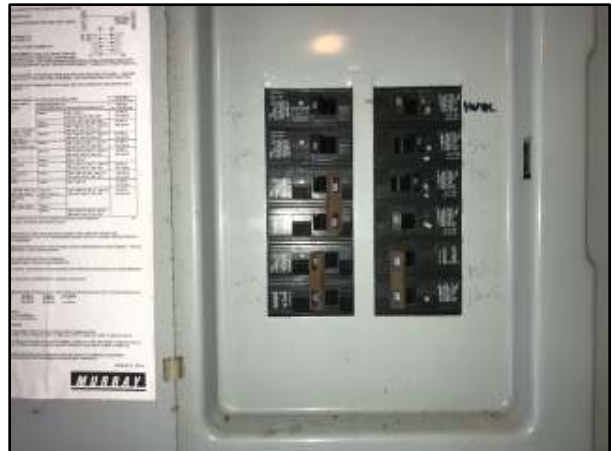
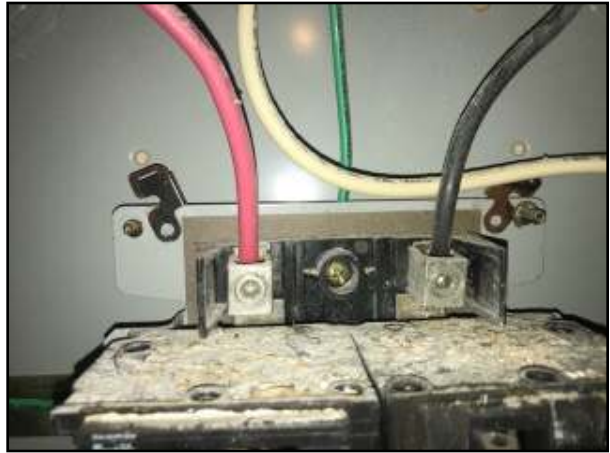
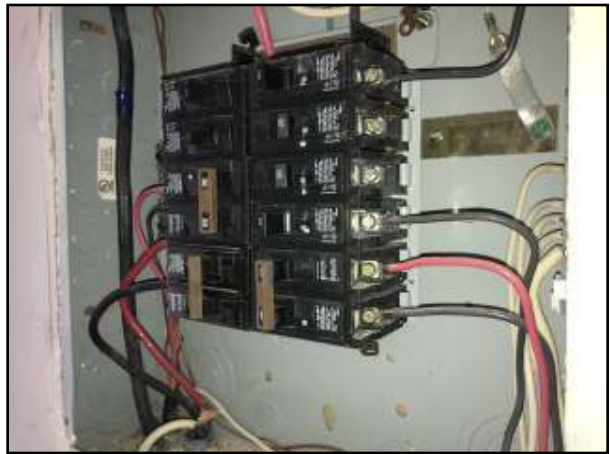
Repair: the breakers in the sub panel box in the garage are not labeled.

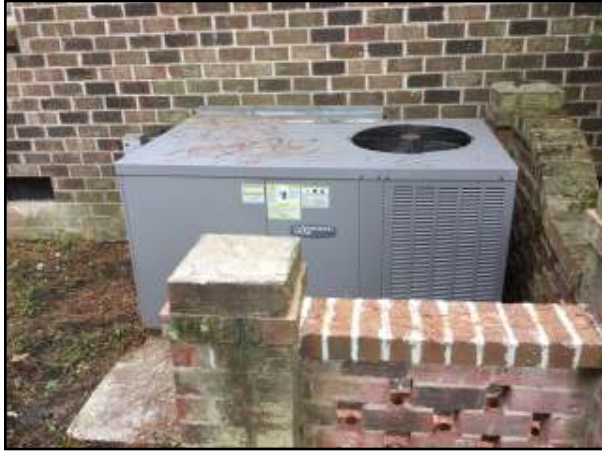
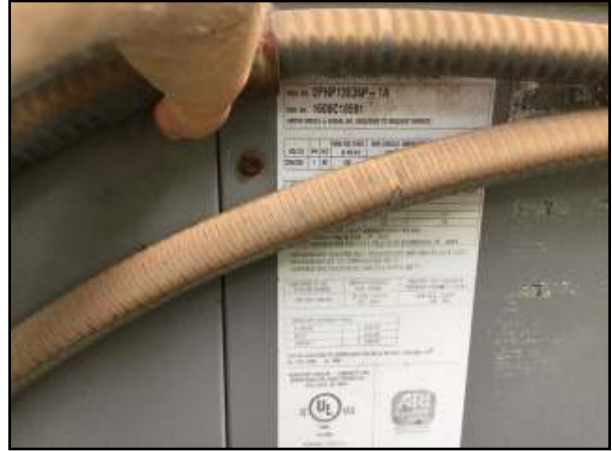
Monitor: The heat pump system was manufactured in 2006. The system responded properly when tested in heating and cooling mode. The typical lifespan of a heat pump system is 20-25 years. No one can predict when replacement will become necessary. It is recommended you obtain a home warranty for unexpected repairs.

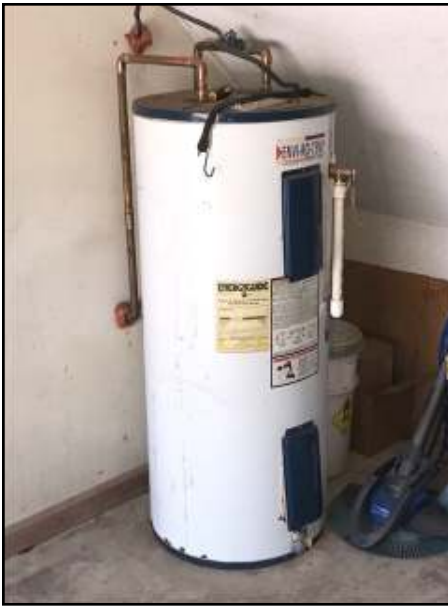
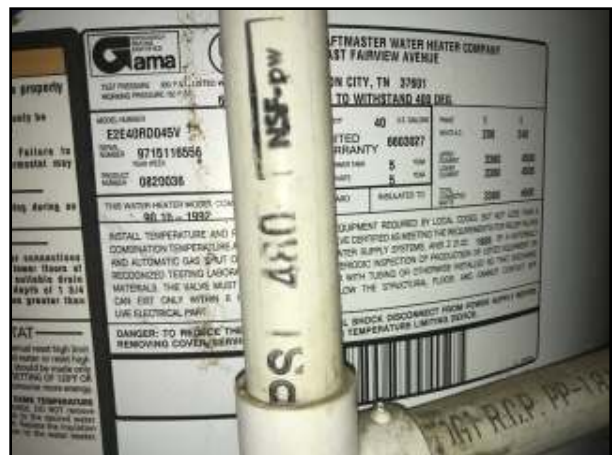
Monitor: The water heater was manufactured in 1997. The typical lifespan of a water heater is 10 to 15 years. The unit responded properly when tested. The system is beyond this age range and may require a higher level of maintenance. No one can predict when replacement will become necessary.

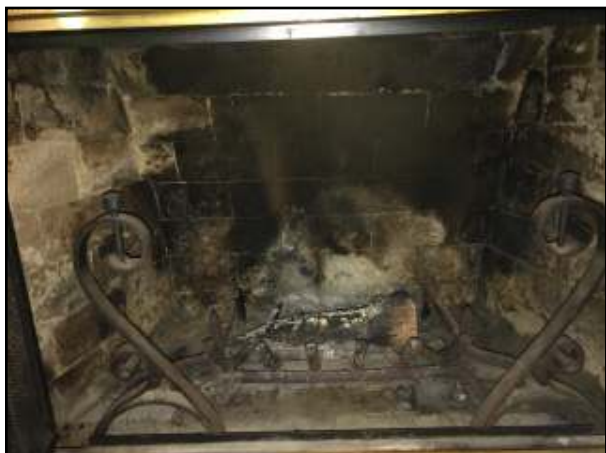
Figure 30-1

Monitor: there is soot buildup in the fireplace flue. Having the flue inspected and cleaned by a chimney sweep is recommended.

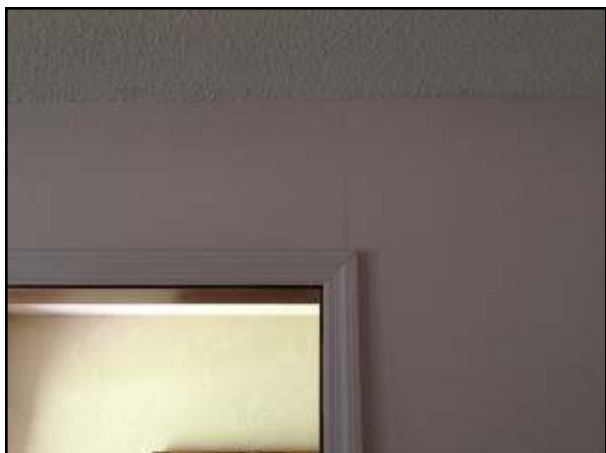
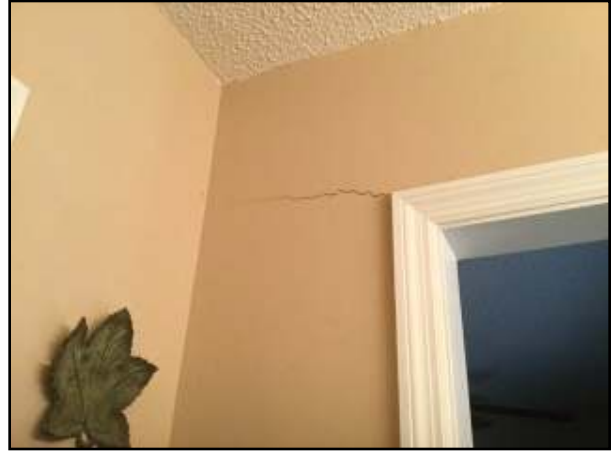
Monitor: several interior settlement cracks were observed. Following floor structure repairs, interior cracks should be repaired.

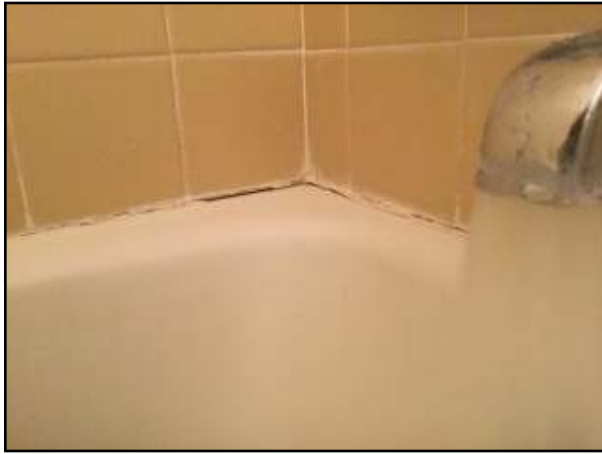
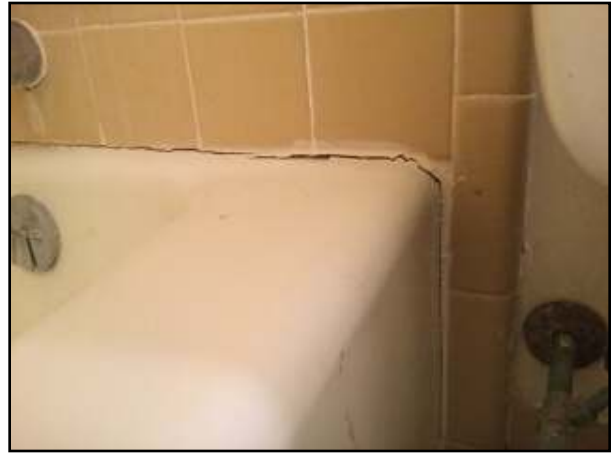
Repair: the tile tub surround in the hall bath needs to be caulked.

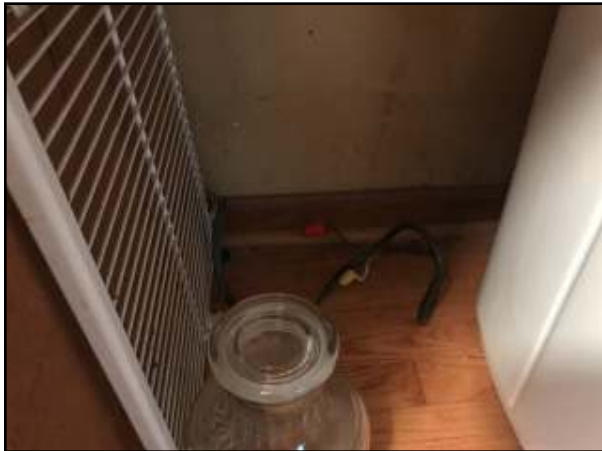
Figure 38-1

Repair: the dishwasher has been removed. The exposed wire needs to be terminated inside a junction box unless a dishwasher is being installed.
