Patriot Home Inspections

Home Inspection Report

123 Sample Ave

Inspected on Wed, Jun 20 2018 at 12:05 PM

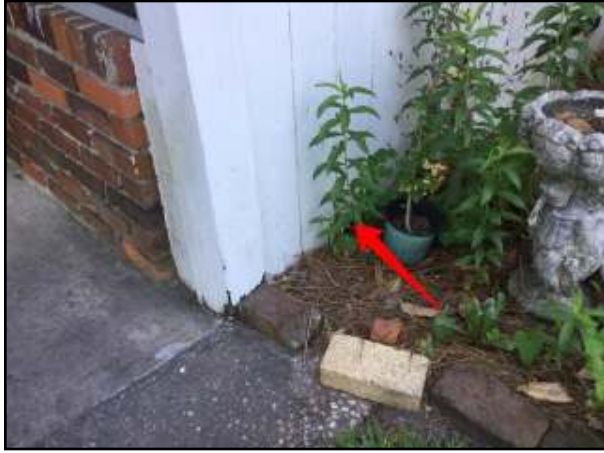
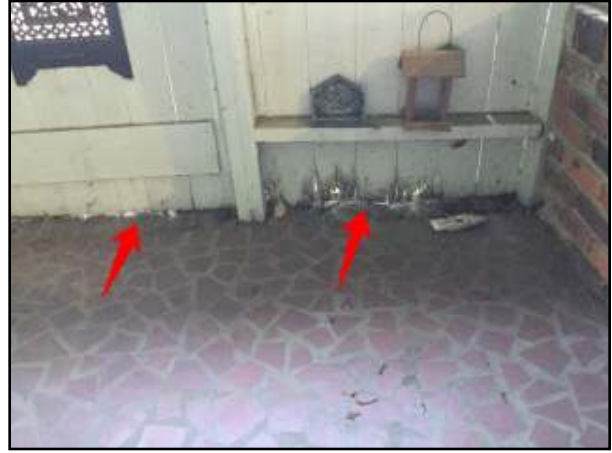
Repair: there wood rot from wood/soil contact along the fence between the carport and the house.

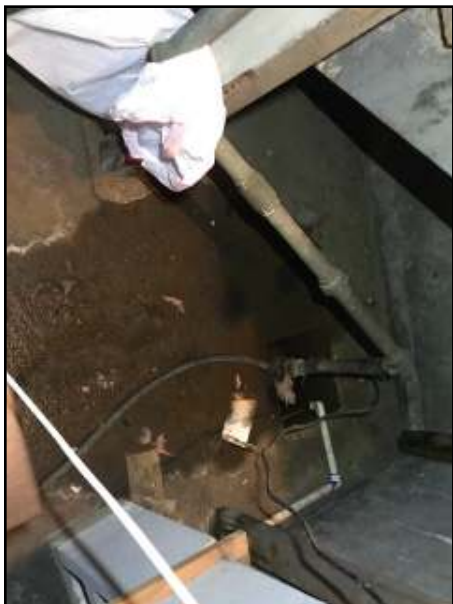
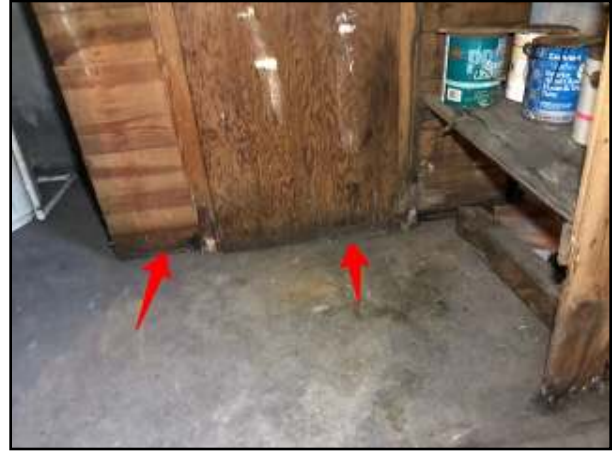
Monitor: there is evidence of prior water in the basement. There is a sump pump present and some wet concrete around the sump pump. There is wood rot on the base of the stairs and bookcases.

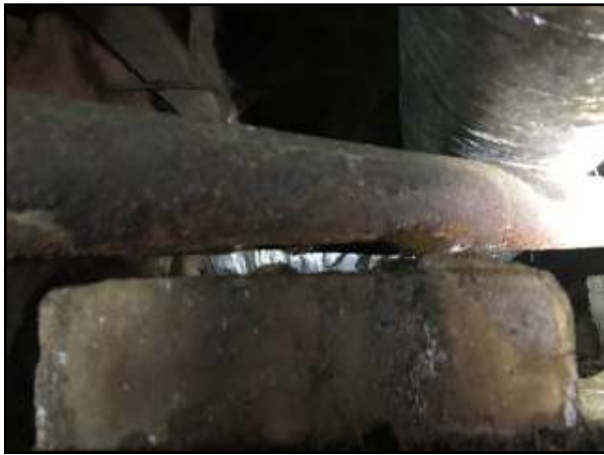
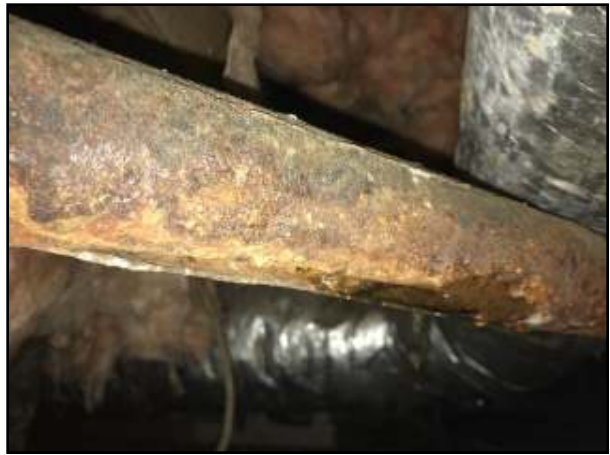
Repair: there is a leaky cast iron waste pipe under the kitchen. The cast iron piping is rusted and needs to be replaced.

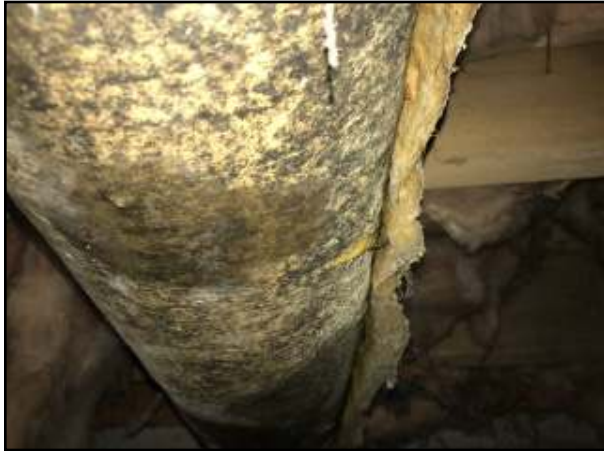
Figure 8-1

Repair: the ductwork is in poor condition and needs to be replaced. The ductwork has been sweating badly due to loose and torn insulation wrapping.

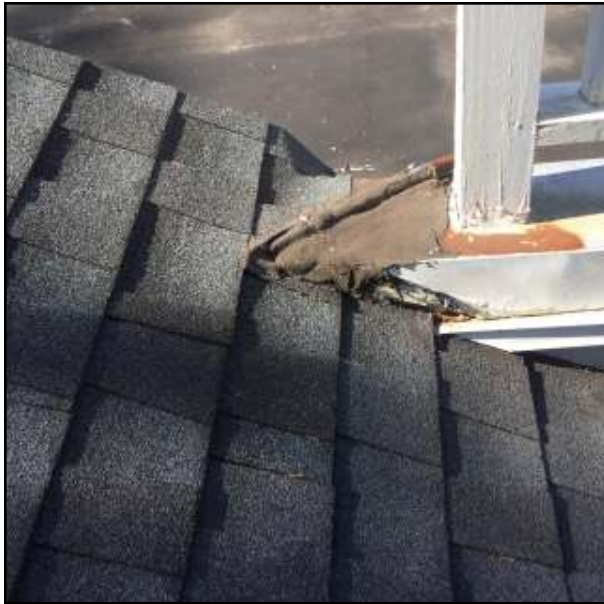
Figure 11-1

Monitor: the area where the left side flat roof and the carport roof intersects should be monitored. This area has been patched previously and may be prone to leaks.

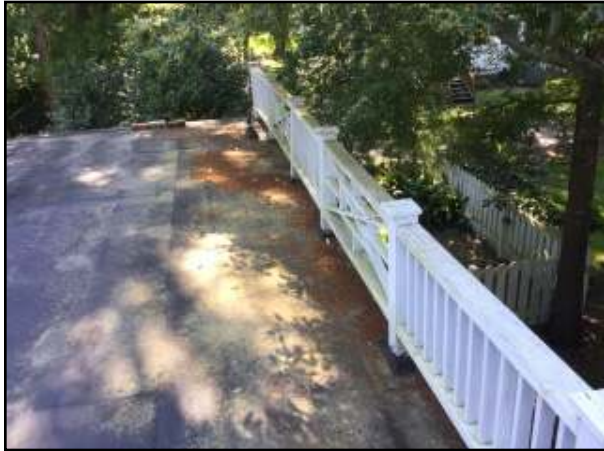
Figure 12-1

Repair: the base of the railings along the flat roof on both sides is loose with wood rot around the base of the posts.

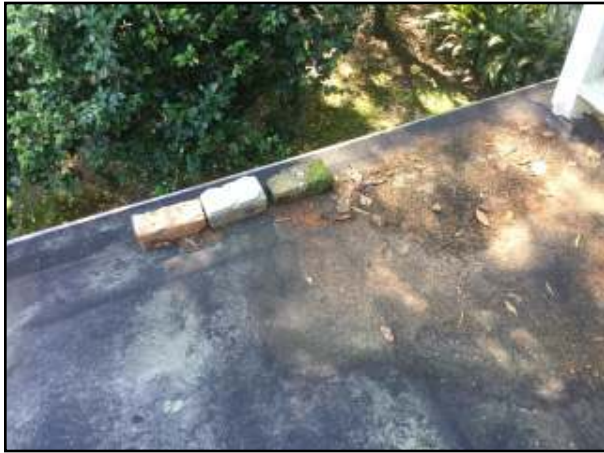
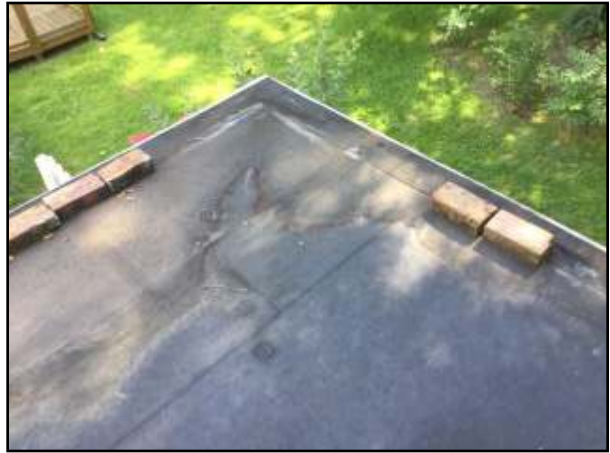
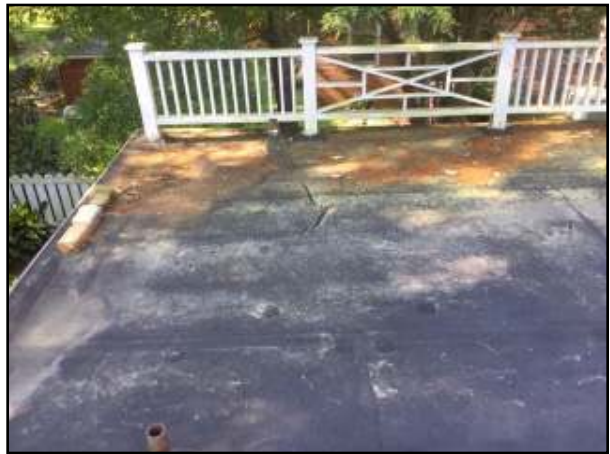
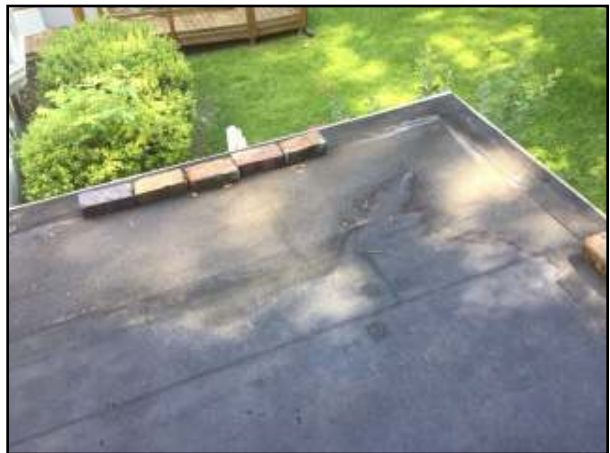
Monitor: There is evidence of water ponding on the flat roof. This condition should be monitored as it could lead to premature failure or leaking around the membrane seals. Grading improvements may be needed to conduct storm water runoff off the roof and into the gutters. Bricks have been placed along the edge to prevent the seams from curling as in the last picture.

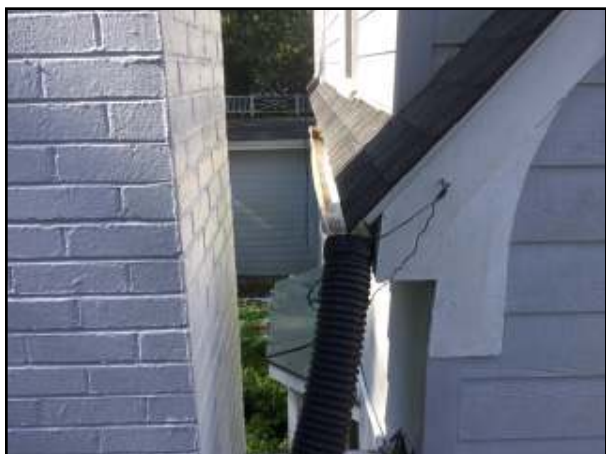
Figure 14-1

Repair: the left side rear gutter is partially clogged with debris. There is a gutter discharging over Head at the rear of the carport.

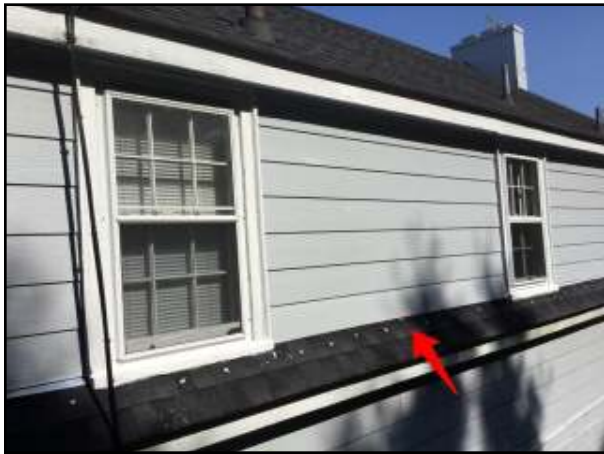
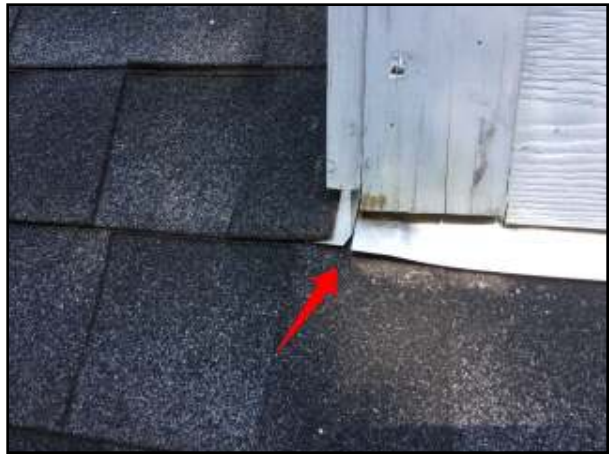
Repair: the rear flashing on the roof is improper and is gapped at the corners.

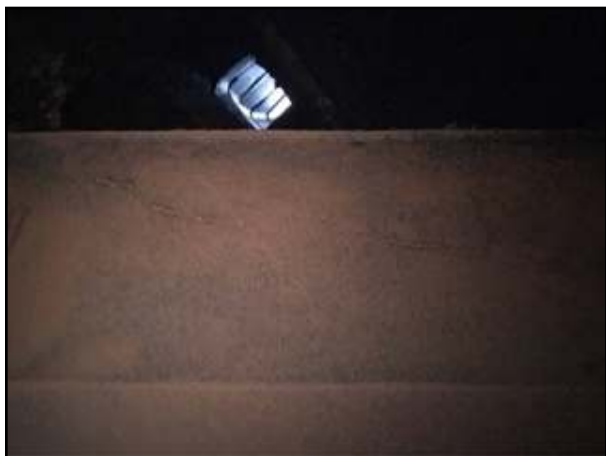
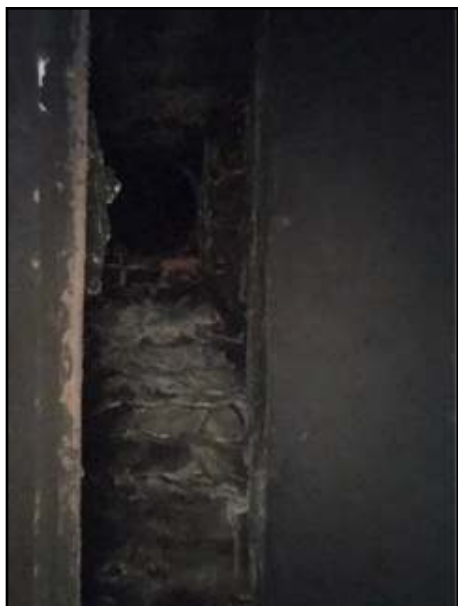
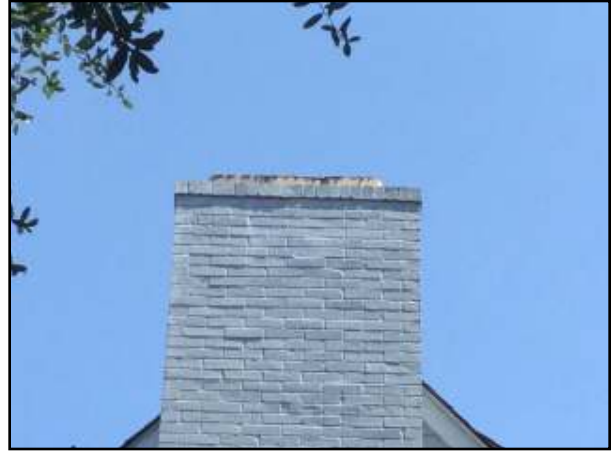
Repair: A rain cap should be installed on the masonry chimney flues and the chimney flues should be checked for damage. Damage flues can be unsafe. The dampers inside have rusted out.

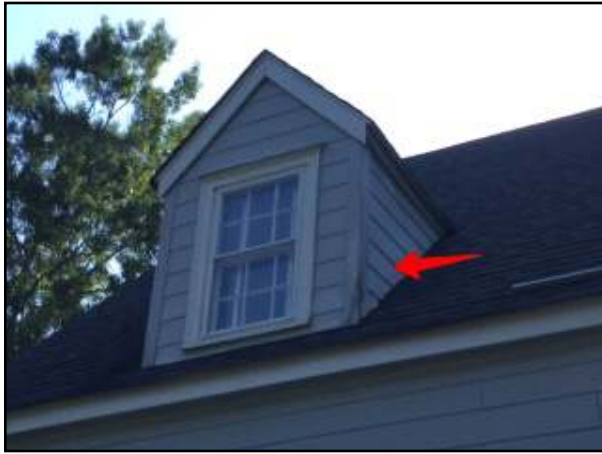
Figure 18-1

Repair: there is minor wood rot in the front left dormer trim.

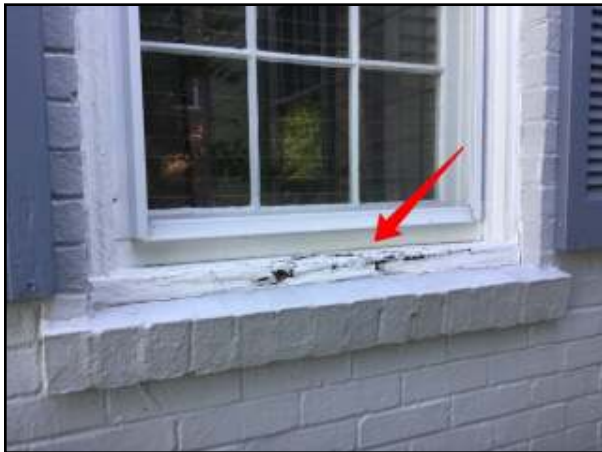
Figure 19-1

Repair: there is wood rot in the right side window frame.

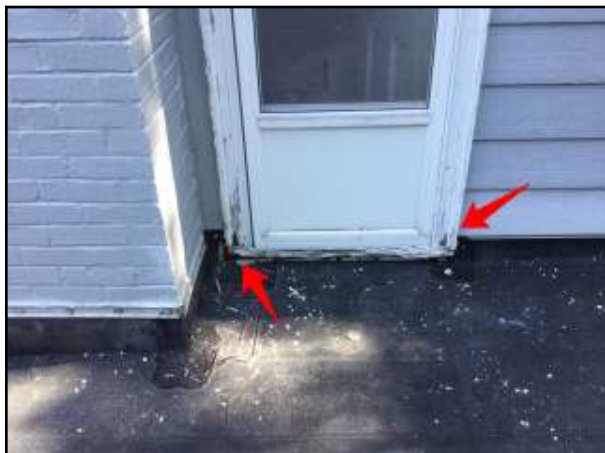
Figure 20-1

Repair: there is wood rot in the exterior door frame off the right side flat roof.

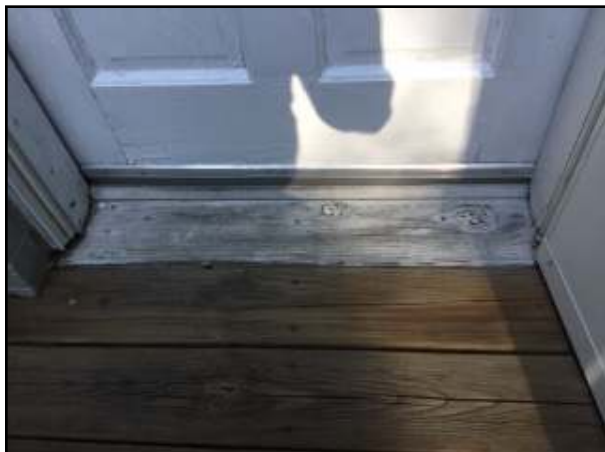
Figure 21-1

Repair: there is wood rot in the rear exterior door frame at the ramp entry.

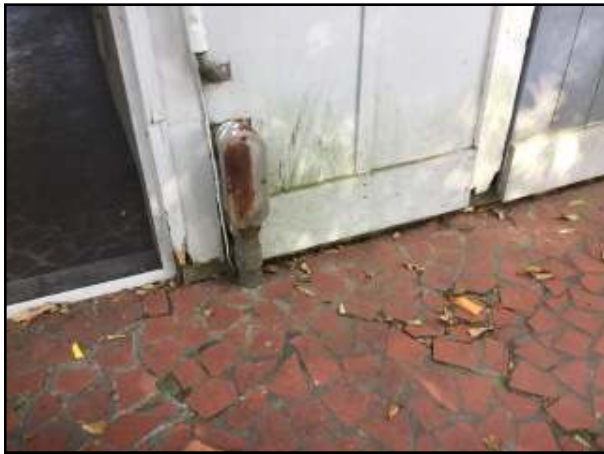
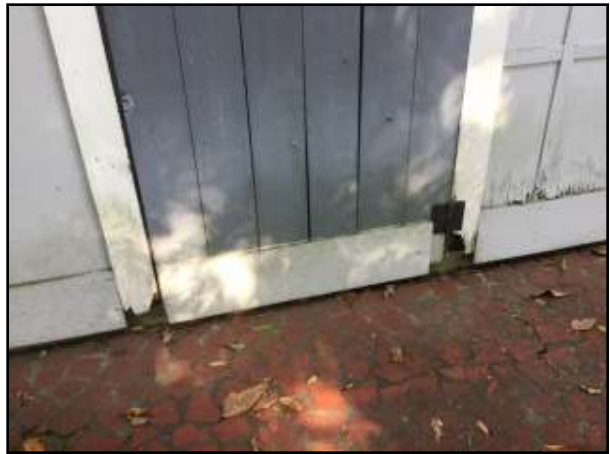
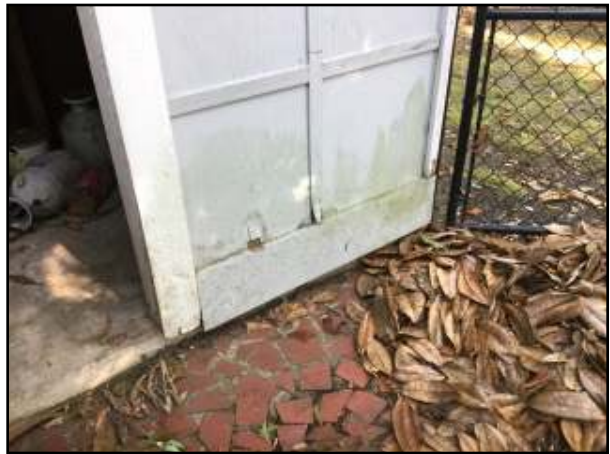
Repair: there is wood rot in the exterior door and siding off the rear storage room.

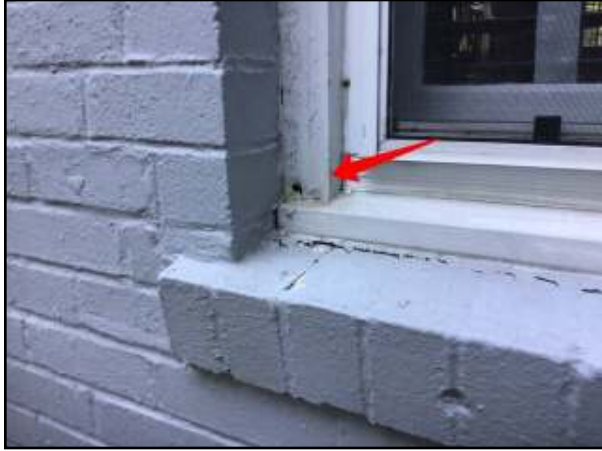
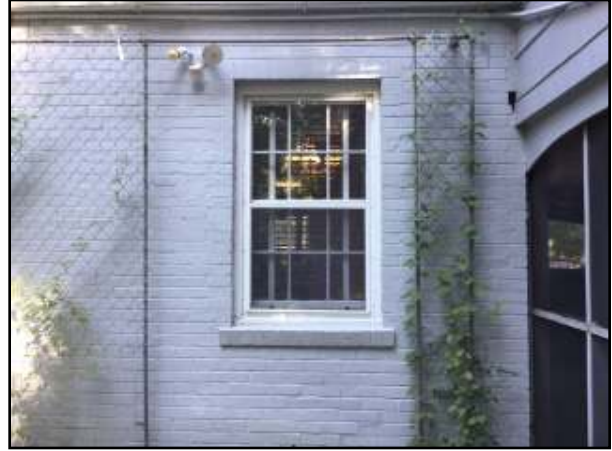
**Comment 23:**
Repair: there is wood rot in the rear window frame by the rear ramp access.

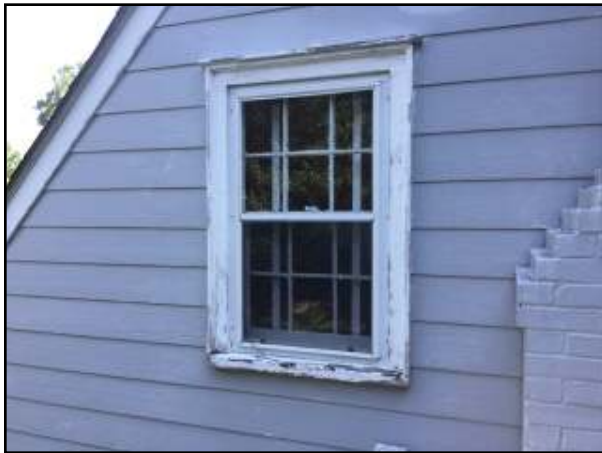
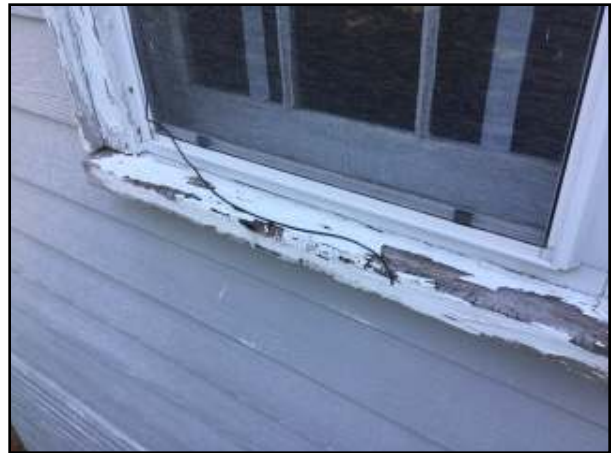
**Comment 24:**
Repair: the second floor window frame off the right side flat roof needs the be painted.

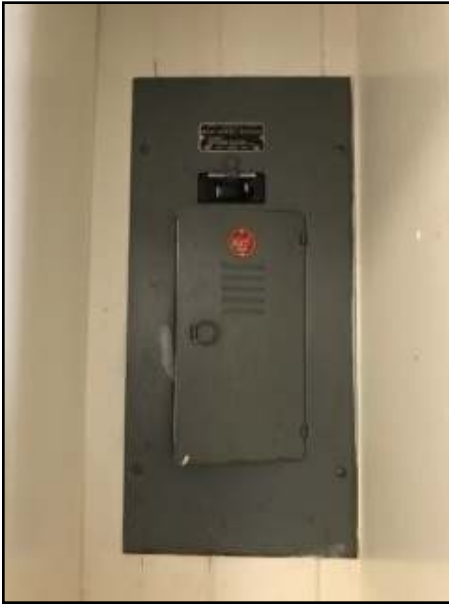
Figure 26-1

Repair: The panel is a FPE Stab-Lok breaker box located in the closet off the kitchen. These panel boxes are considered to be obsolete among industry professionals and insurance carriers. The panel box needs to be replaced. See write-up in the Electrical section of this report concerning FPE Stab-Lok breaker boxes. The panel should be replaced by a licensed electrician.

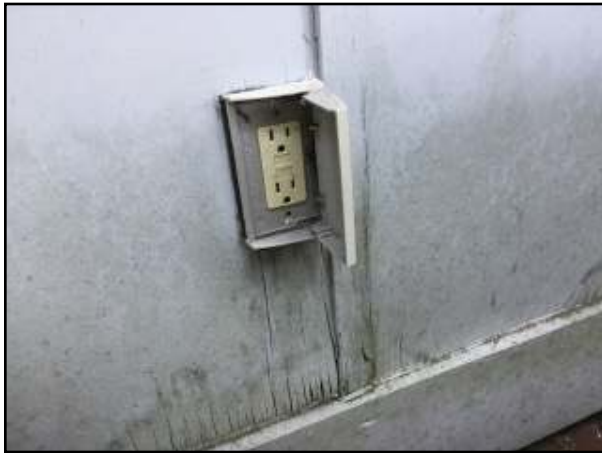
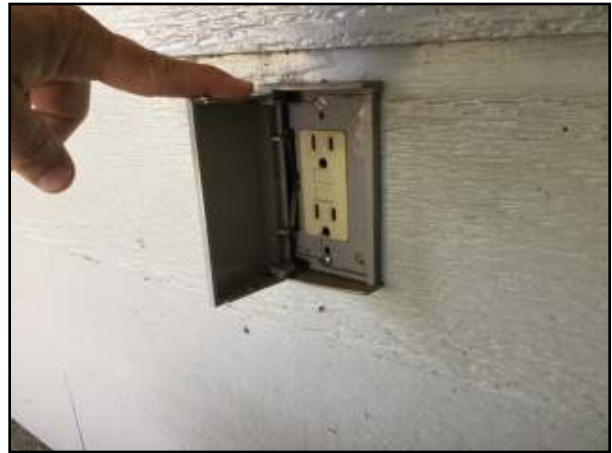
Repair: the front and rear GFCI outlets off the storage roof failed to trip when tested. The outlets need to be replaced.

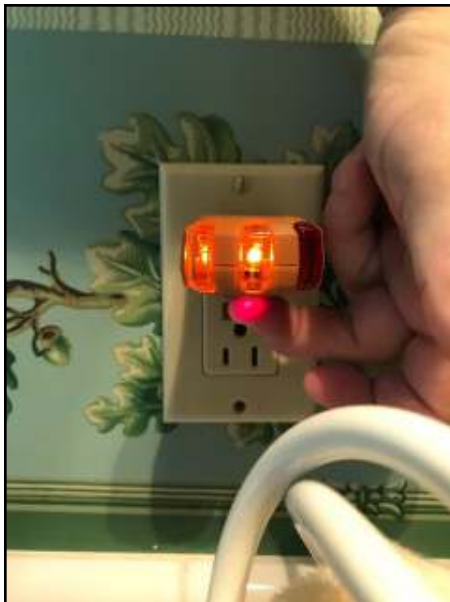
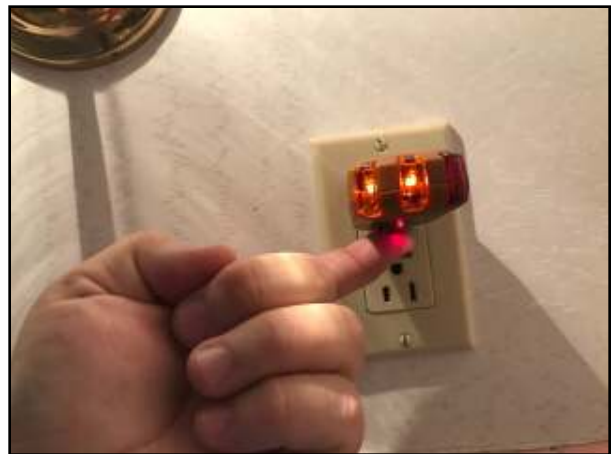
Repair: the half bath and second floor master bath GFCI outlets off the storage roof failed to trip when tested. The outlets need to be replaced.

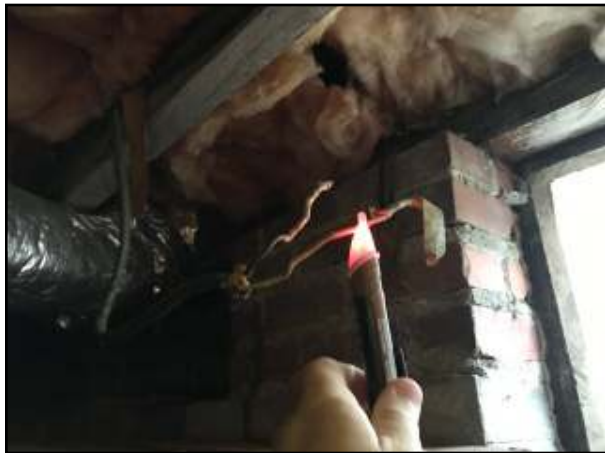
Figure 29-1

Repair: there is an abandoned live electrical wire in the basement. The wire needs to be removed or properly terminated inside an electrical junction box fitted with a cover plate.

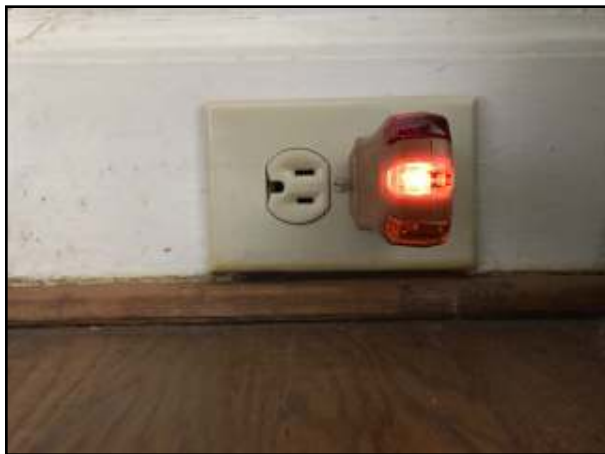
Figure 30-1

Repair: there is an ungrounded outlet in the dining room.

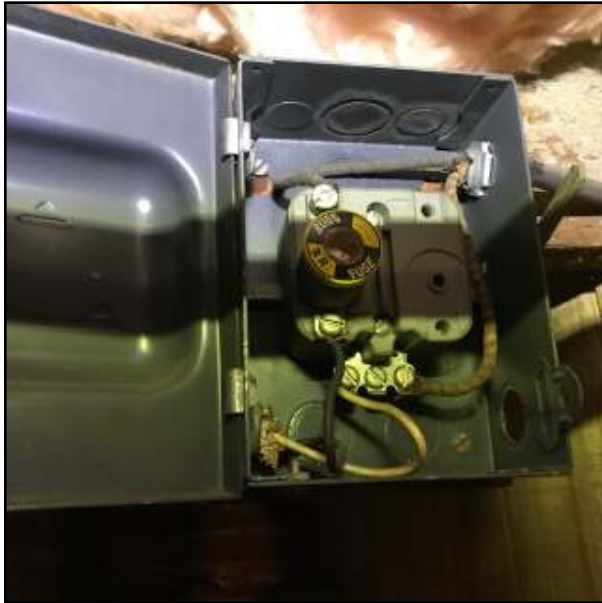
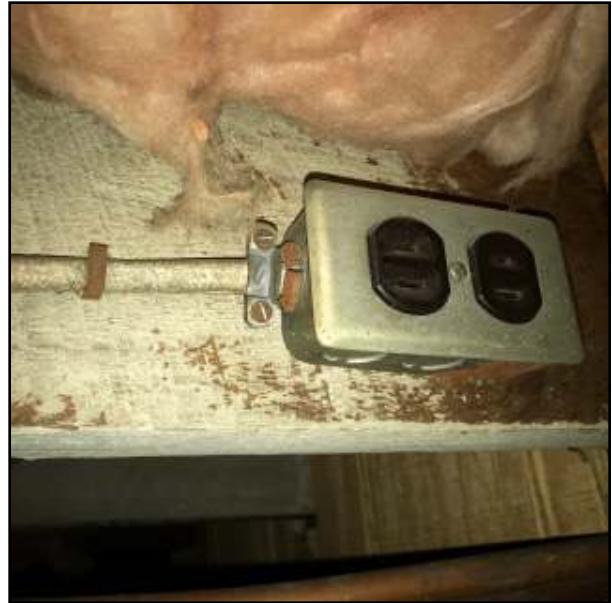
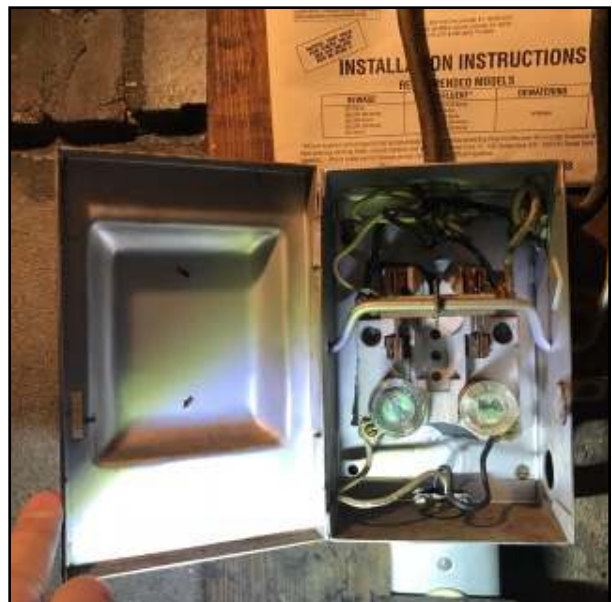
Repair: there are two fuse boxes in the basement with cloth covered wiring. Cloth covered wiring should be replaced. The fuse boxes should be replaced with breaker boxes.

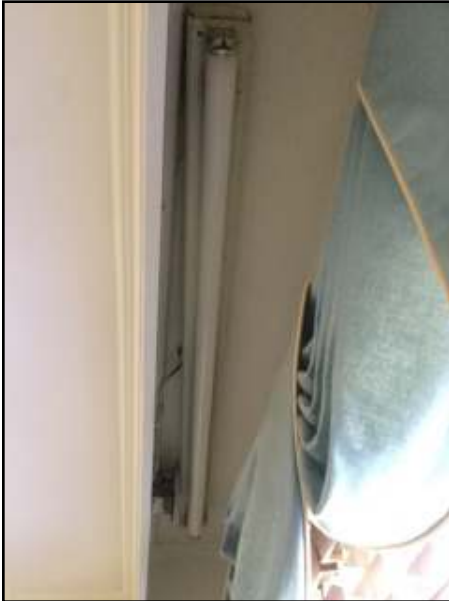
Figure 32-1

Repair: the fluorescent light over the kitchen sink is inoperative.

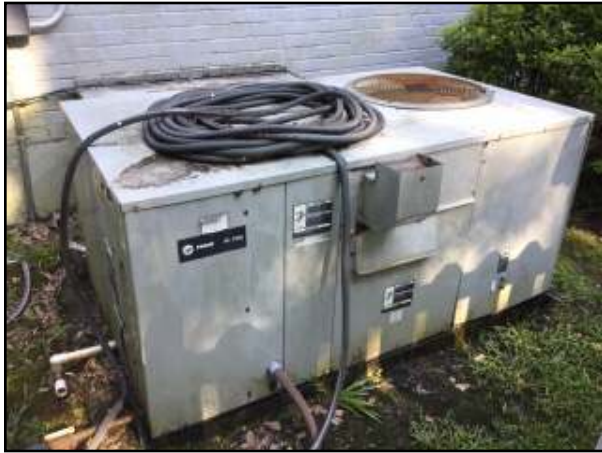
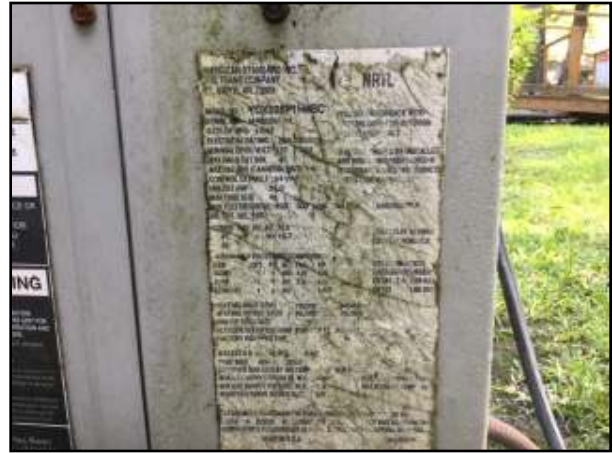
Monitor: The gas pack heating and cooling system was manufactured in 1997. The system responded properly when tested in cooling mode. The typical lifespan of a forced air system is 20 to 25 years. The system is within this age range. The size and configuration should be adequate for a home this size. No one can predict when replacement will become necessary. It is recommended a home warranty be maintained for unexpected repairs.

Furnaces over 10 years old should be checked, cleaned and serviced yearly by a licensed contractor.

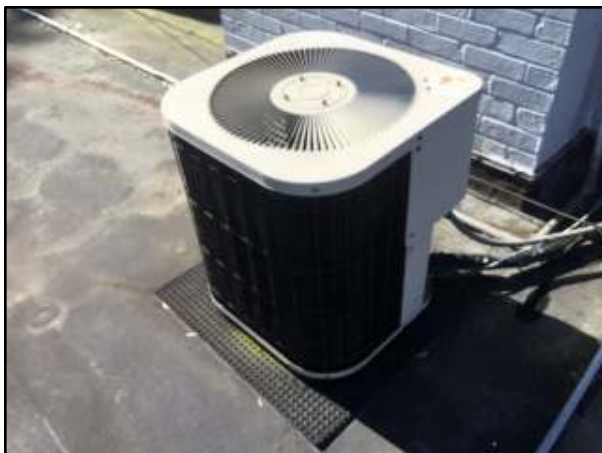
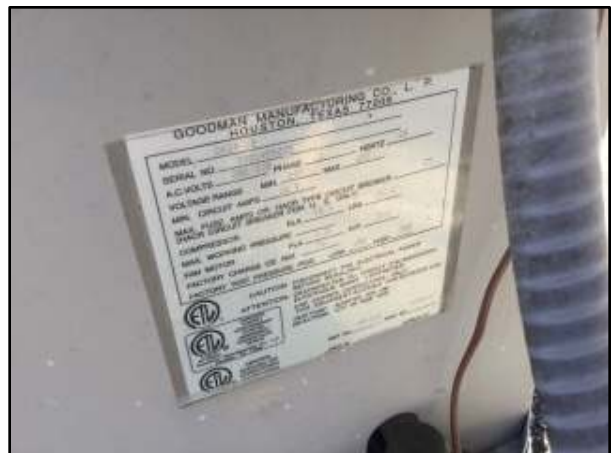
Monitor: the condensing unit was manufactured in 1998. The system responded properly when tested. The typical lifespan of an air conditioning system is 20-25 years, depending on the level of care it receives. The system is within this age range. No one can predict when replacement will become necessary. It is recommended a home warranty be obtained to cover unexpected repairs.

Air conditioners over 10 years old and heat pumps over 5 years old should be checked, cleaned and serviced yearly by a licensed contractor.

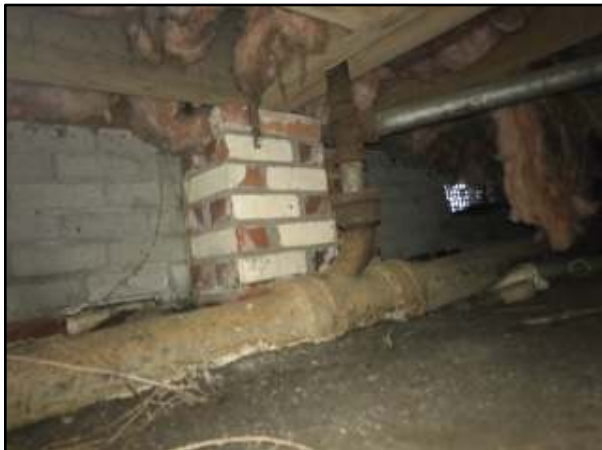
Figure 37-1

Monitor: there is some cast iron waste pipes inside the crawl space. The older piping may be prone to leaks and generally replaced on an as needed basis or during planned renovations.

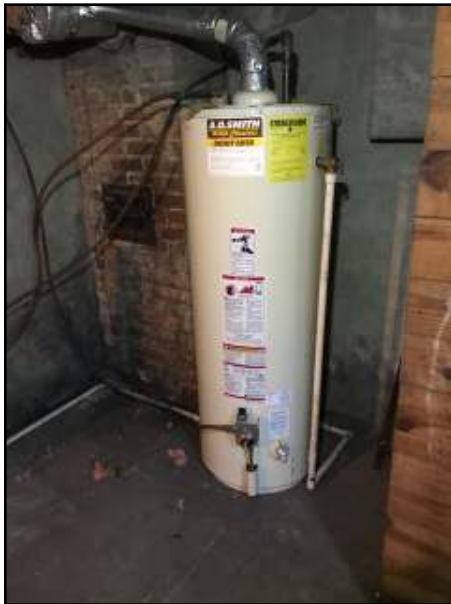
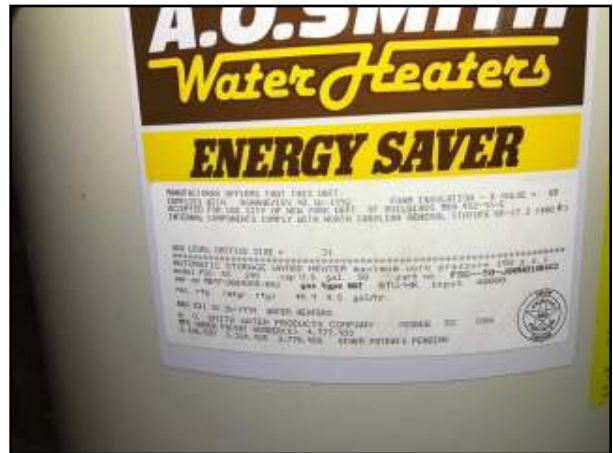
Monitor: The water heater was manufactured in 1997. The system responded properly when tested. The typical lifespan of a water heater is 10 to 15 years. The existing water heater is beyond this age range. No one can predict when repair will become necessary.

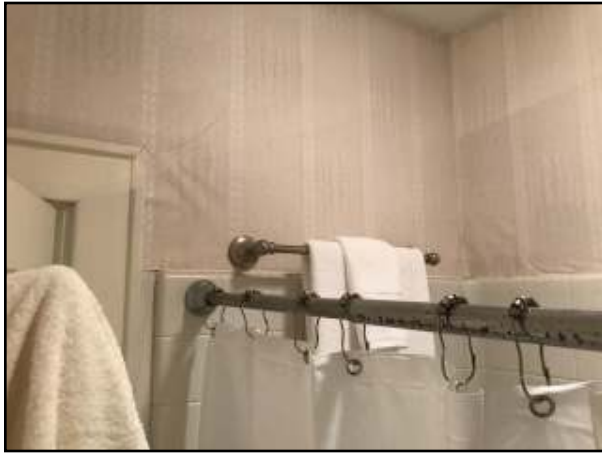
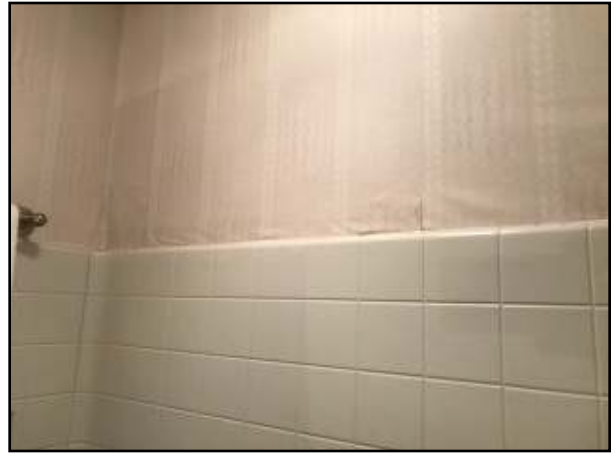
Repair: there is peeling wallpaper in the master bathroom over the shower.

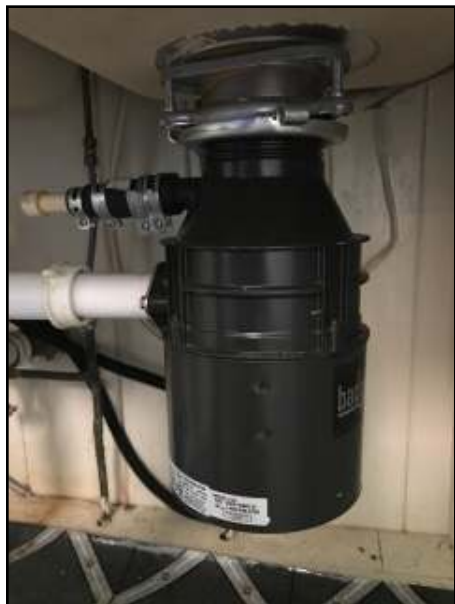
Figure 45-1

Monitor: The appliances are older units and responded properly when testing. Some useful life is remaining. Ultimately replacement will likely be desired.

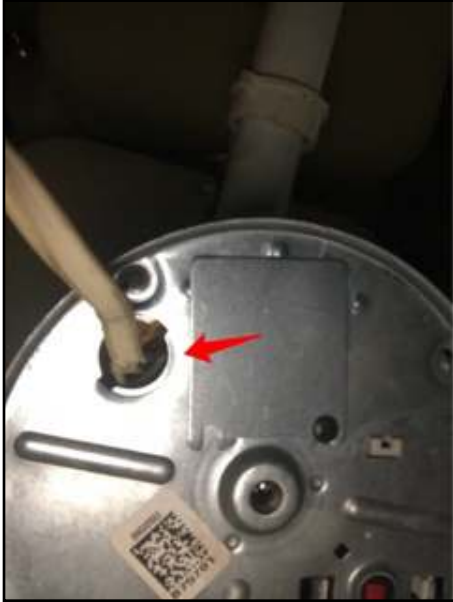
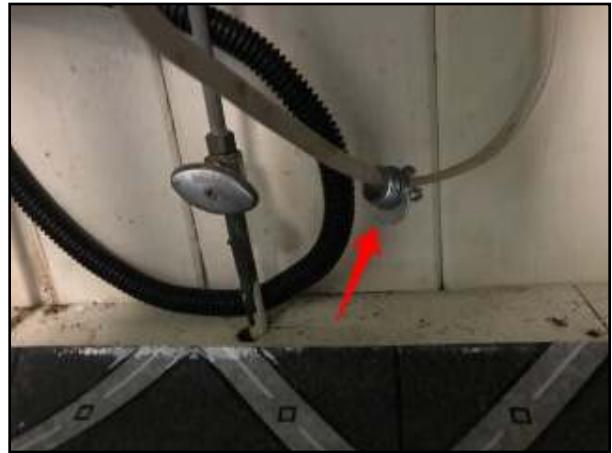
Repair: the connection clamp on the bottom of the waste disposal needs to be repaired so that the wires are not exposed.
