Patriot Home Inspections

Home Inspection Report

123 Sample Ave

Inspected on Wed, Jun 20 2018 at 12:02 PM

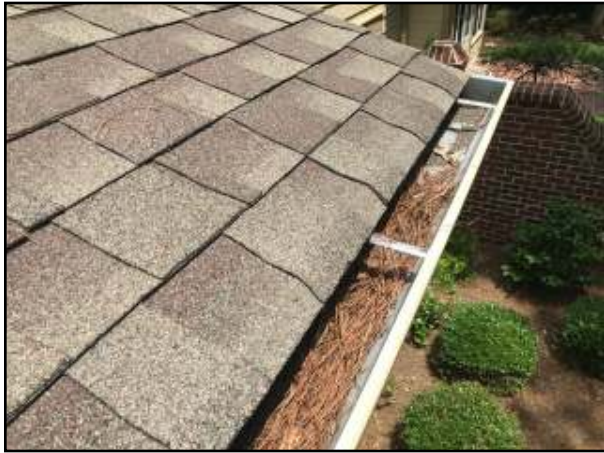
Figure 5-1

Repair: the rear gutter on the home needs to be cleaned to allow storm water run off to flow freely from the roof.

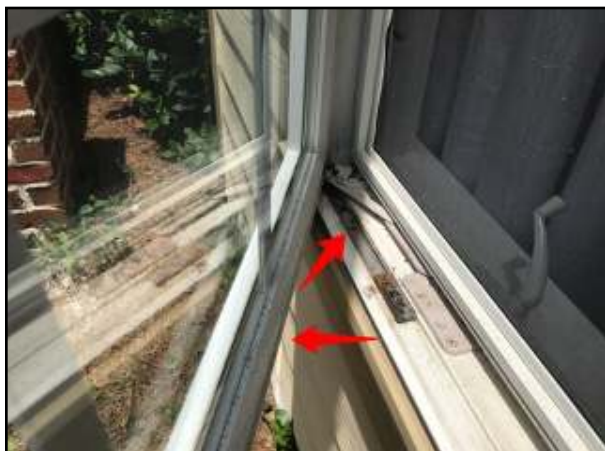
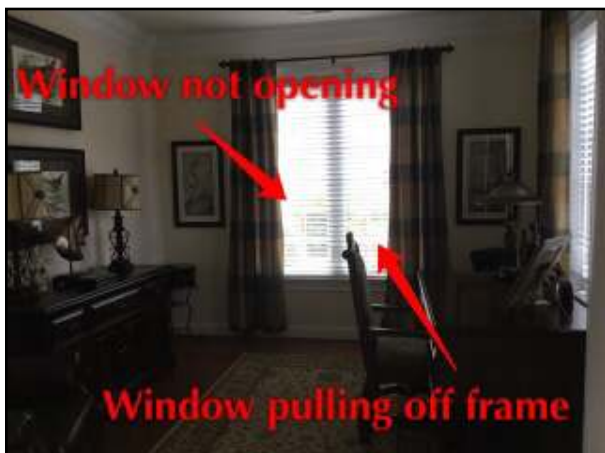
Repair: the crack hinge on the right side office window is broken causing the window to pull away from the frame during operation. The left side office window will not open due to the top of the window not clearing the frame.

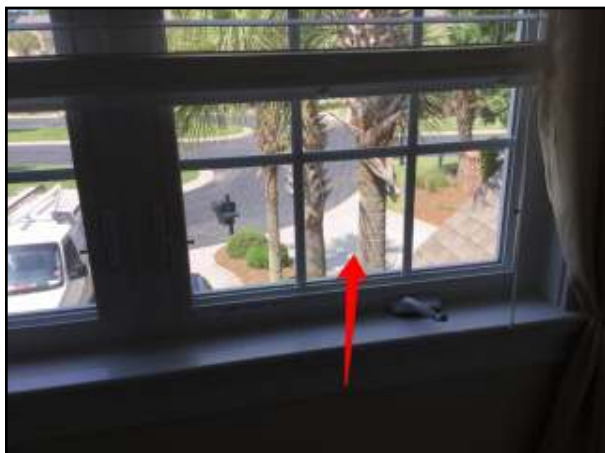
Figure 8-1

Repair: the right side second floor bedroom window is not opening properly during operation.

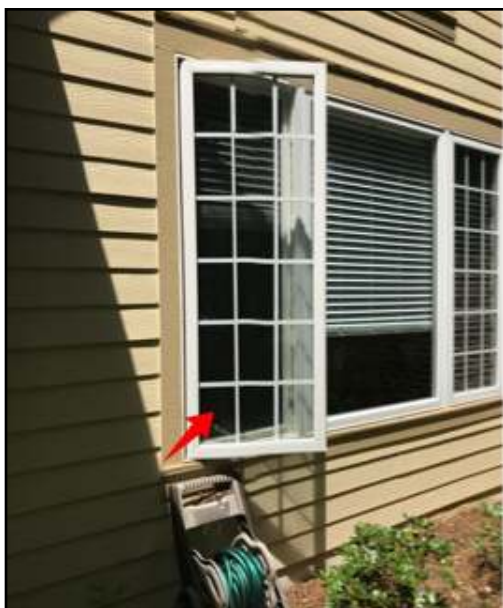
Figure 9-1

Repair: the right side window and the half moon window in the master bedroom have broken thermal seals. This results in fogging of the glass between the glass panes.

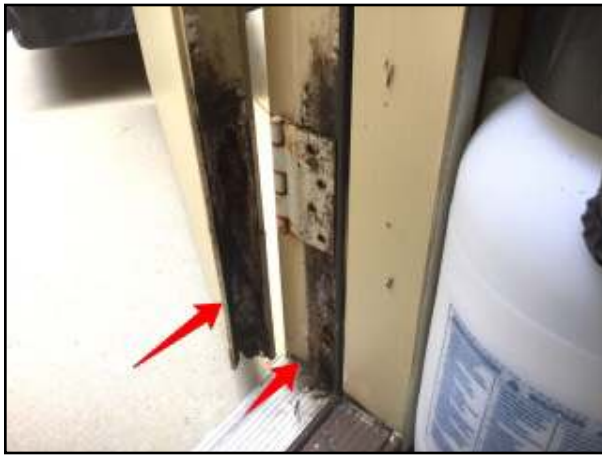
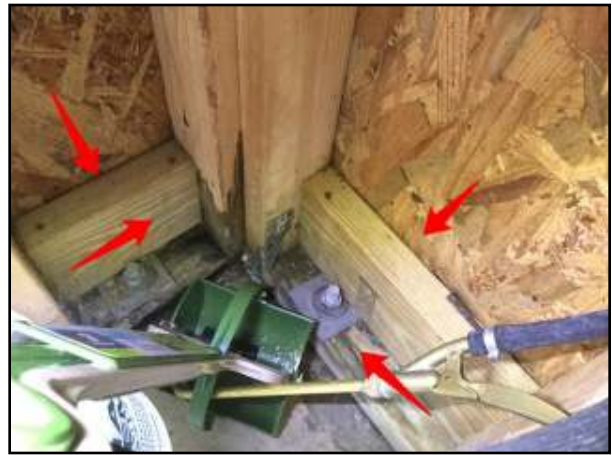
Repair: there has been water intrusion around the french door unit to the rear storage room. Both sides of the door unit have severe wood rot in the door and door frame. Water stains were observed to the wood framing around the door but the framing appears to be solid. Some treated wood has been added between the framing likely to support some water staining to the OSB Wall sheathing. The most severe damage appears to be isolated to the french door and door frame. Replacement is recommended.

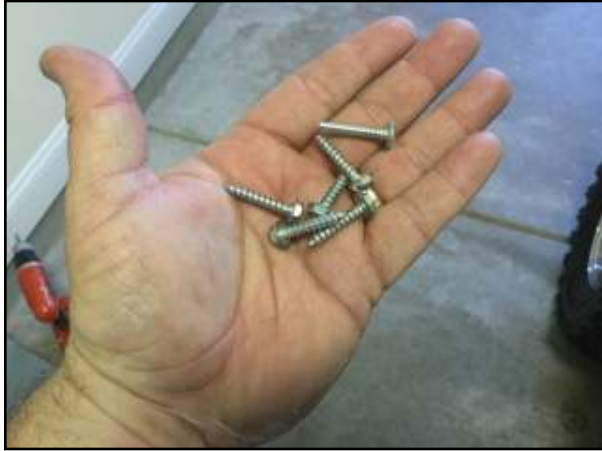
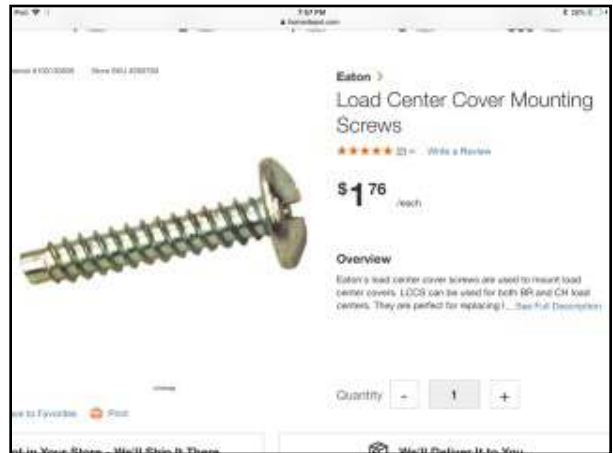
Repair: the screws used on the service panel cover are incorrect and sharp. Sharp screws can nick wires. The screws should be blunt ended screws designed for panel boxes. See example photo. They are sold in packs of 6 at most local hardware stores.

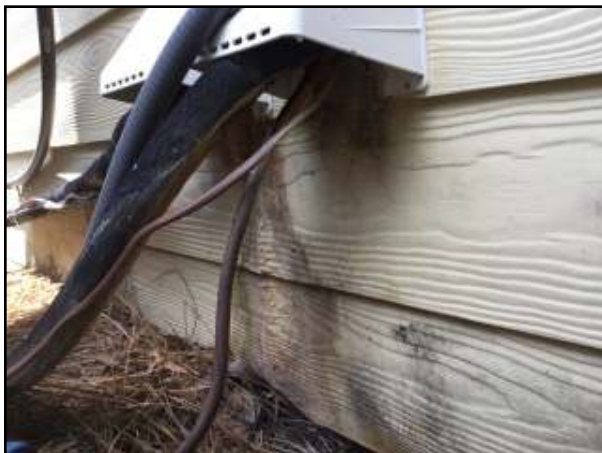
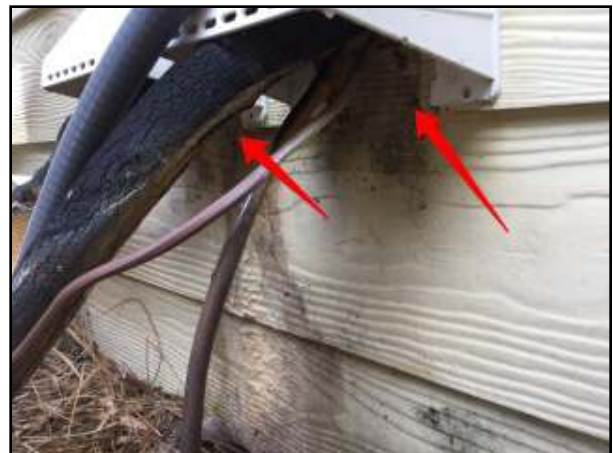
Repair: the condensate discharge pipes are discharging near the house. There is staining on the siding. This condition should be repaired by a licensed heating and cooling contractor. There is a risk of hidden damage inside the wall cavity.

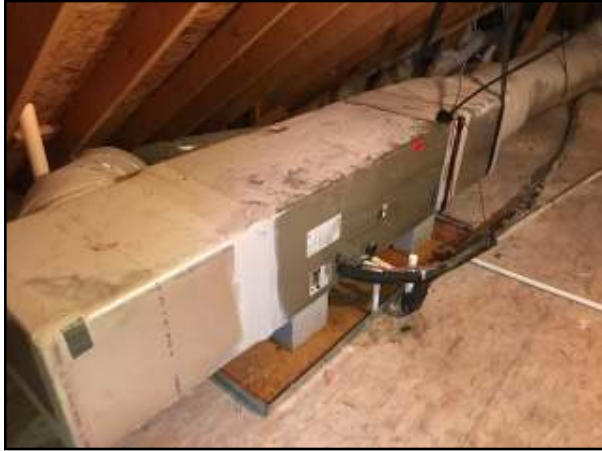
Figure 17-1

Monitor: The air handler of the heat pump system was manufactured in 2005. The system responded properly when tested. The typical lifespan of a heat pump system is 20-25 years. No one can predict when replacement will become necessary. It is recommended you obtain a home warranty for unexpected repairs.

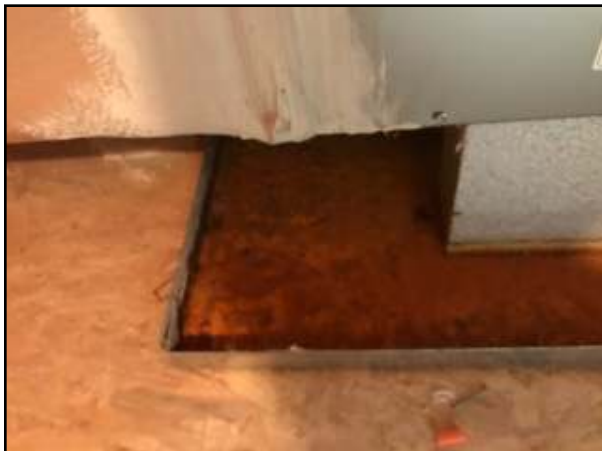
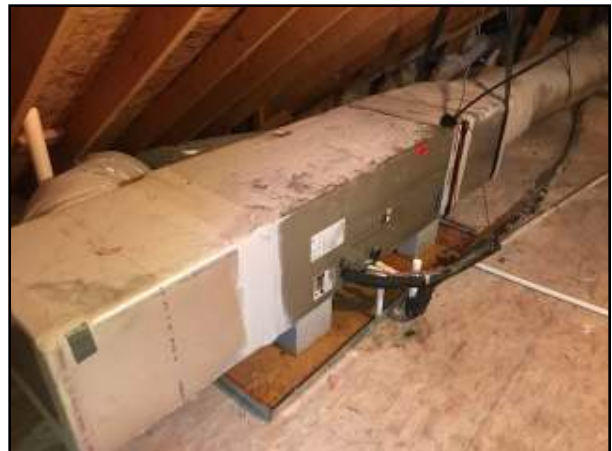
Monitor: there is evidence of prior water inside the secondary pan underneath the air handler. The pan is rusted. This indicates that the pan has held water in the past with pour properly draining out. This condition should be monitored.

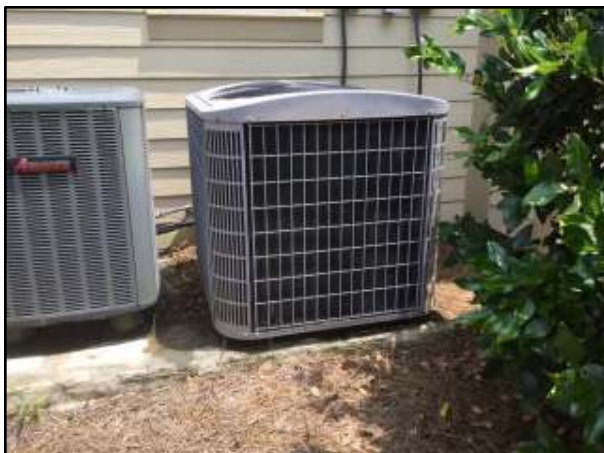
Figure 19-1

Monitor: the condensing unit was manufactured in 2006. The system responded properly when tested. The typical lifespan of a air conditioning system is 15-20 years in coastal climates. No one can predict when replacement will become necessary. It is recommended a home warranty be obtained to cover unexpected repairs.

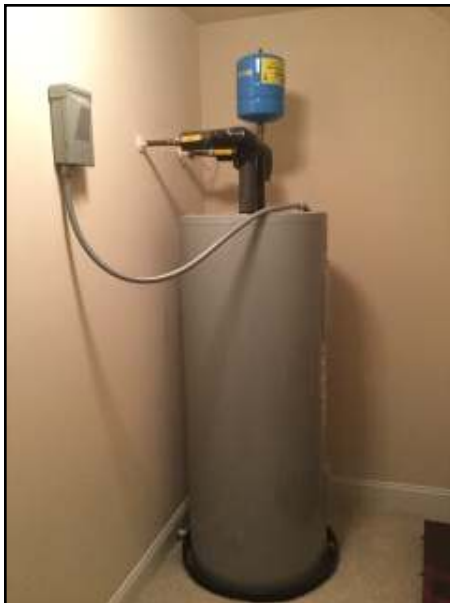
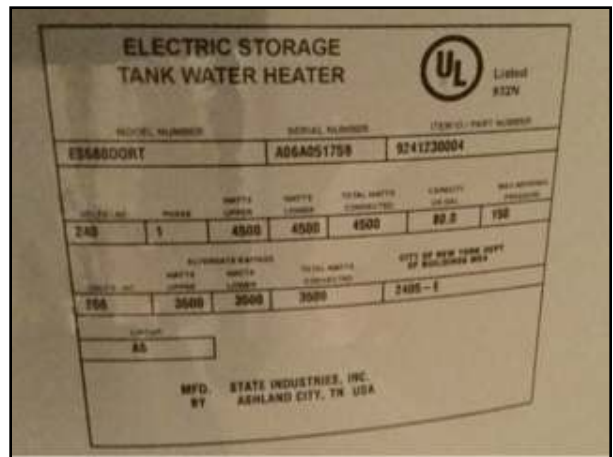
Monitor: The water heater was manufactured in 2006. The typical lifespan of a water heater is 10 to 15 years. The unit responded properly when tested. The system is within this age range and may require a higher level of maintenance. No one can predict when replacement will become necessary.

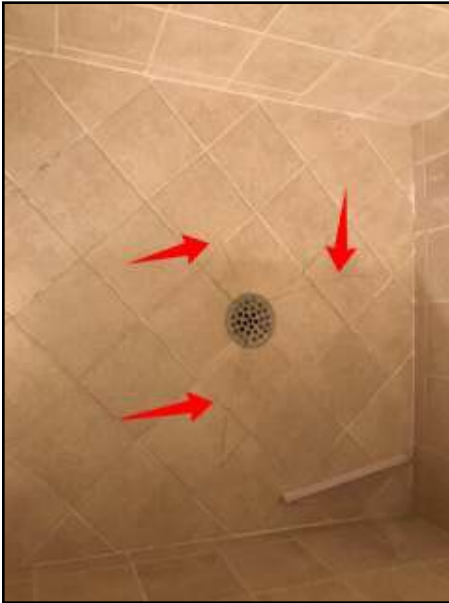
Figure 23-1

Monitor: the tile base in the shower is cracked. The base is concrete so therefore this is listed as a monitor item since there is no wood to rot. Keeping the base sealed will prolong the life of the tile and help prevent the tiles from coming loose.
