Patriot Home Inspections

Home Inspection Report

**123 Sample Ave
Anytown, SC 29555**

Inspected on Wed, Jun 20 2018 at 12:12 PM

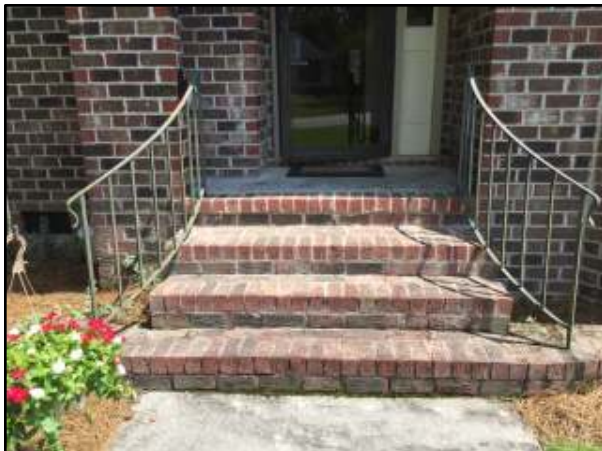
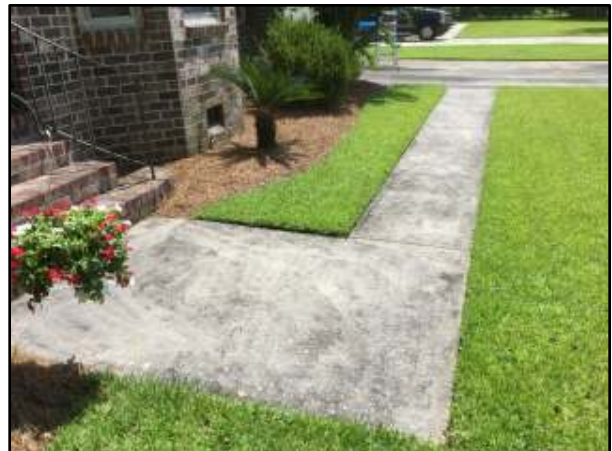
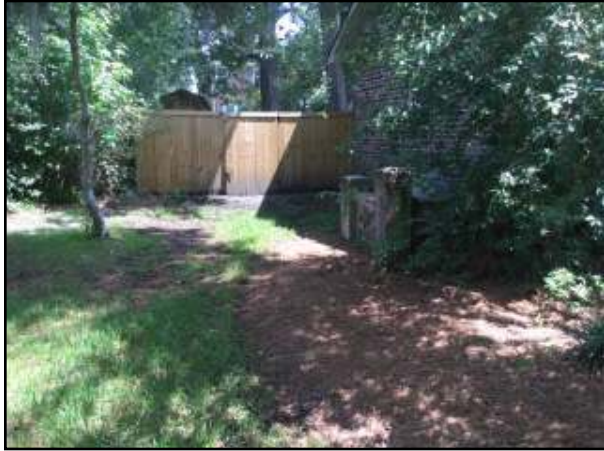
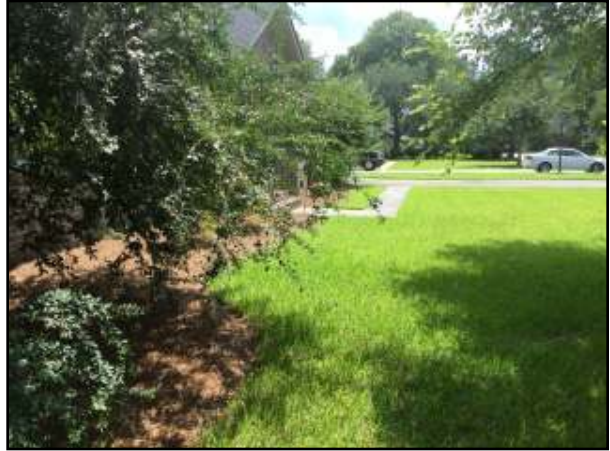
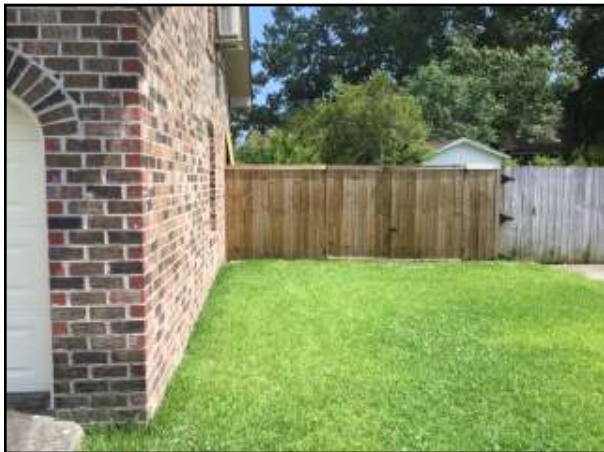
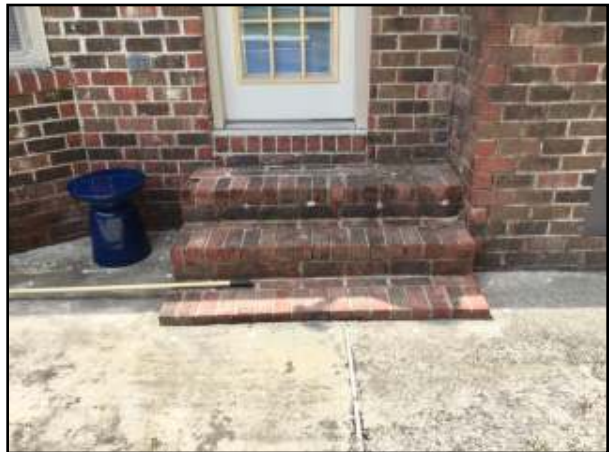
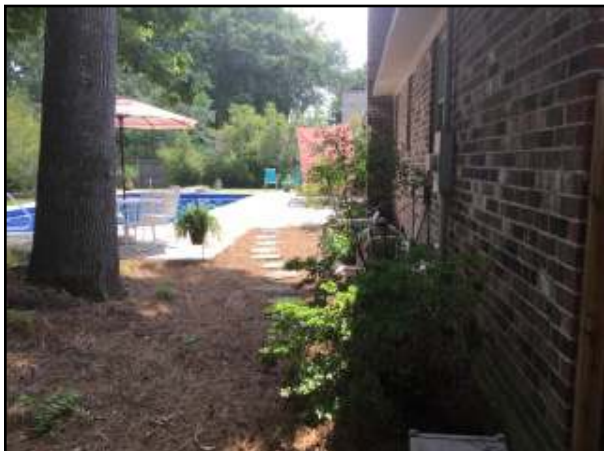
The lot is generally level grading. The steps and stoops are in generally good condition.

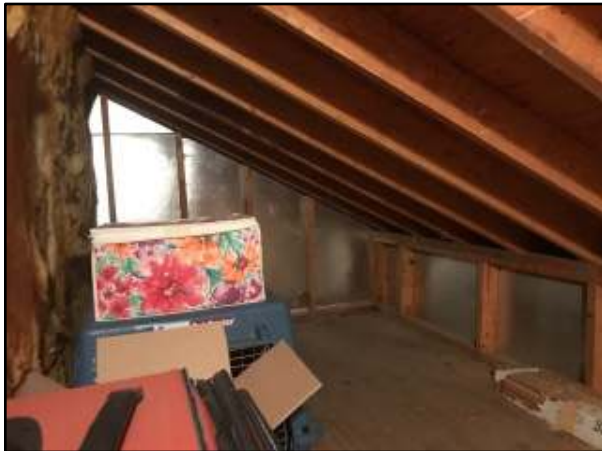
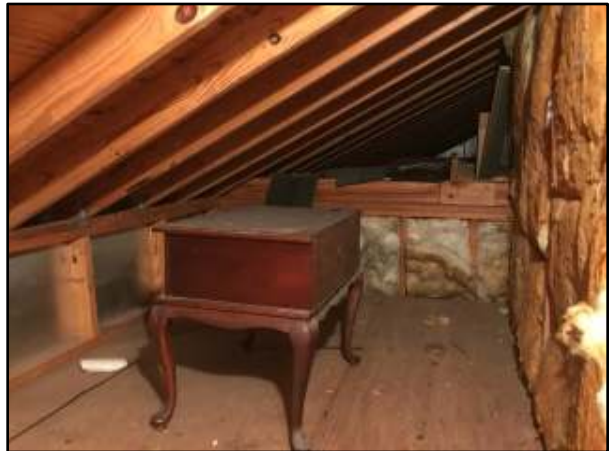
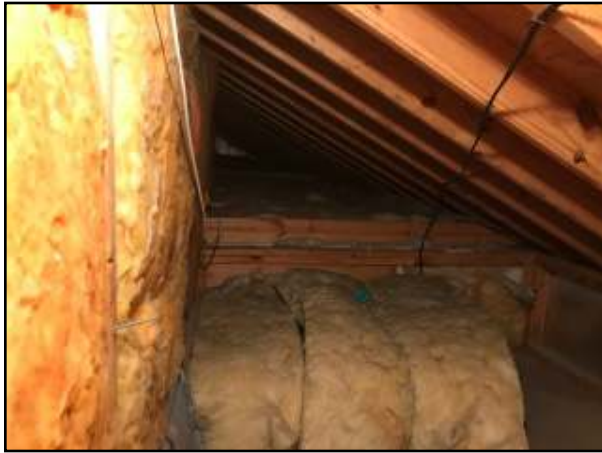
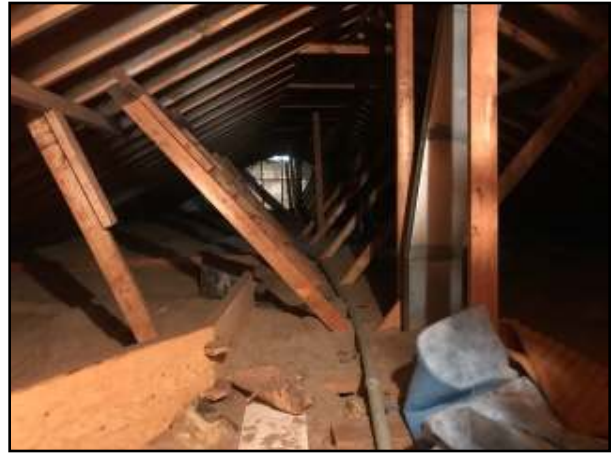
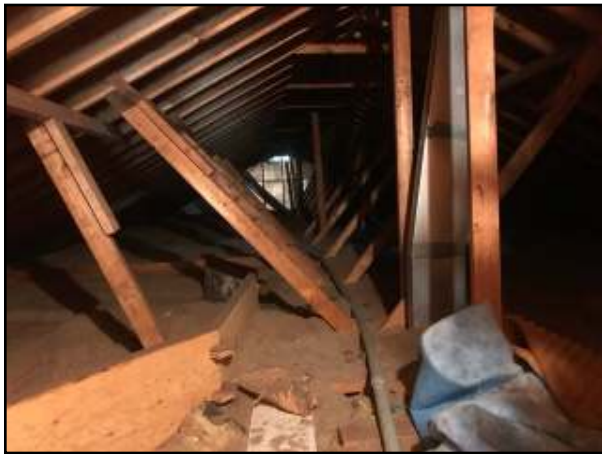
Insulation levels are typical for a home of this age and construction. Improvements can be made as needed or desired.

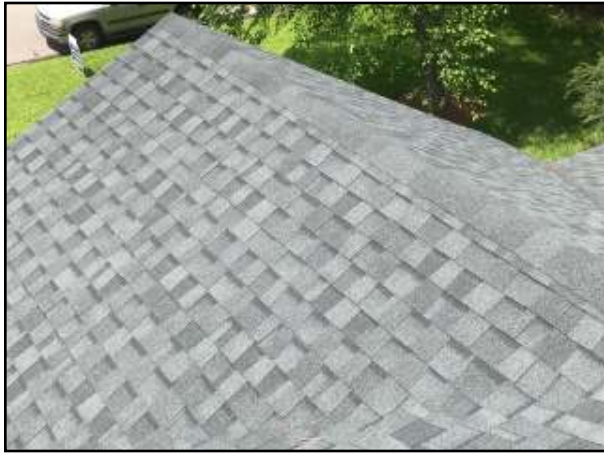
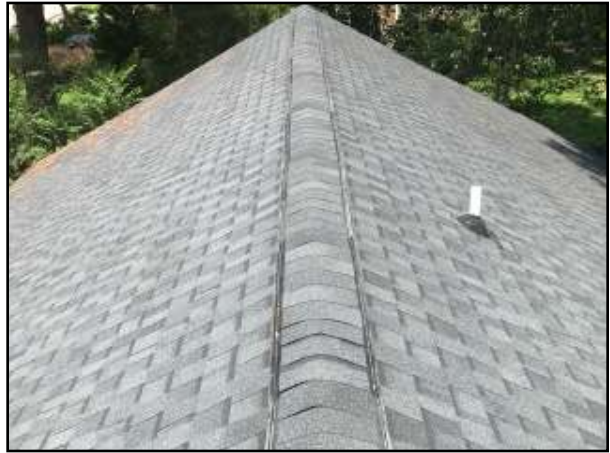
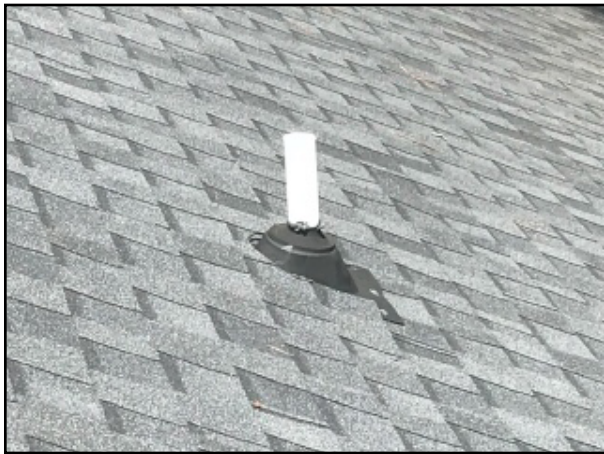
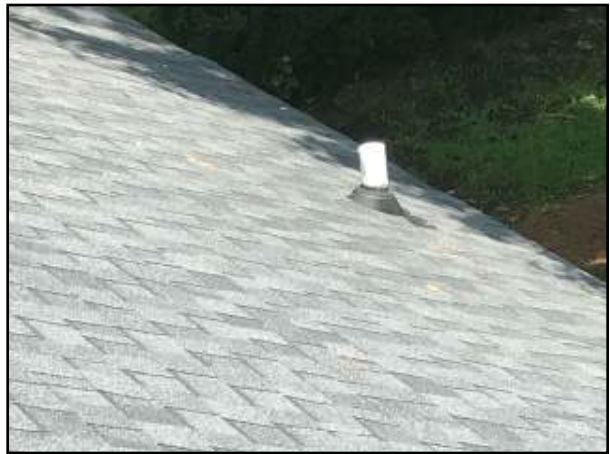
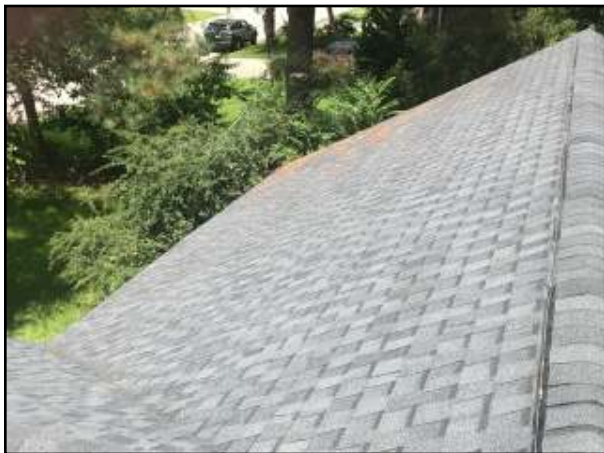
In all, the roof coverings show evidence of normal wear and tear for a home of this age. The roof age is estimated to be 5-10 years old. Architecture shingles have an approximate lifespan of approximately 30 years, depending on care and weather conditions.

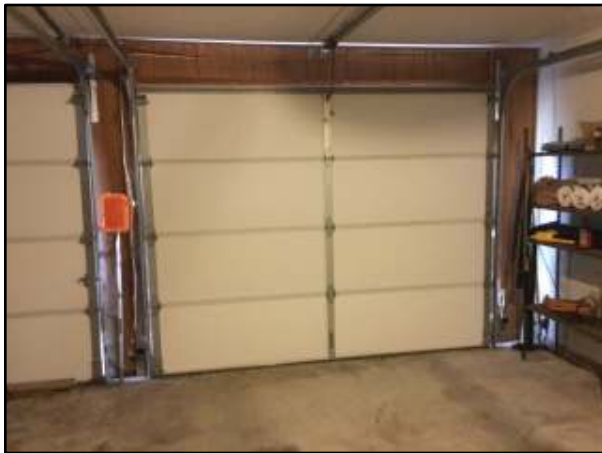
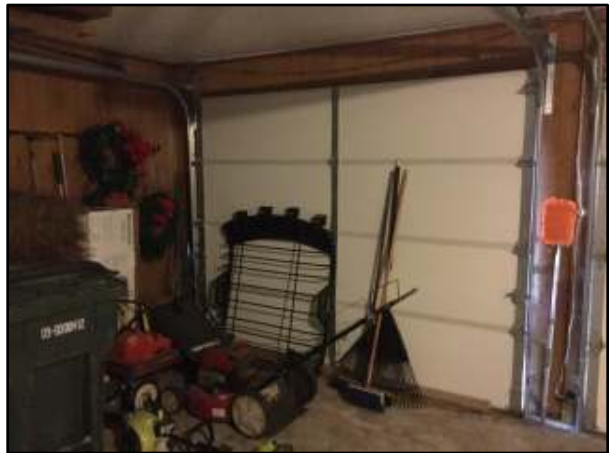
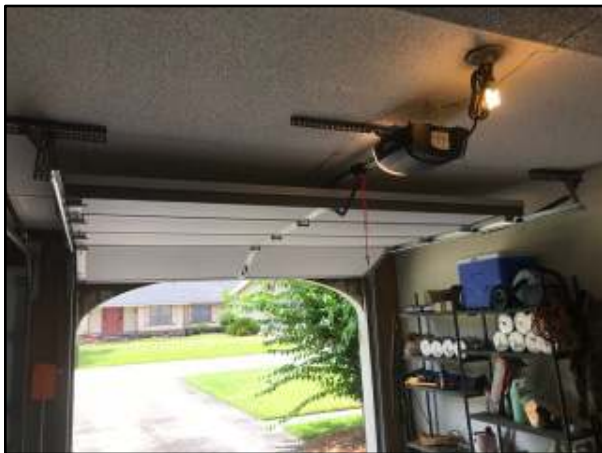
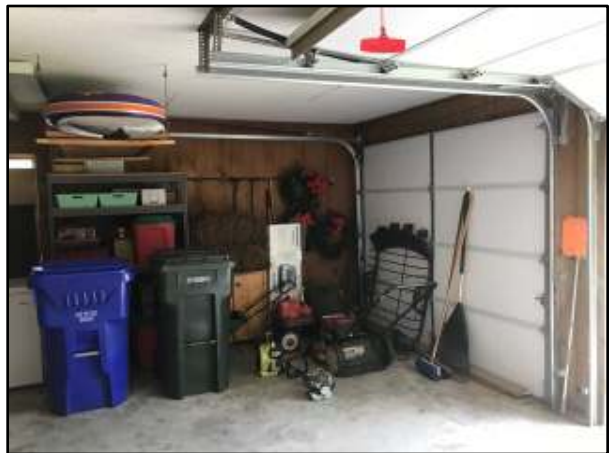
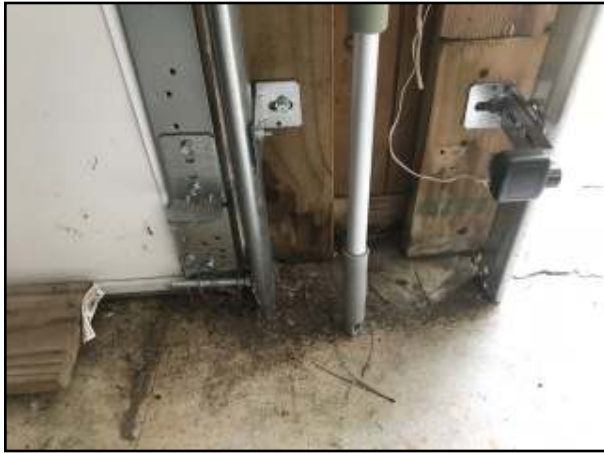
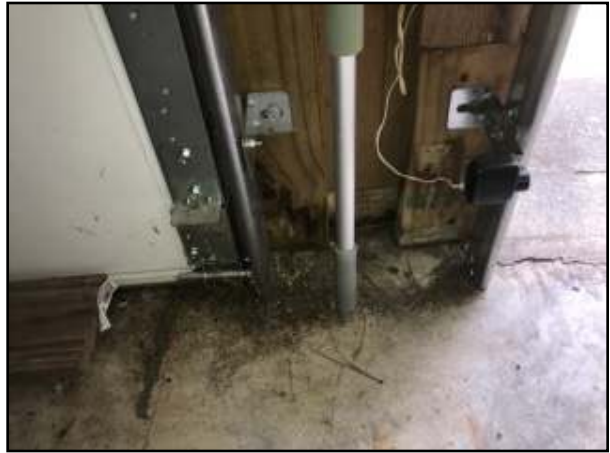
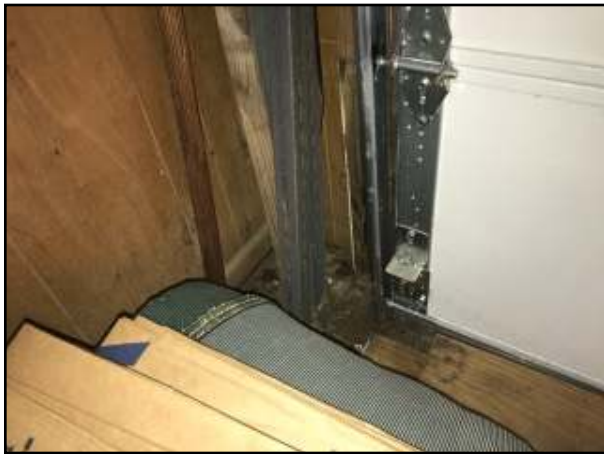
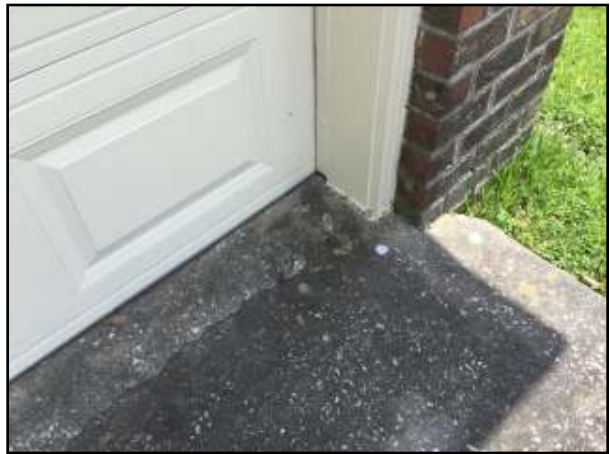
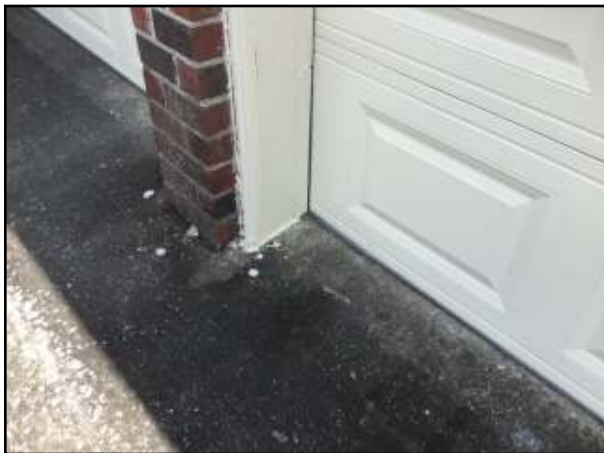
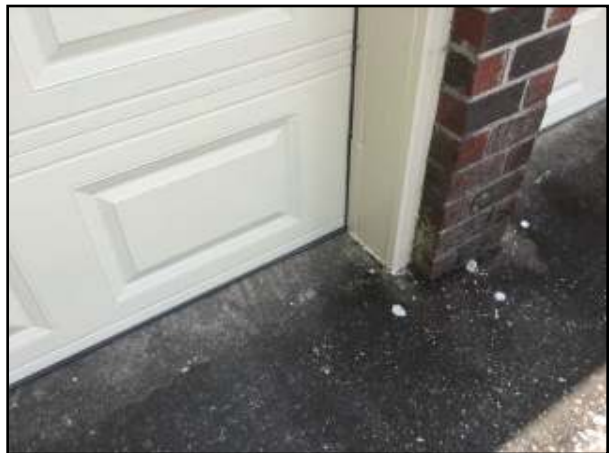
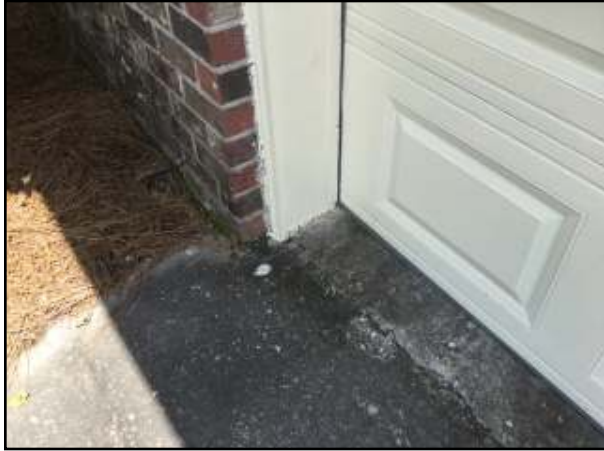
The garage door opener auto reverse feature responded properly when tested. The garage door is in good condition. One garage door is manually operated.

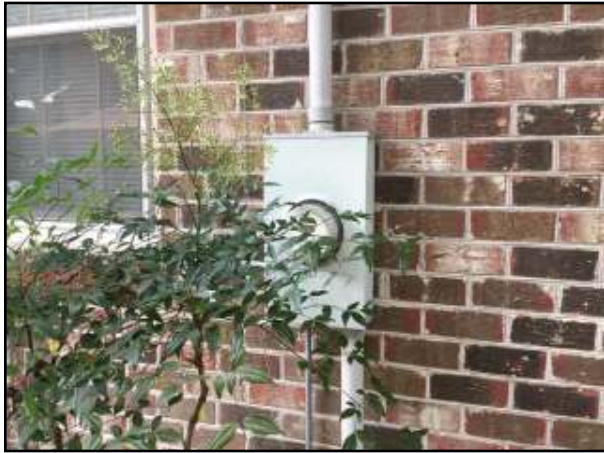
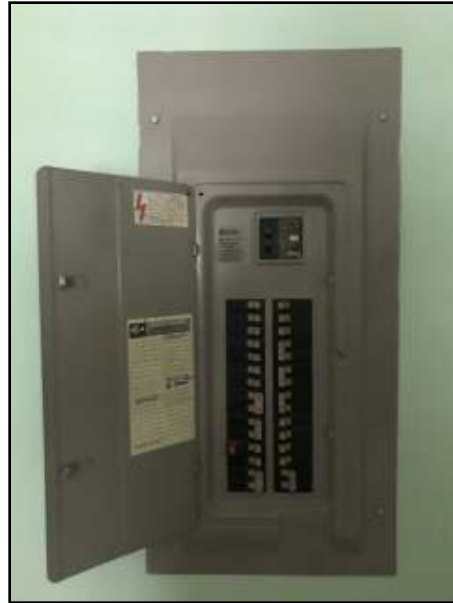
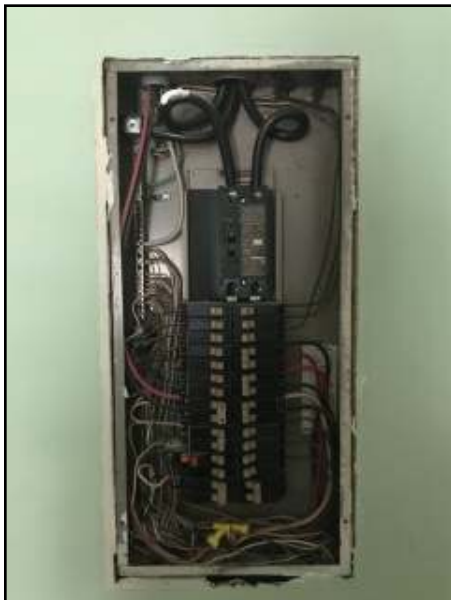
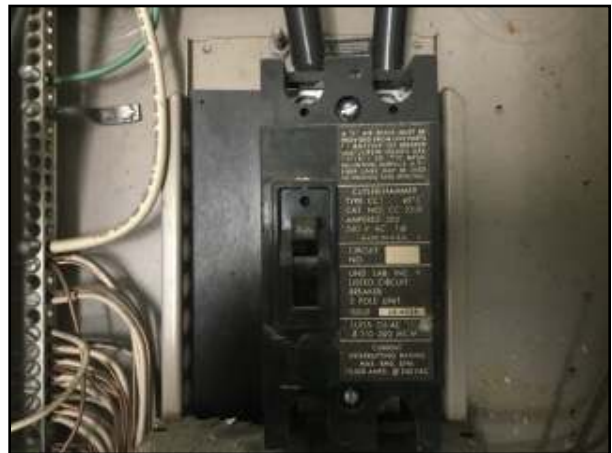
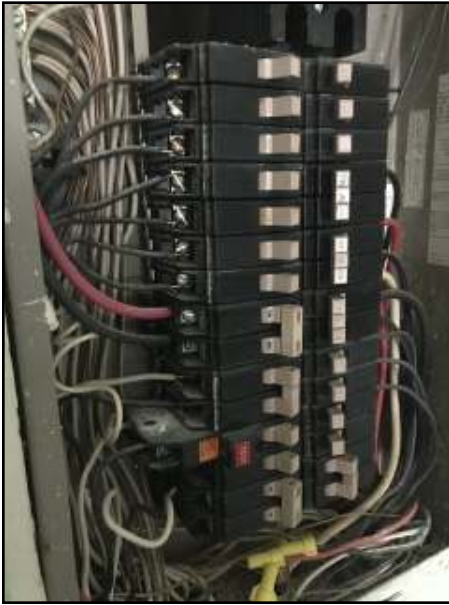
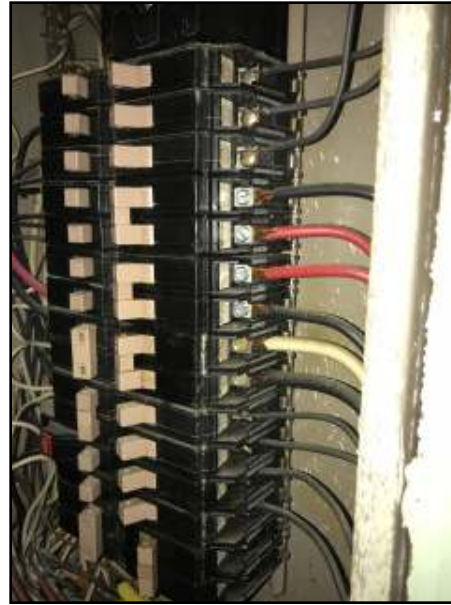
The main electrical service is sufficient for a building of the size and type. The electric is in good order with no major defects present. The distribution of electricity within the building is good. All visible wiring within the building is copper. All outlets tested are appropriately grounded. Most GFCI outlets responded properly when tested. The 200amp main disconnect is located in the service panel box in the garage. All GFCI breakers responded properly when tested. All breakers are appropriately sized and responded properly when tested.

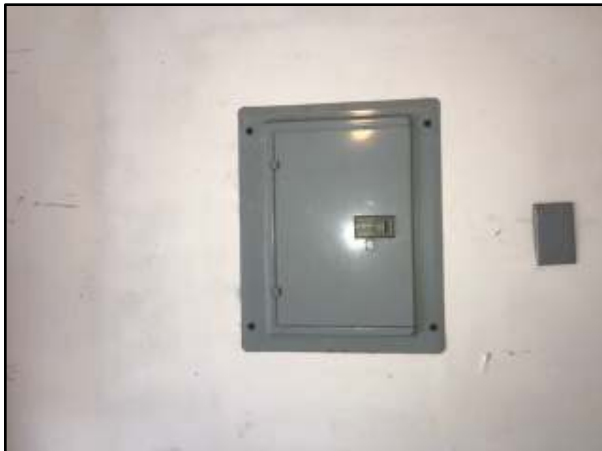
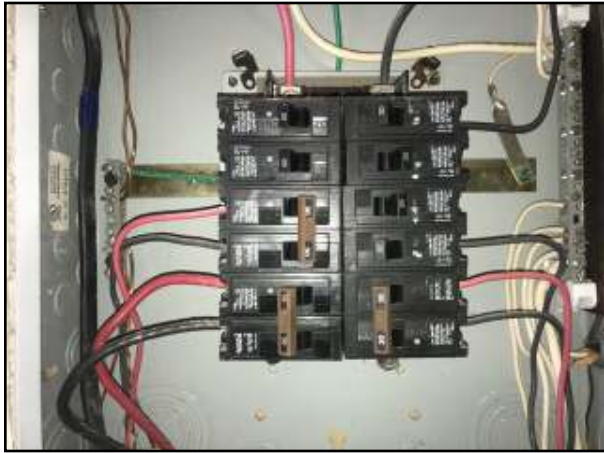
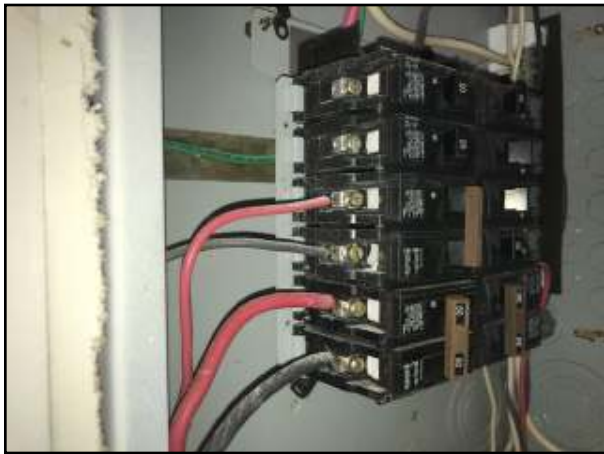
All breakers are appropriately sized and responded properly when tested. Not all breakers are in use.

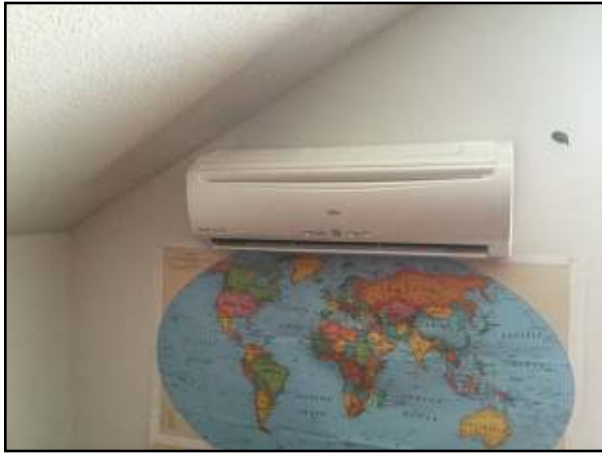
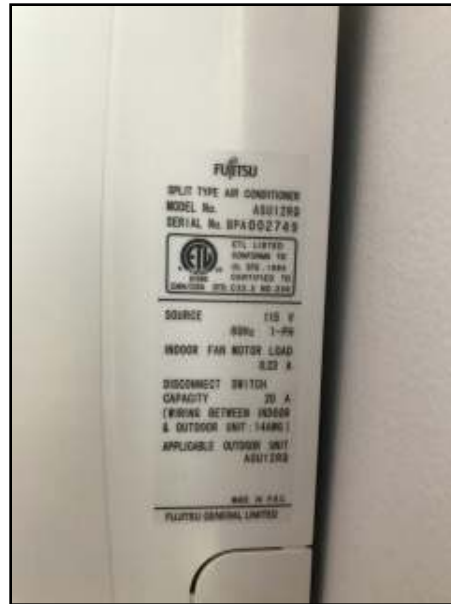
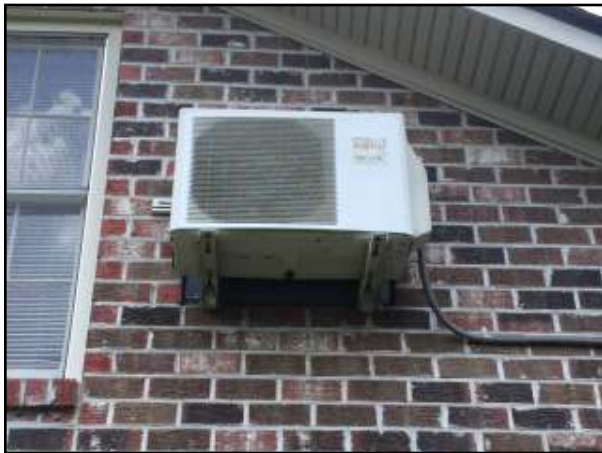
Monitor: The ductless mini split heat pump system is estimated to have been manufactured in 2000. The system responded properly when tested in cooling mode. The typical lifespan of a ductless mini split heat pump system is 15-20 years.

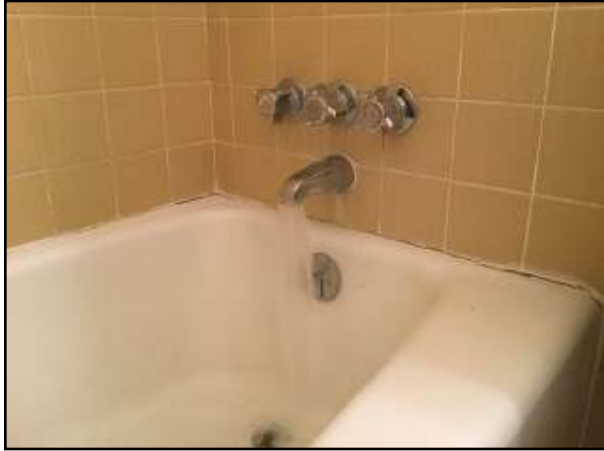
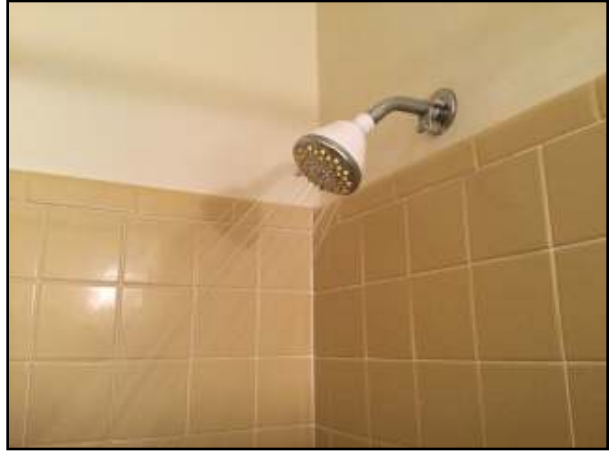
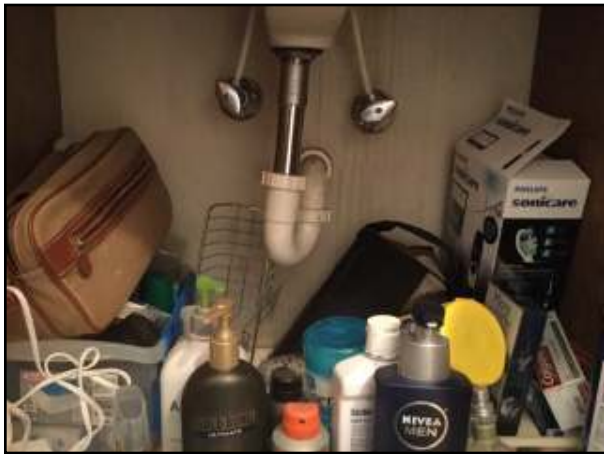
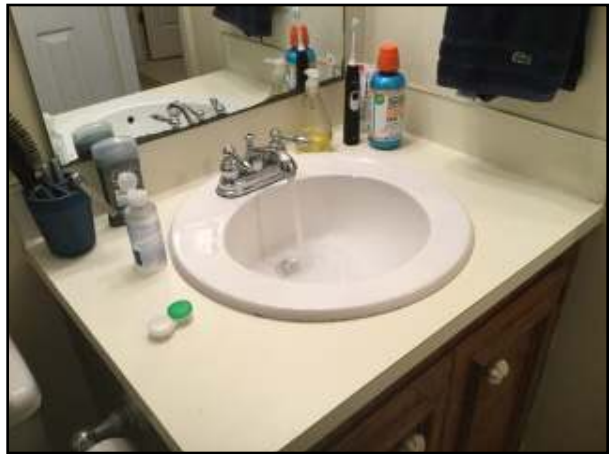
All fixtures responded properly when tested. The water pressure to the fixtures is good. Only a slight decrease in pressure was observed when multiple fixtures are operated simultaneously.

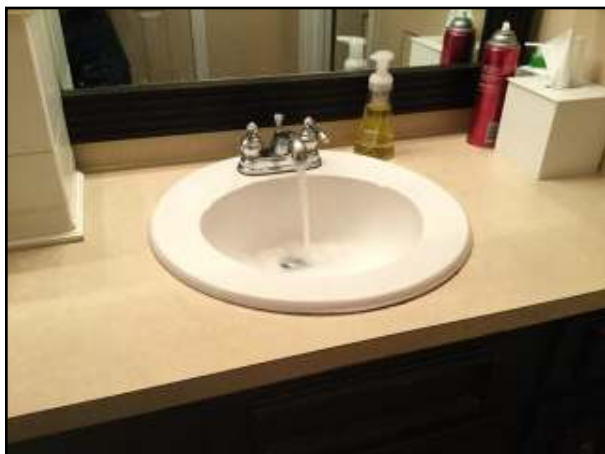
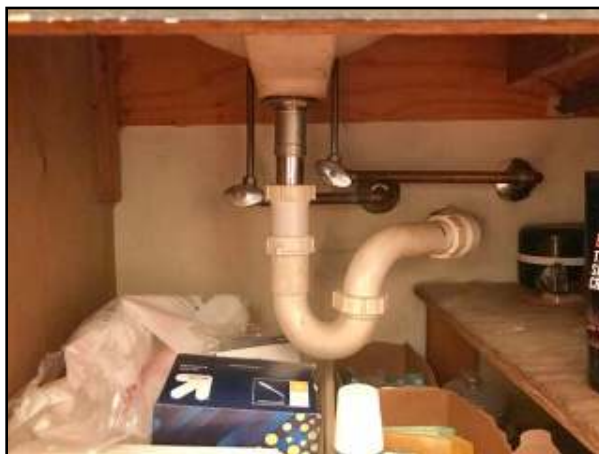
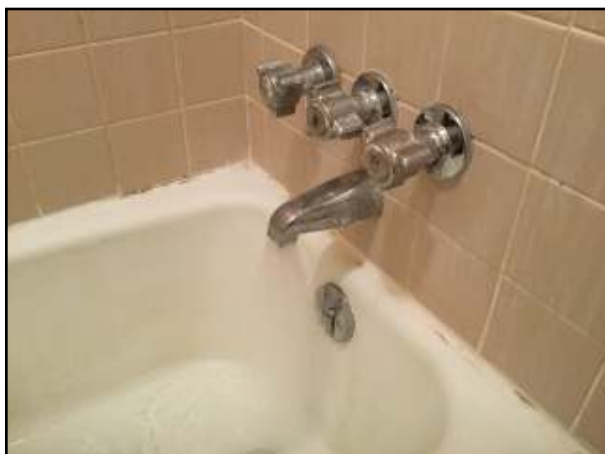
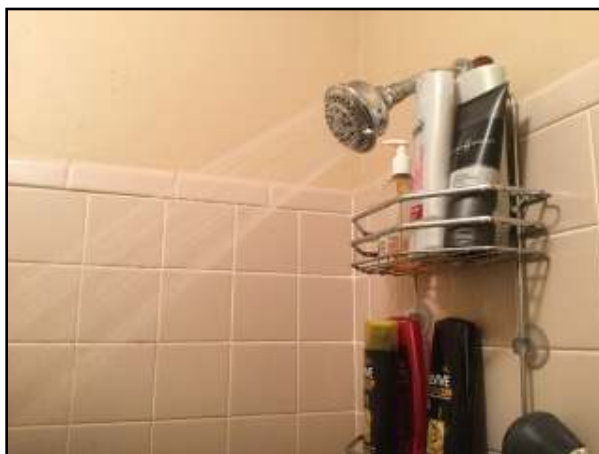
All fixtures responded properly when tested. The water pressure to the fixtures is good. Only a slight decrease in pressure was observed when multiple fixtures are operated simultaneously.

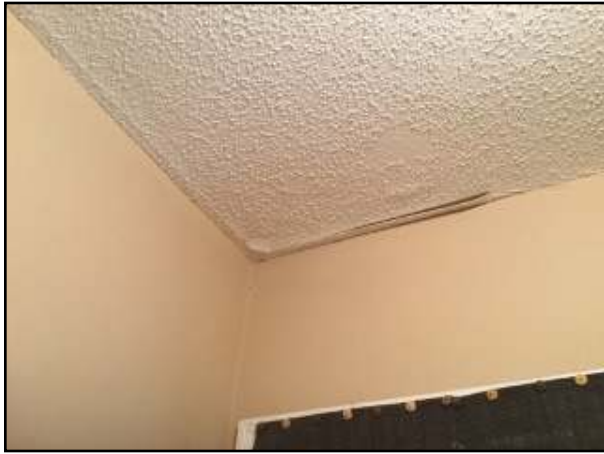
Figure 35-1

Monitor: the ceiling texture and tape joints in the master bathroom.

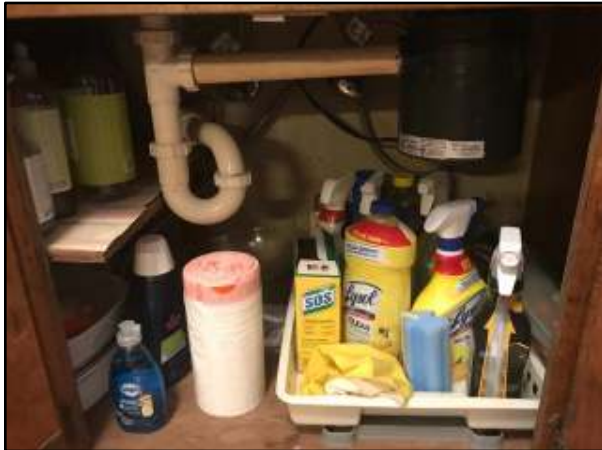
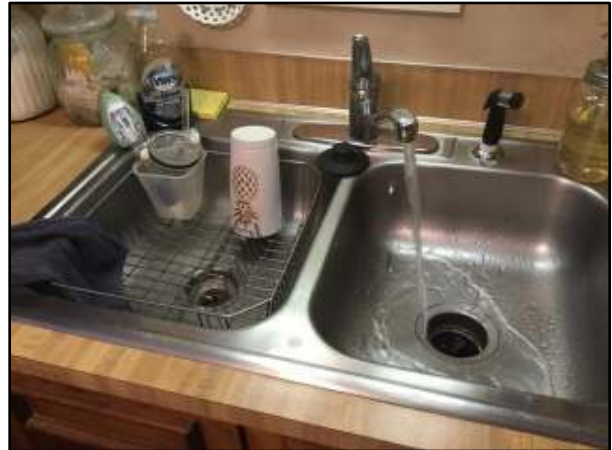
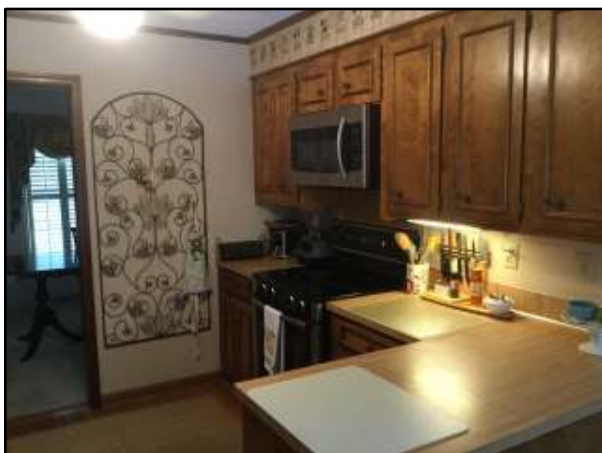
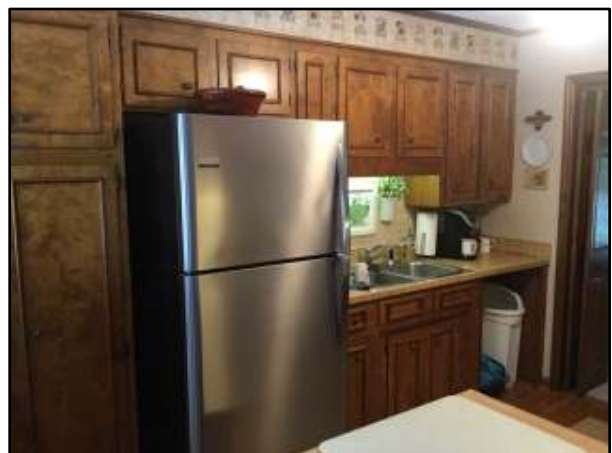
The kitchen cabinets and countertops are of average quality and good condition. No major defects were observed. Some minor flaws were observed.

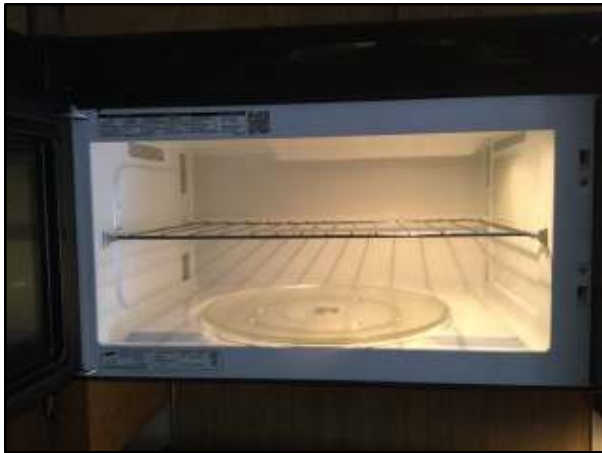
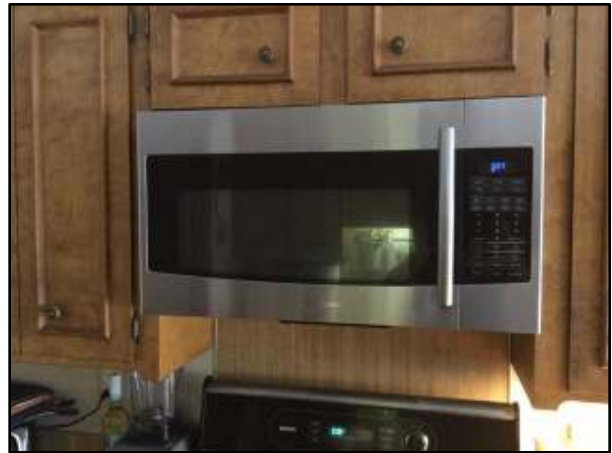
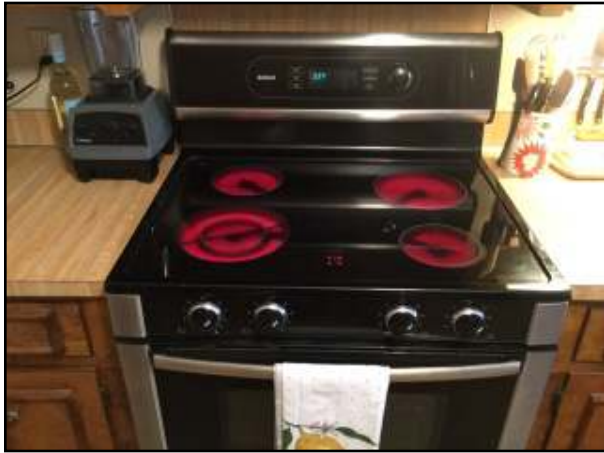
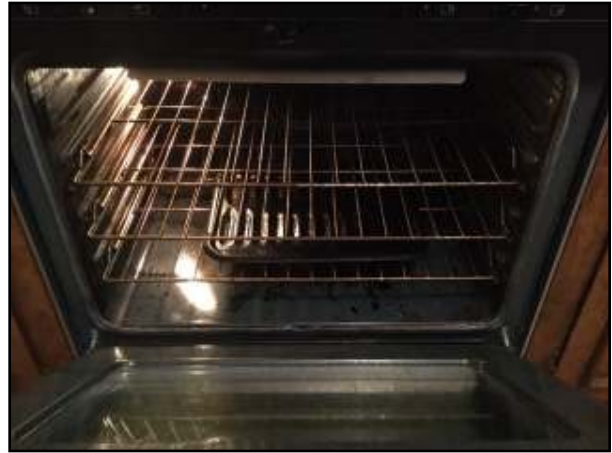
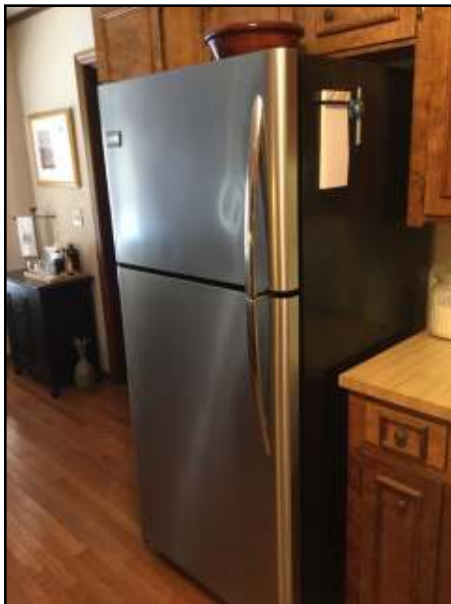
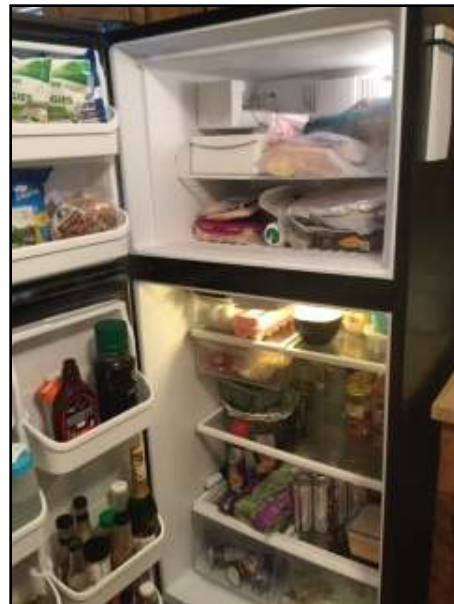
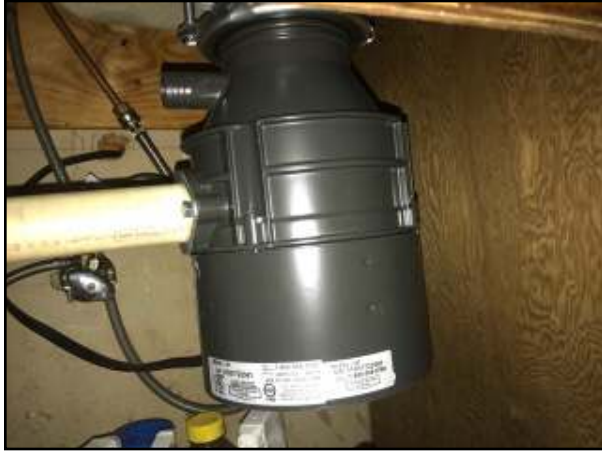
The appliances are relatively new units. The appliances responded properly when tested and there should be a few years of useful life remaining.
