Patriot Home Inspections

Home Inspection Report

123 Sample Ave

Inspected on Wed, Jun 20 2018 at 12:02 PM

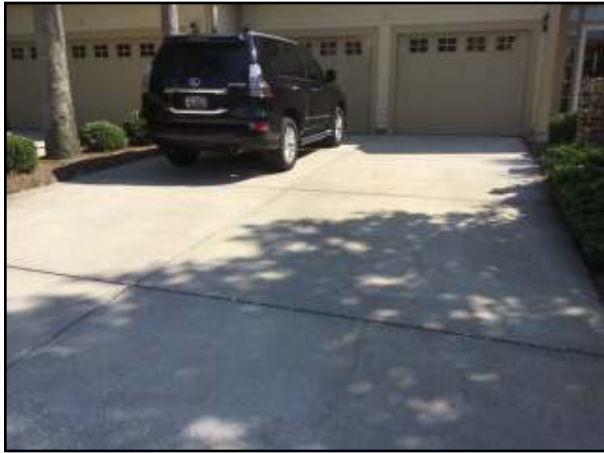
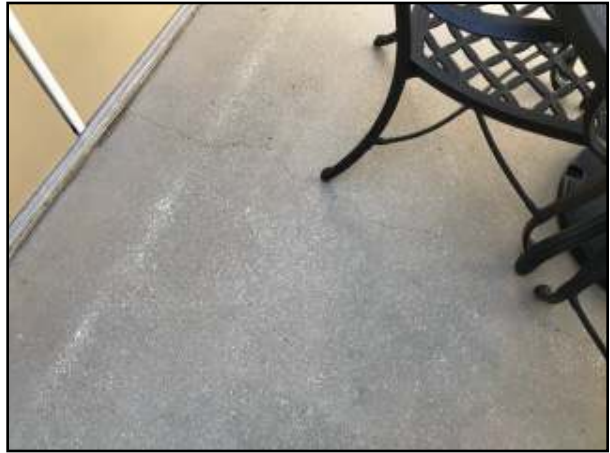
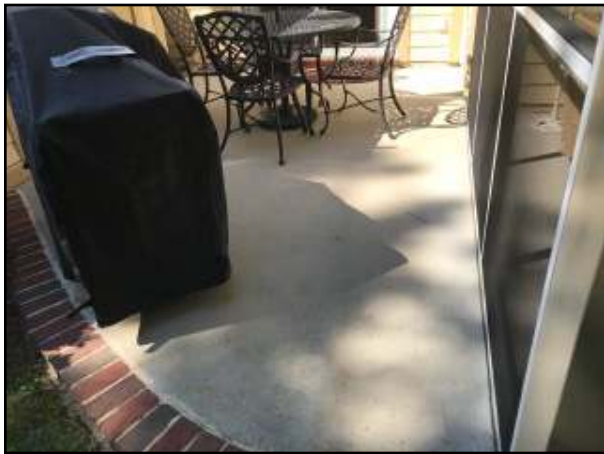
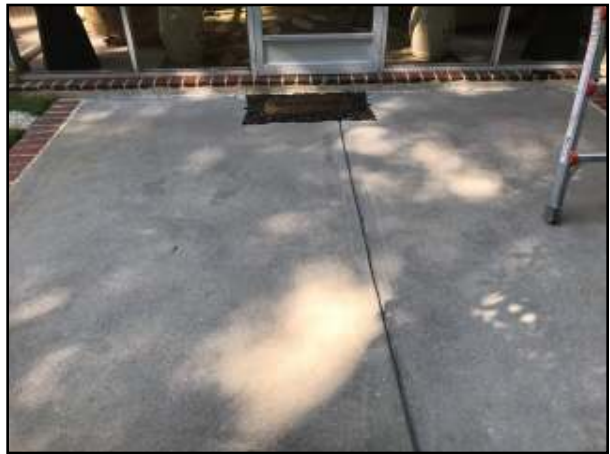
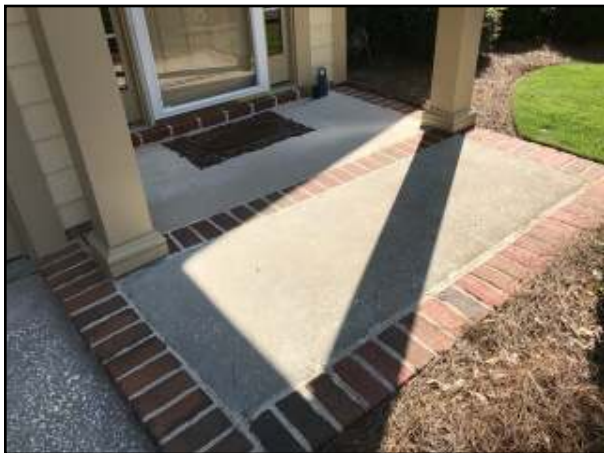
The lot is generally level grading. The driveway, walkways, and stoops are of good quality and good condition. Some typical minor cracking was observed in the concrete.

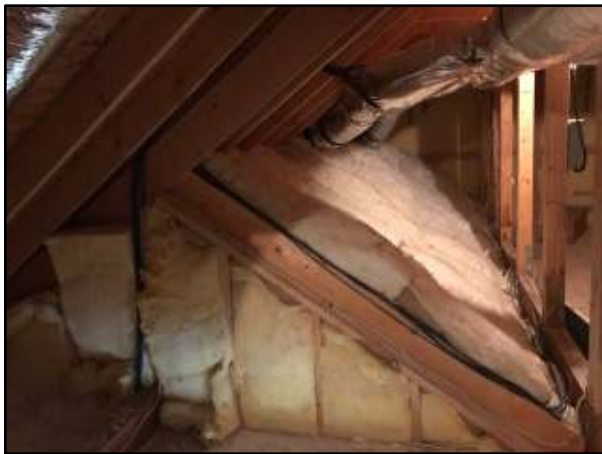
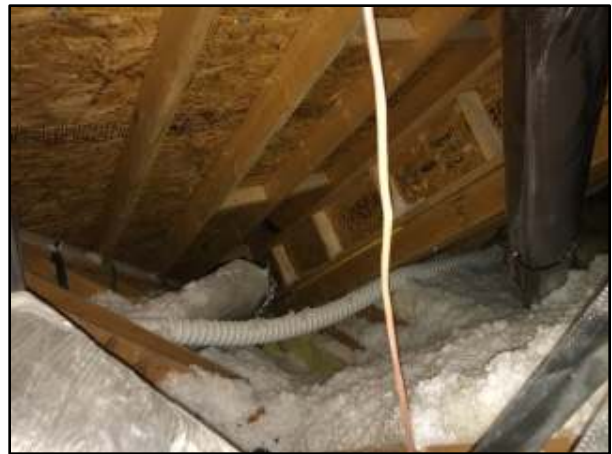
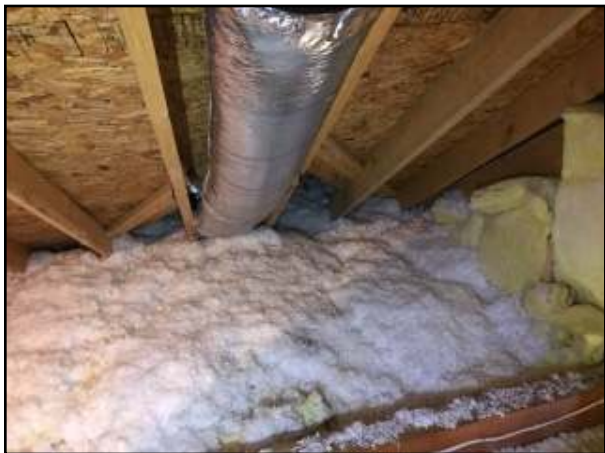
This is a well insulated home. There are no signs of roof leaks and the underside of the sheathing is in good condition.

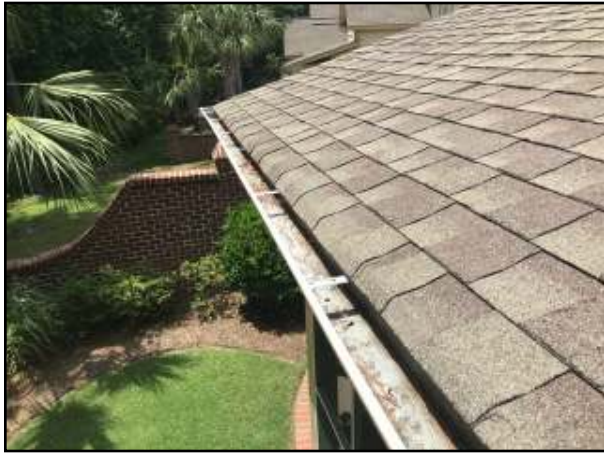
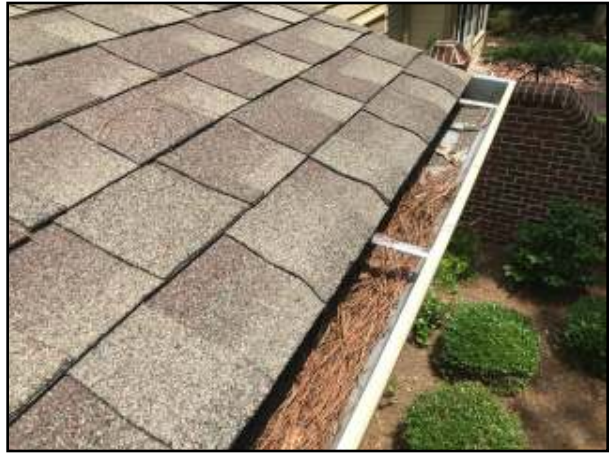
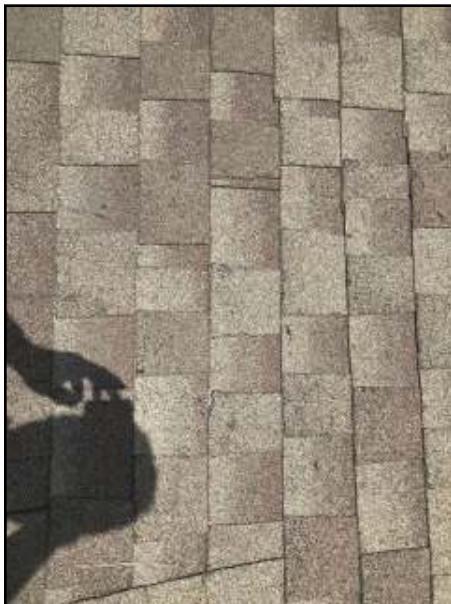
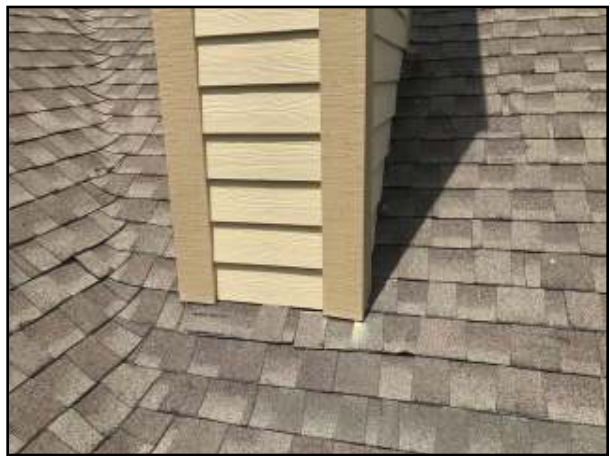
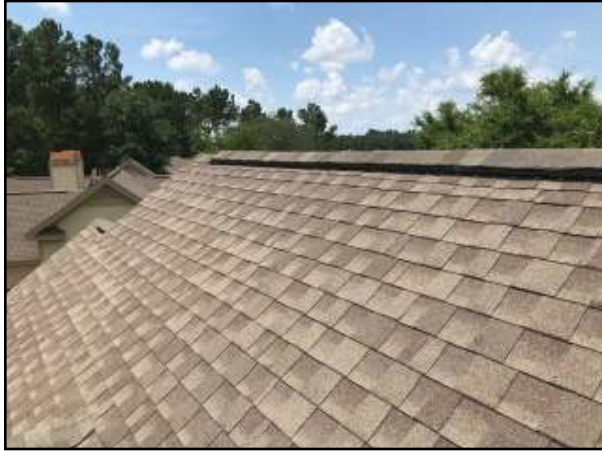
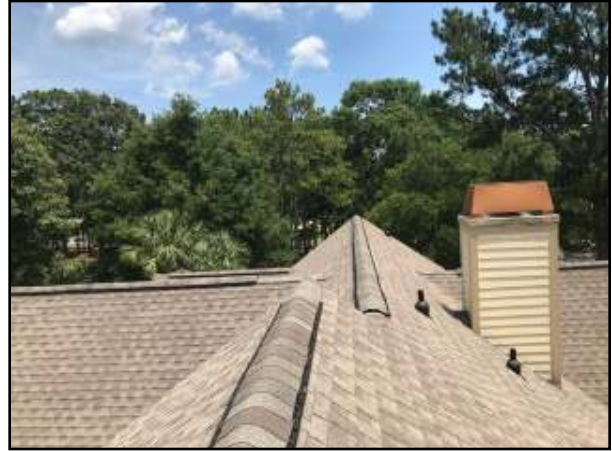
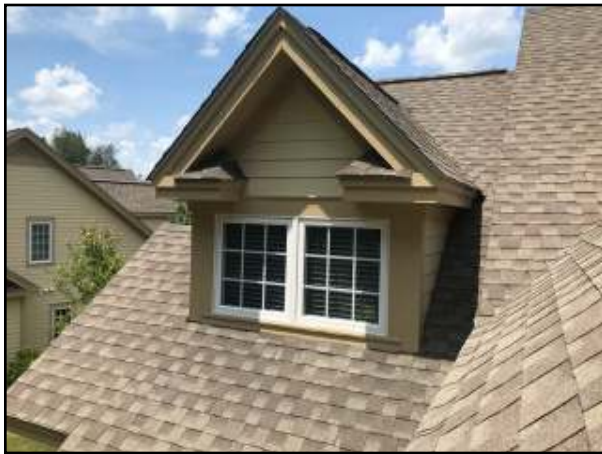
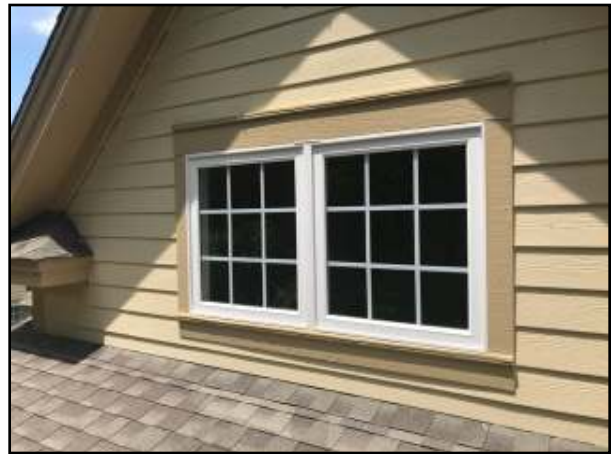
In all, the roof coverings show evidence of normal wear and tear for a home of this age. The roof age is estimated to be 10-15 years old. Architecture shingles have an approximate lifespan of approximately 30 years, depending on care and weather conditions.

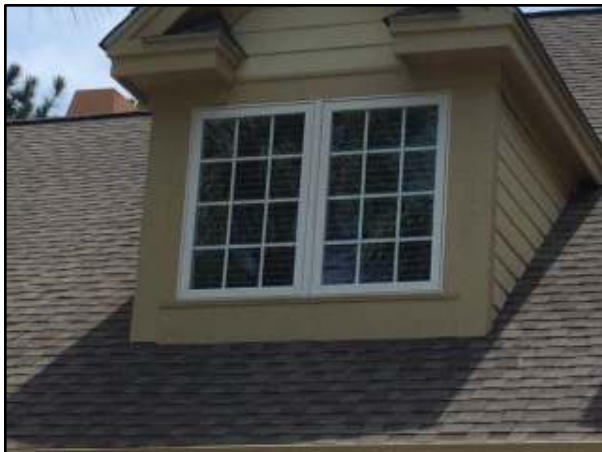
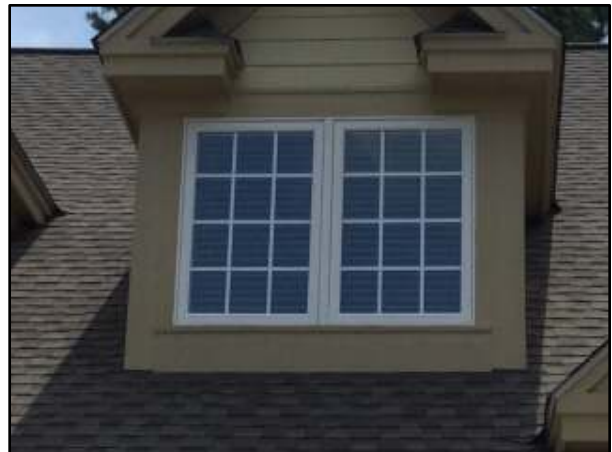
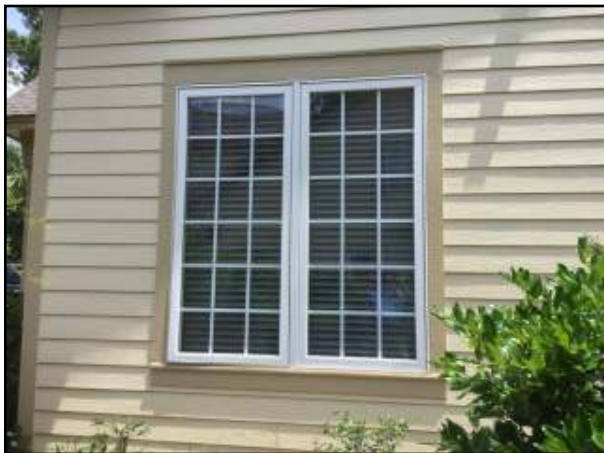
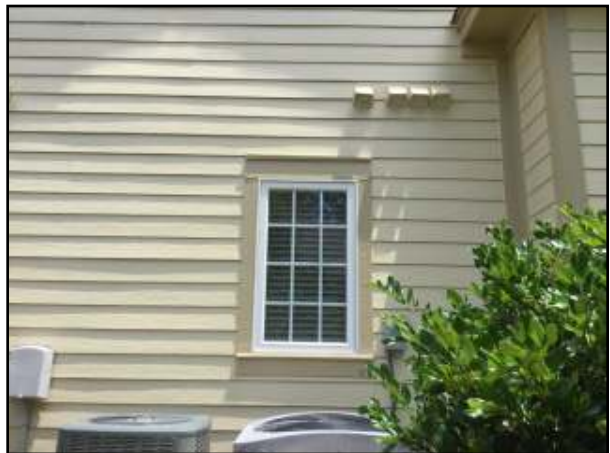
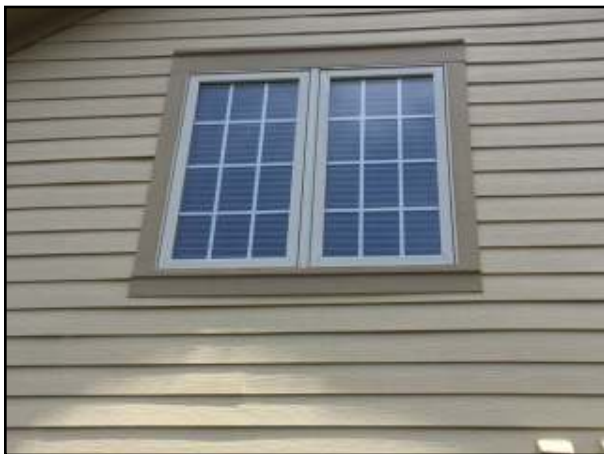
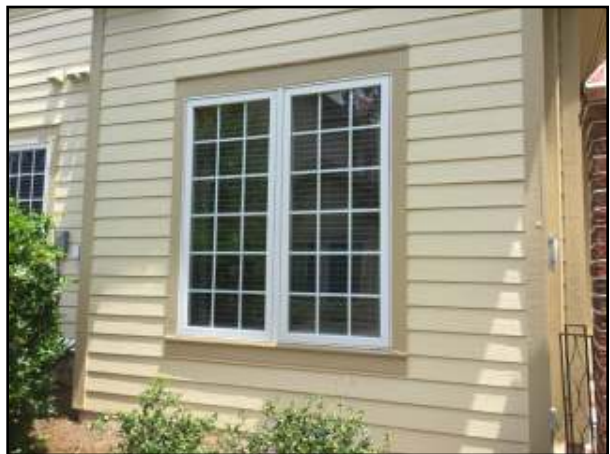
The exterior of the home shows normal wear and tear for a home of this age. No significant deficiencies were observed. The exterior siding is relatively low maintenance. The windows are energy efficient and are relatively low maintenance.

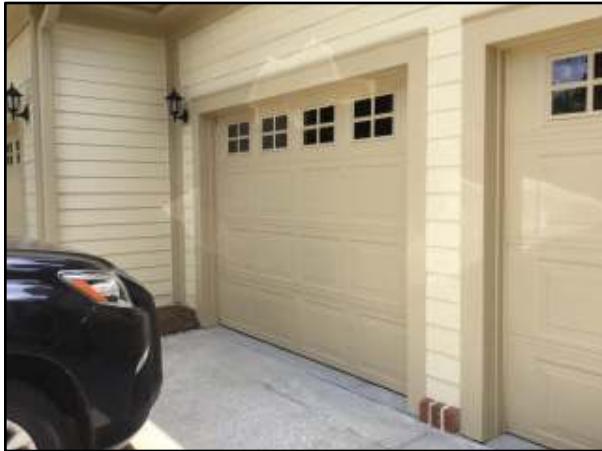
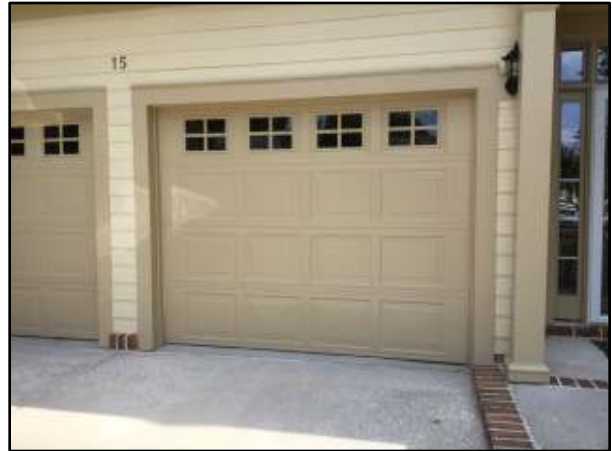
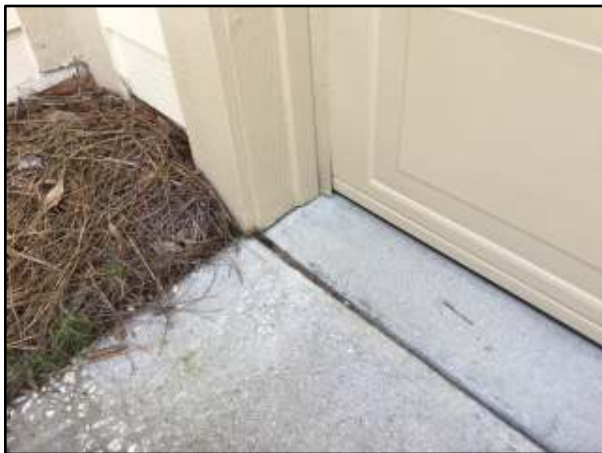
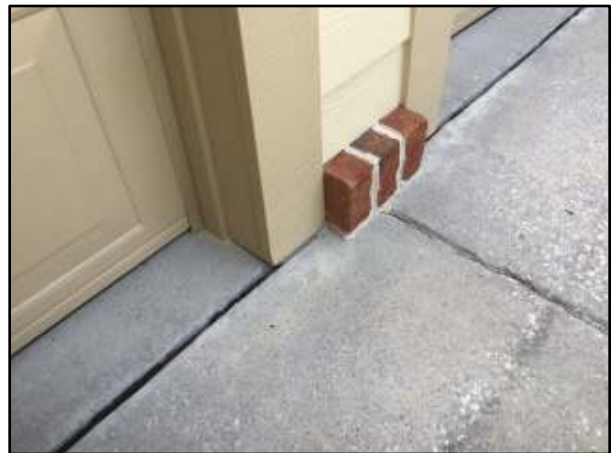
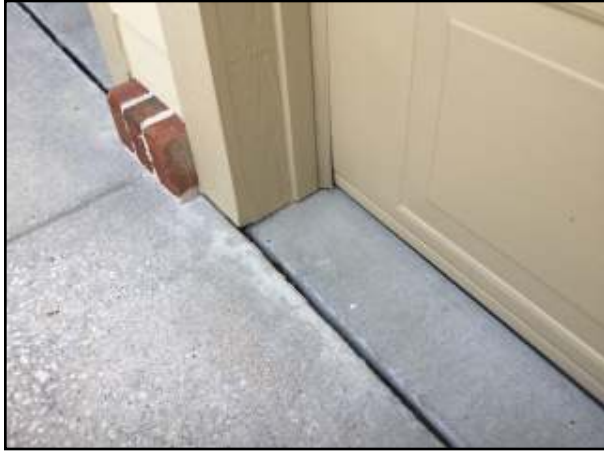
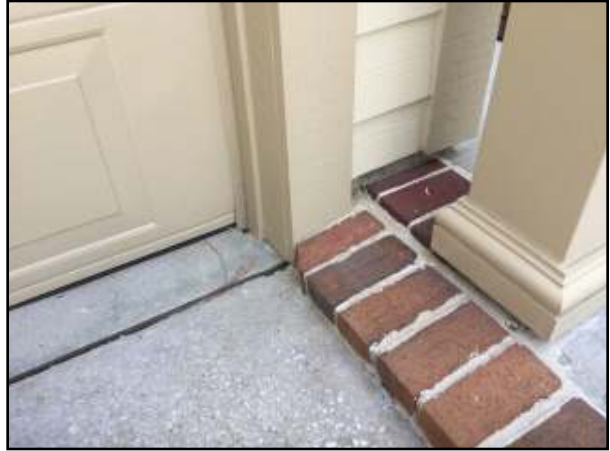
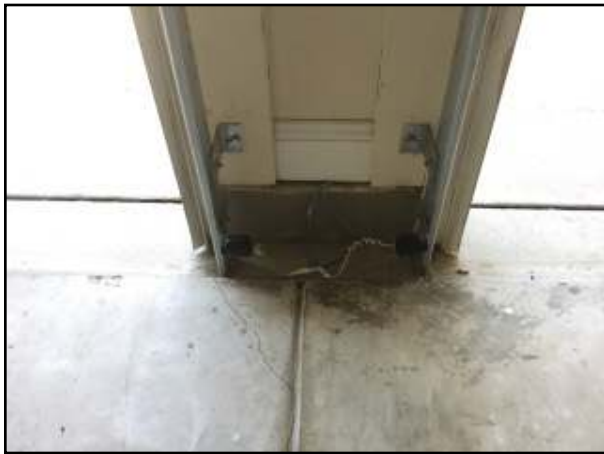
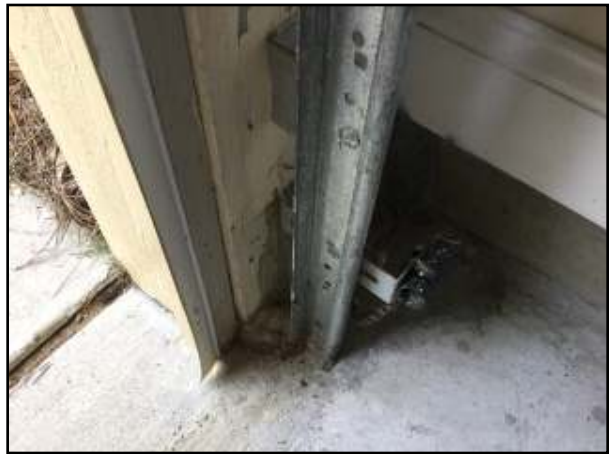
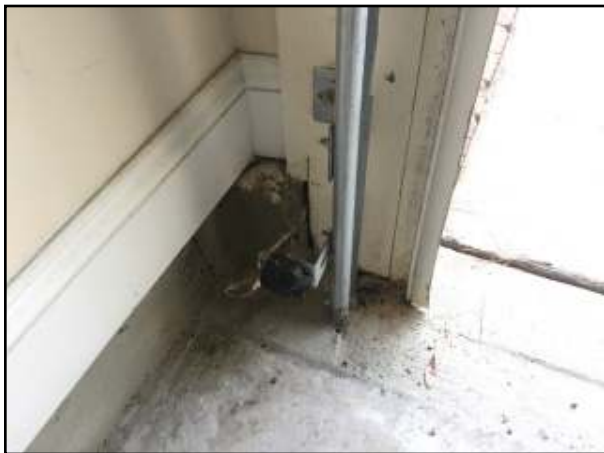
The garage door opener auto reverse feature responded properly when tested. The garage door and door frames are in good condition.

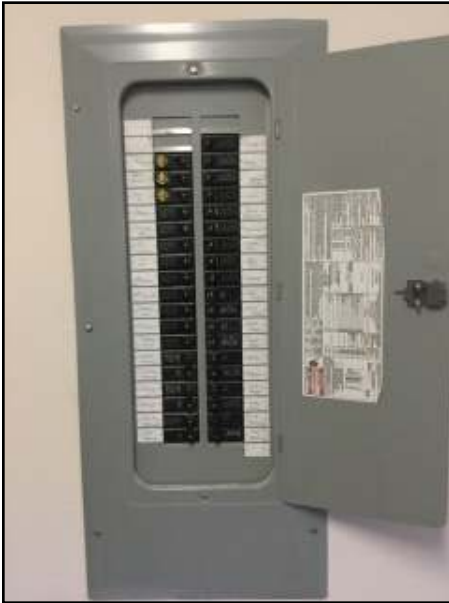
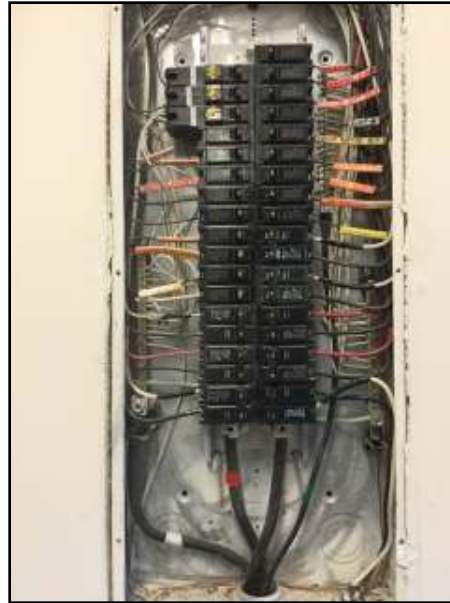
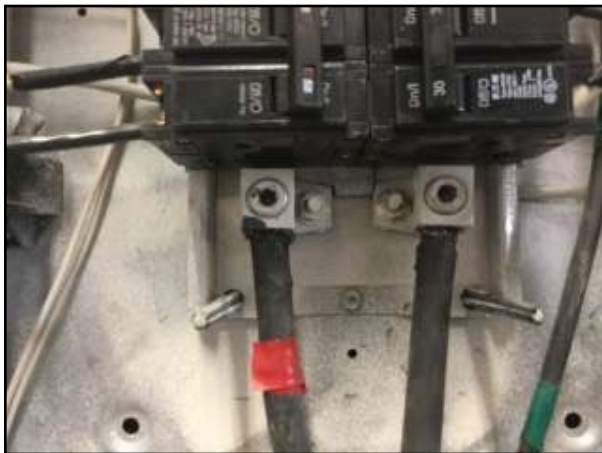
The main electrical service is sufficient for a building of the size and type. The electric is in good order with no major defects present. The distribution of electricity within the building is good. All visible wiring within the building is copper. All outlets tested are appropriately grounded. All GFCI outlets responded properly when tested. The 200amp main disconnect is located in the meter box. All AFCI breakers responded properly when tested. All breakers are appropriately sized and responded properly when tested.

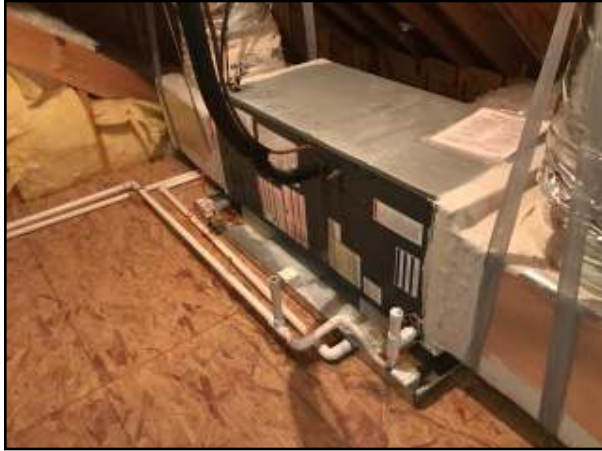
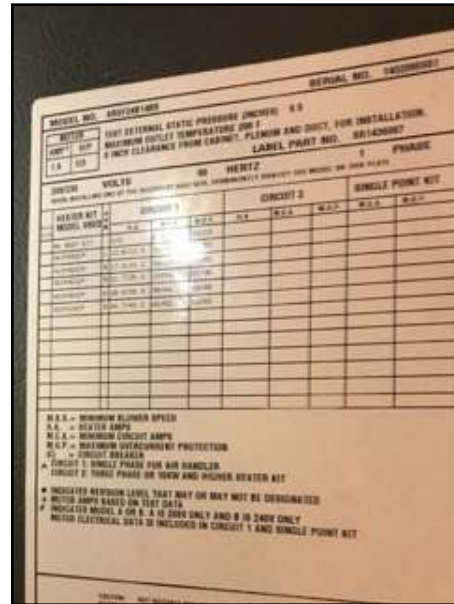
The air handler of the heat pump system was manufactured in 2014. The system responded properly when tested in heating mode. The typical lifespan of a heat pump system is 20-25 years. The size and configuration should be adequate for a home this size.

Furnaces over 10 years old should be checked, cleaned and serviced yearly by a licensed contractor.

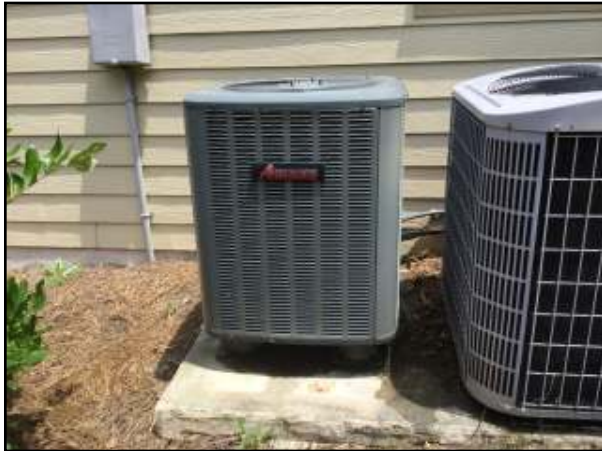
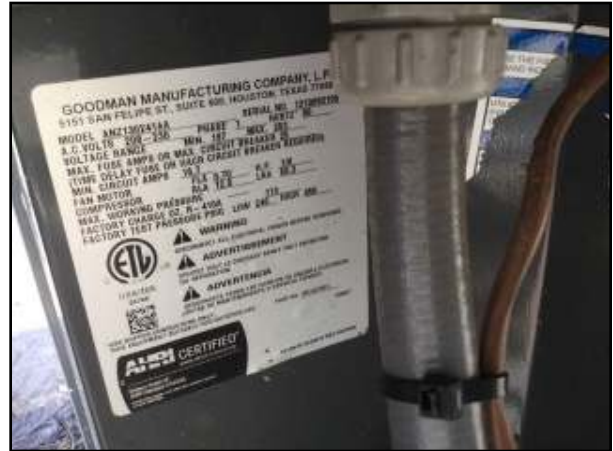
The condensing unit was manufactured in 2013. The system responded properly when tested in cooling mode. The typical lifespan of an air conditioning system is 15-20 years in coastal climates, depending on the level of care and maintenance it receives.

Repair: the condensate discharge pipes are discharging near the house. There is staining on the siding. This condition should be repaired by a licensed heating and cooling contractor. There is a risk of hidden damage inside the wall cavity.

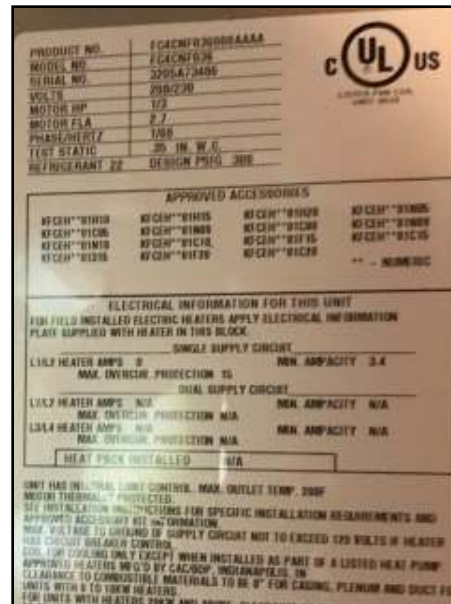
Figure 17-2

Monitor: there is evidence of prior water inside the secondary pan underneath the air handler. The pan is rusted. This indicates that the pan has held water in the past with pour properly draining out. This condition should be monitored.

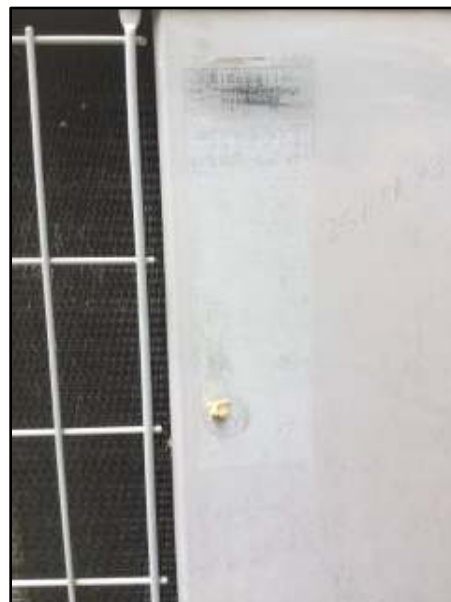
Figure 19-2

Monitor: the condensing unit was manufactured in 2006. The system responded properly when tested. The typical lifespan of a air conditioning system is 15-20 years in coastal climates. No one can predict when replacement will become necessary. It is recommended a home warranty be obtained to cover unexpected repairs.

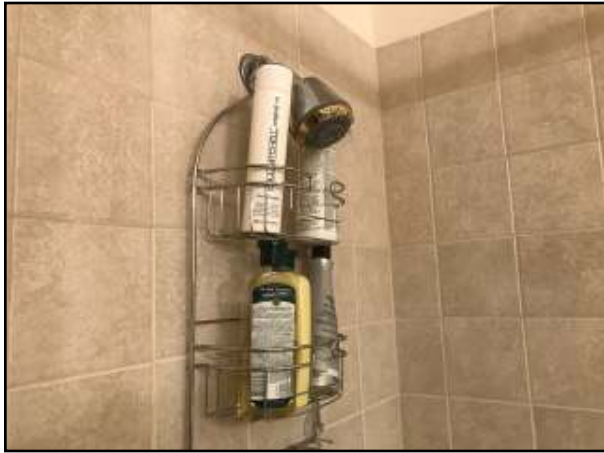
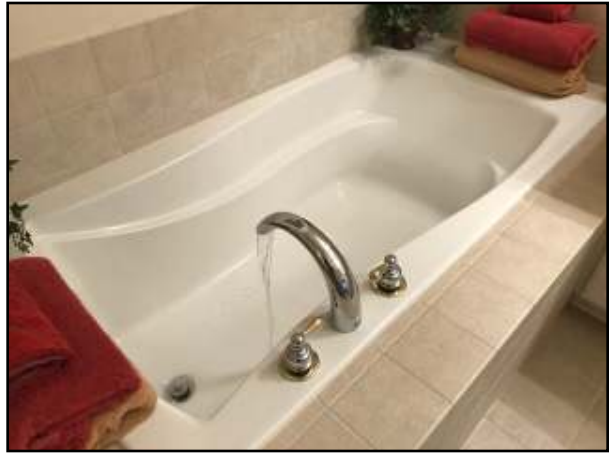
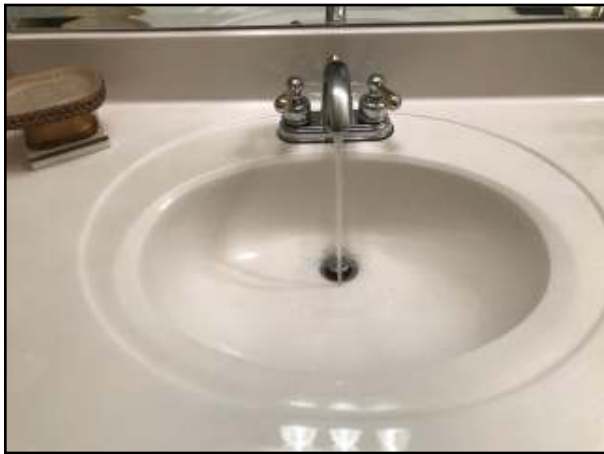
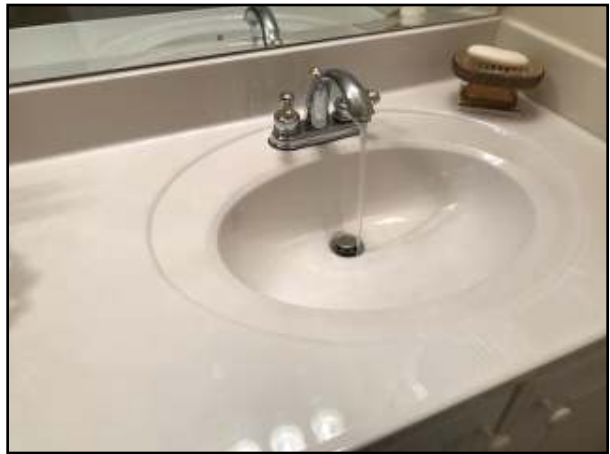
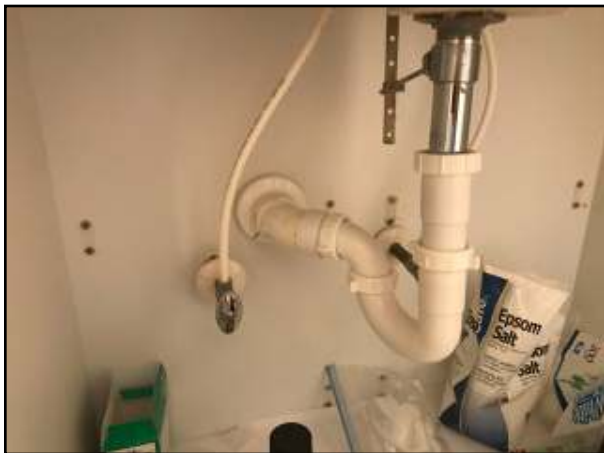
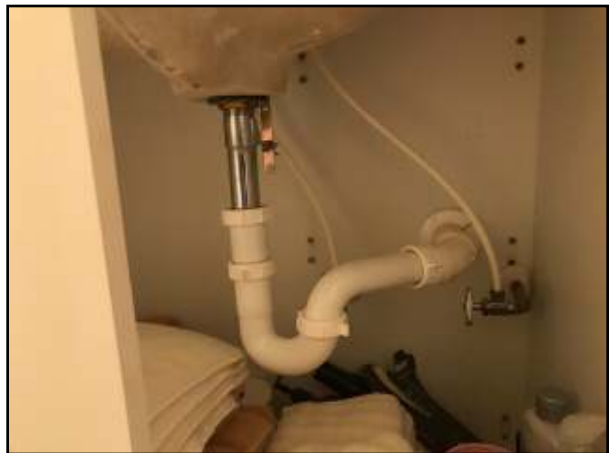
All fixtures responded properly when tested. The water pressure to the fixtures is good. Only a slight decrease in pressure was observed when multiple fixtures are operated simultaneously.

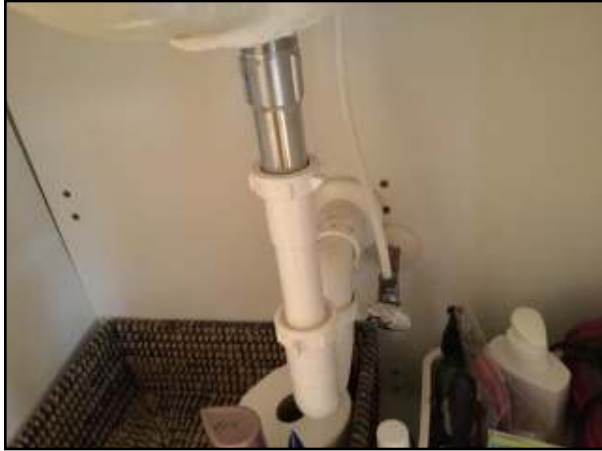
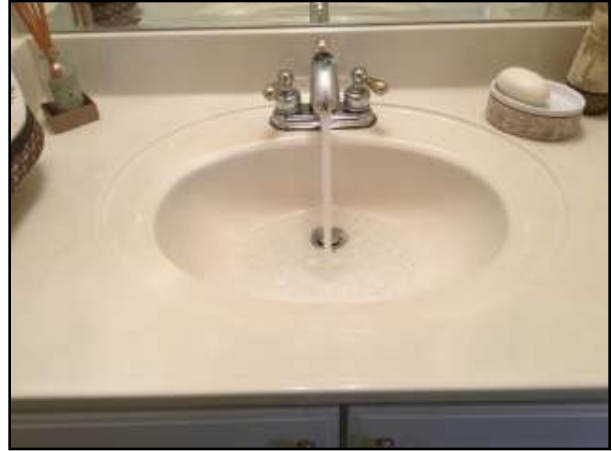
All fixtures responded properly when tested. The water pressure to the fixtures is good. Only a slight decrease in pressure was observed when multiple fixtures are operated simultaneously.

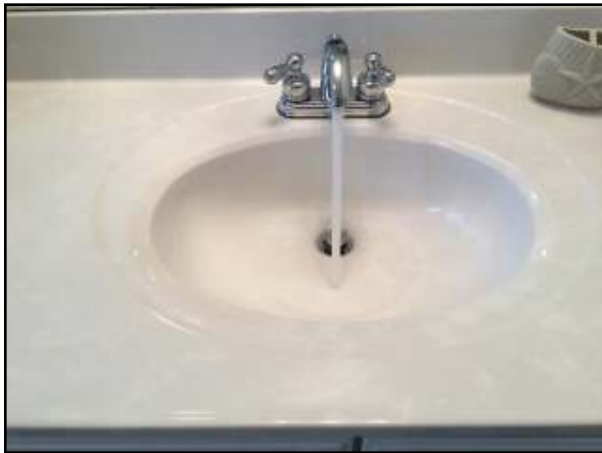
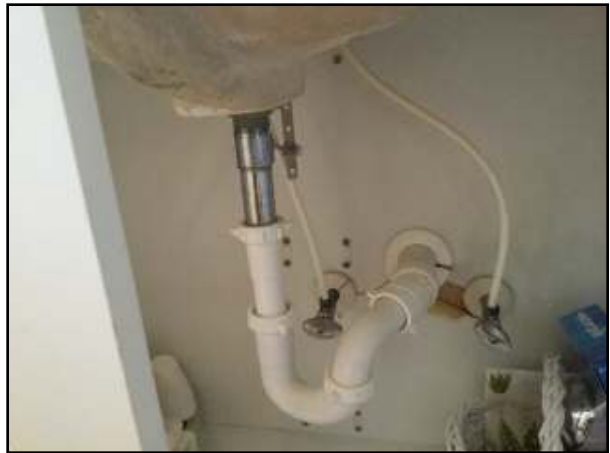
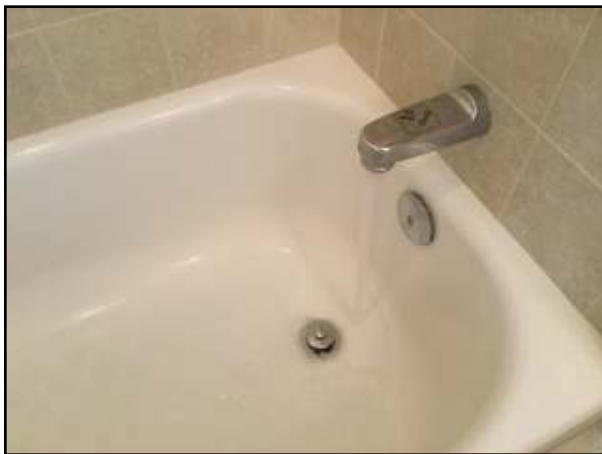
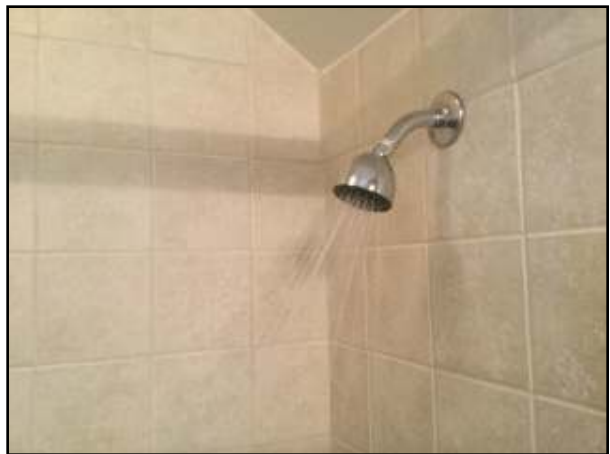
All fixtures responded properly when tested. The water pressure to the fixtures is good. Only a slight decrease in pressure was observed when multiple fixtures are operated simultaneously.

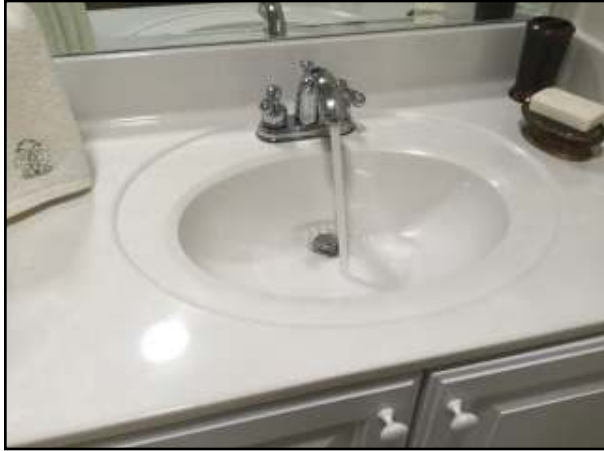
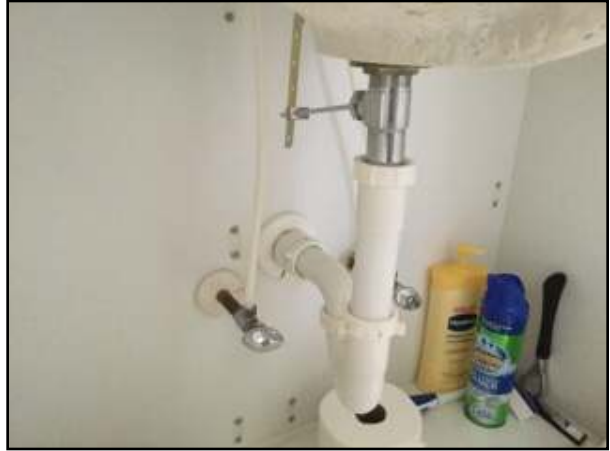
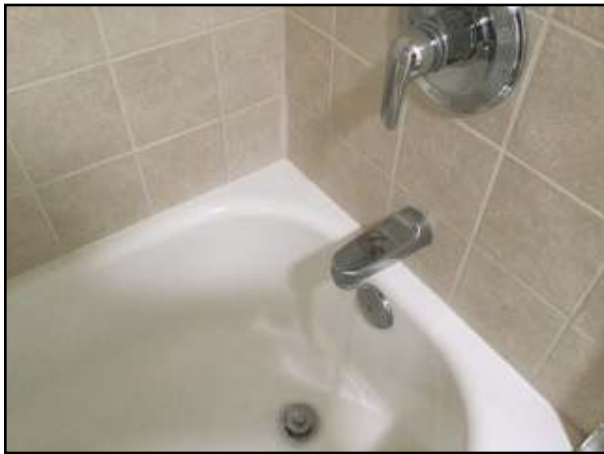
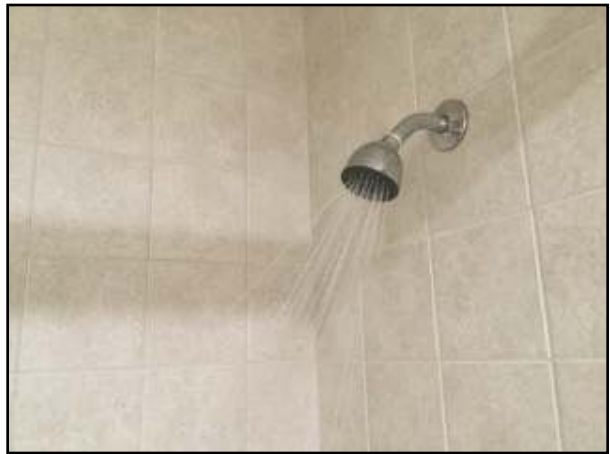
All fixtures responded properly when tested. The water pressure to the fixtures is good. Only a slight decrease in pressure was observed when multiple fixtures are operated simultaneously.

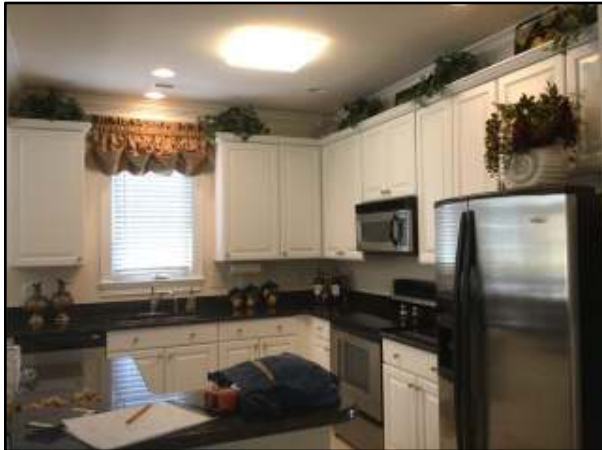
Figure 27-1

The kitchen cabinets and countertops are of good quality and good condition. No major defects were observed. Some minor flaws were observed.

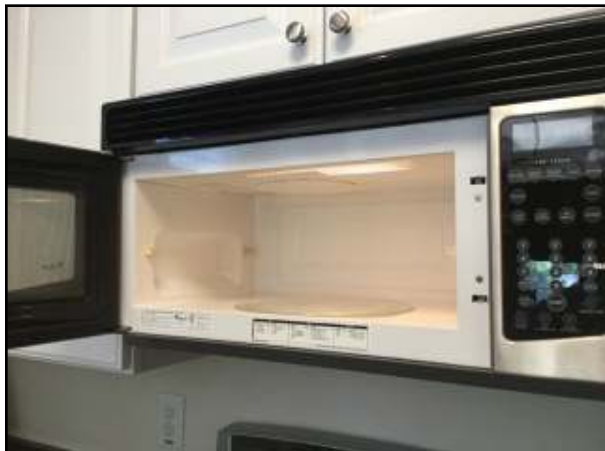
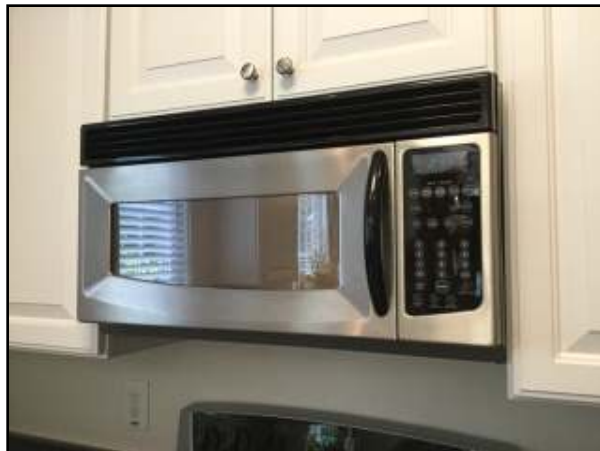
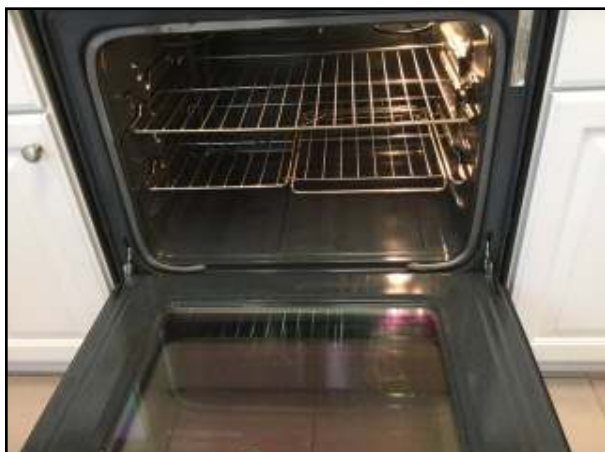
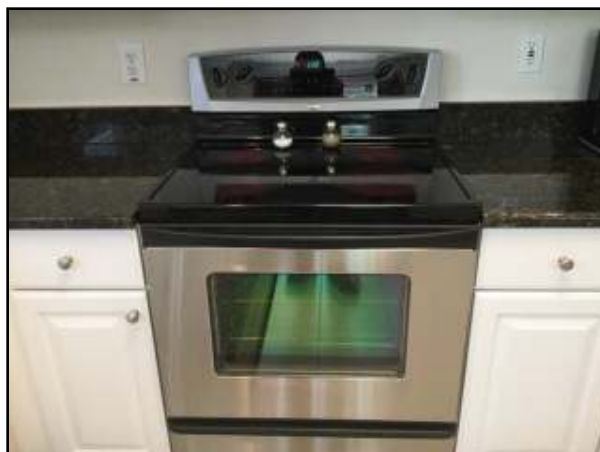
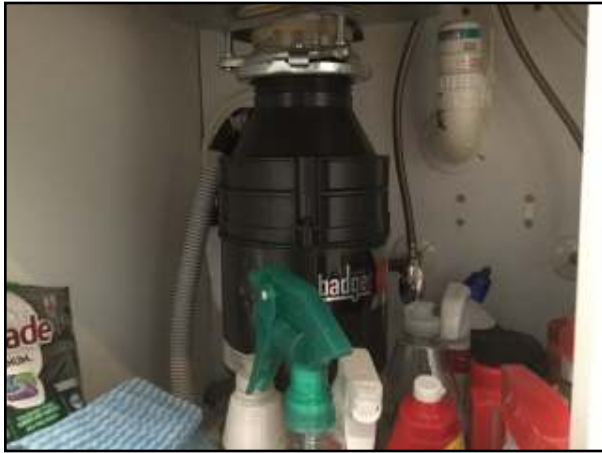
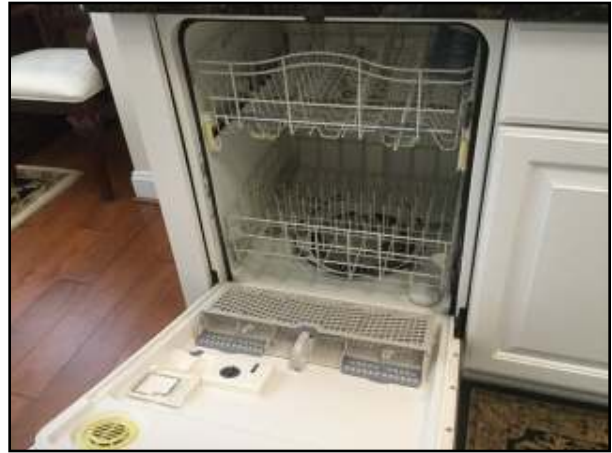
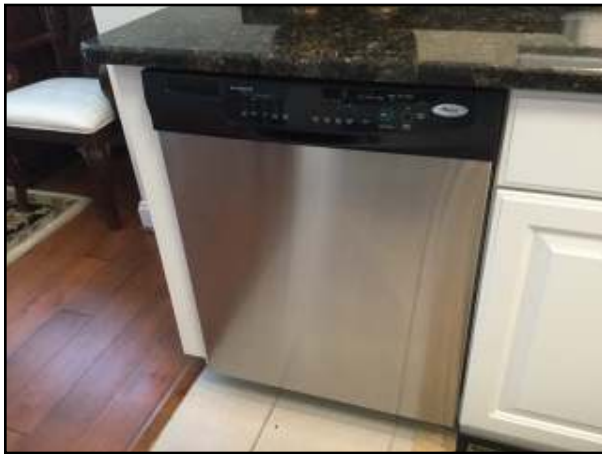
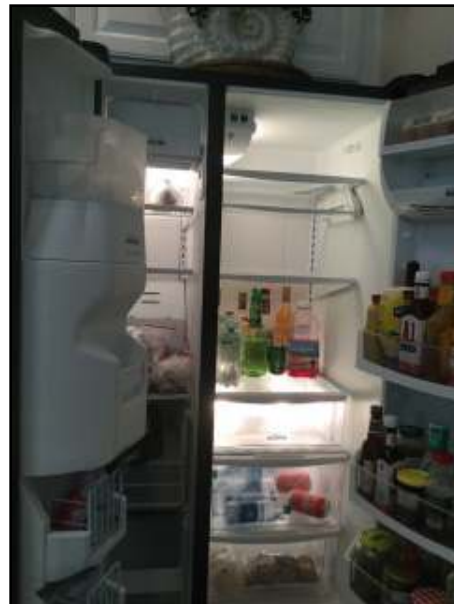
The appliances are middle aged units (2005). The appliances responded properly when tested and there should be a few years of useful life remaining.

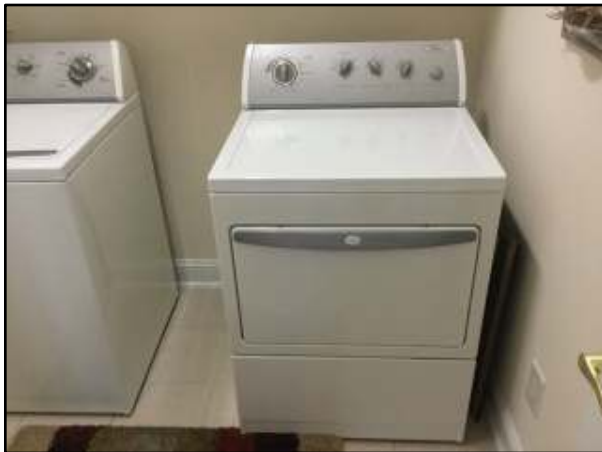
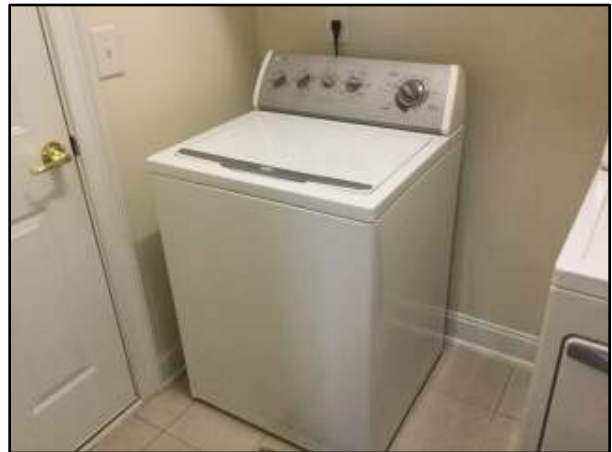
Comment 29:

Clothes washer and dryer are relatively new units and responded properly when tested.
