Patriot Home Inspections

Home Inspection Report

123 Sample Ave

Inspected on Wed, Jun 20 2018 at 12:05 PM

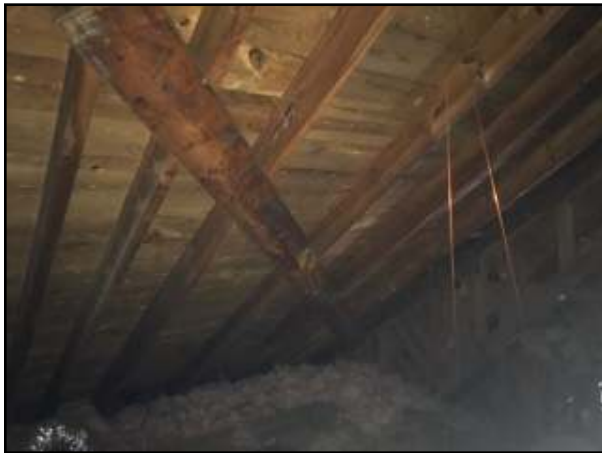
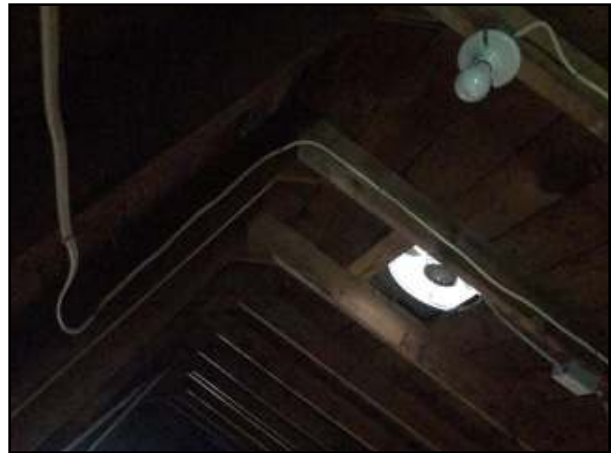
Insulation levels are typical for a home of this age and construction. Improvements can be made as needed or desired.

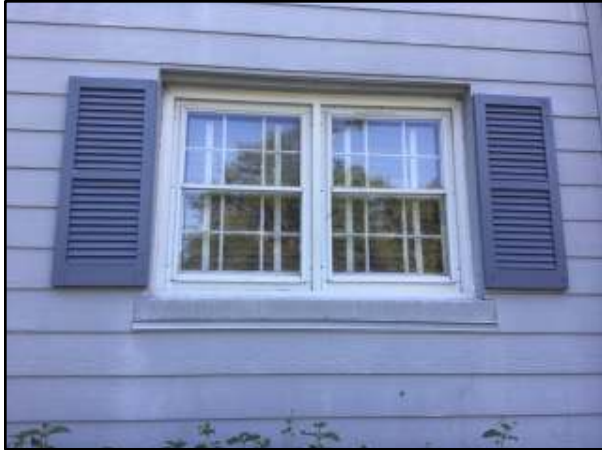
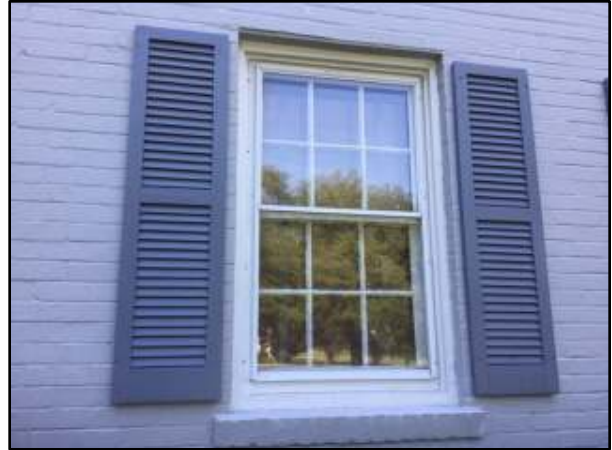
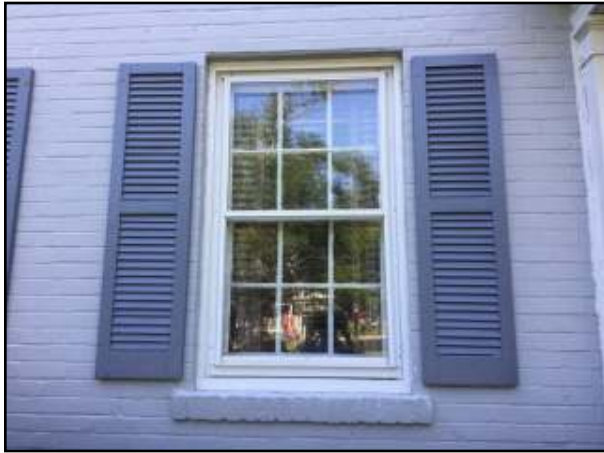
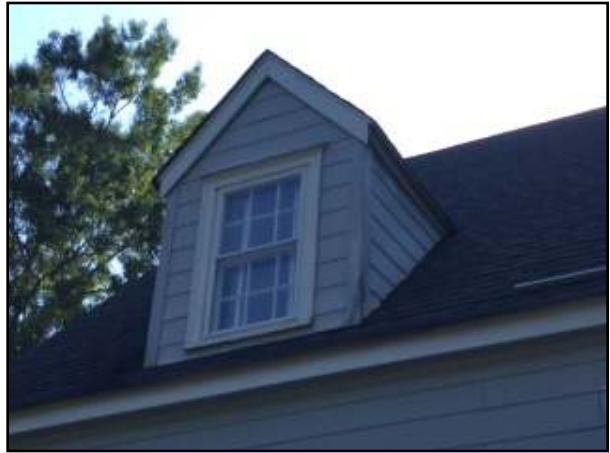
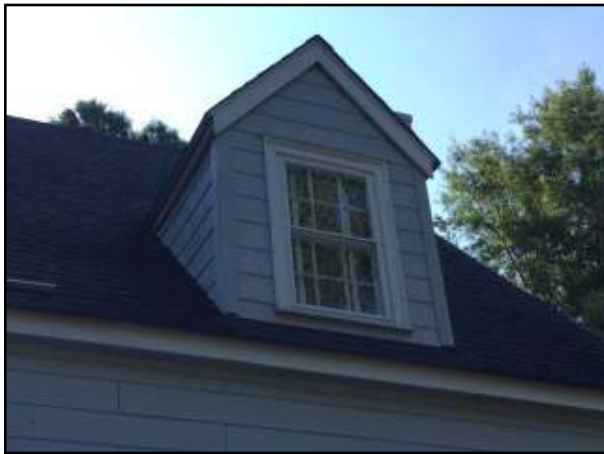
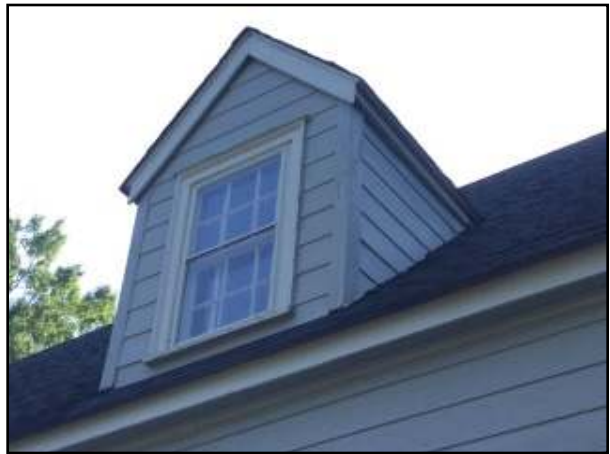
The exterior of the home shows normal wear and tear for a home of this age.

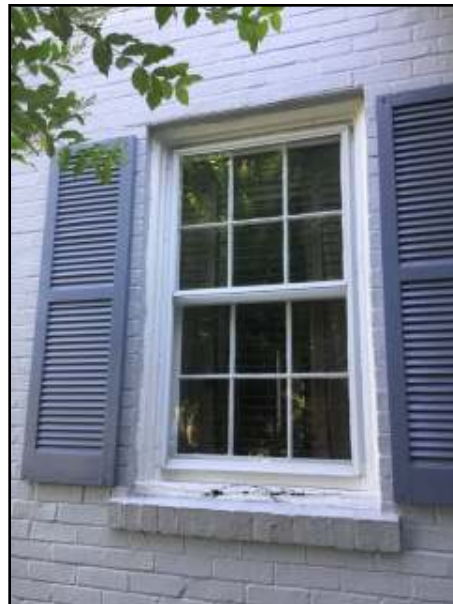
Figure 19-2

Repair: there is wood rot in the right side window frame.

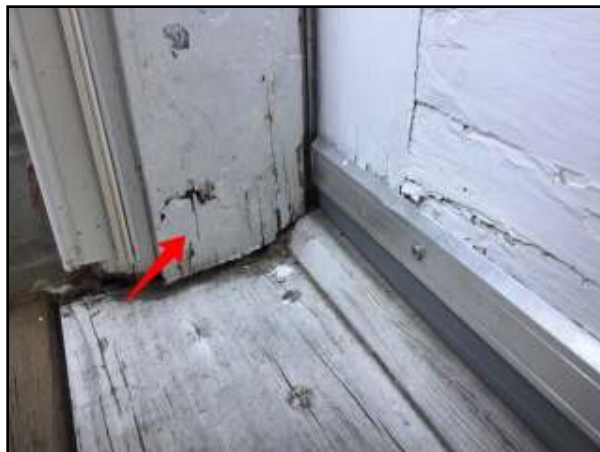
Figure 21-2

Repair: there is wood rot in the rear exterior door frame at the ramp entry.

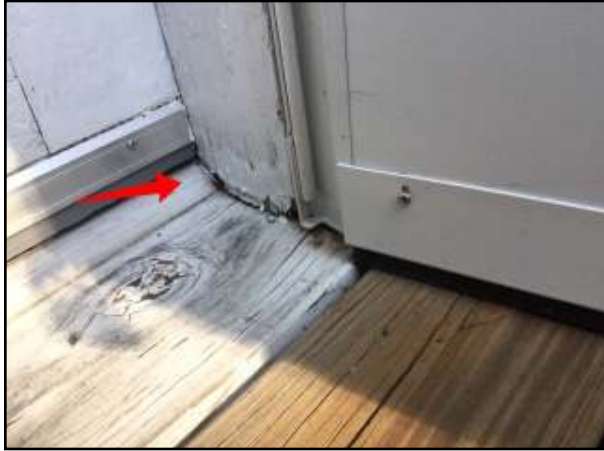
Figure 21-3

Repair: there is wood rot in the exterior door and siding off the rear storage room.

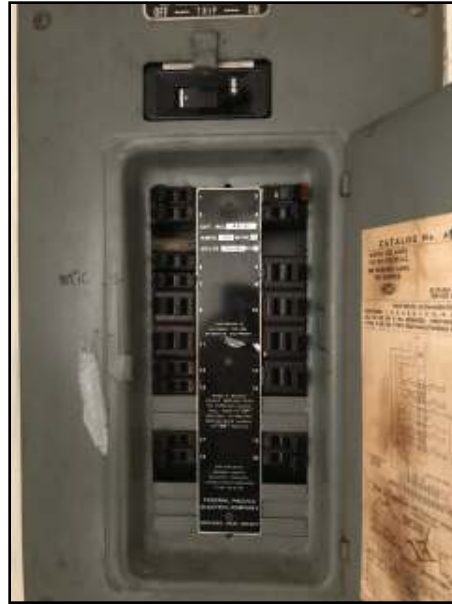
Figure 26-2

Repair: The panel is a FPE Stab-Lok breaker box located in the closet off the kitchen. These panel boxes are considered to be obsolete among industry professionals and insurance carriers. The panel box needs to be replaced. See write-up in the Electrical section of this report concerning FPE Stab-Lok breaker boxes. The panel should be replaced by a licensed electrician.

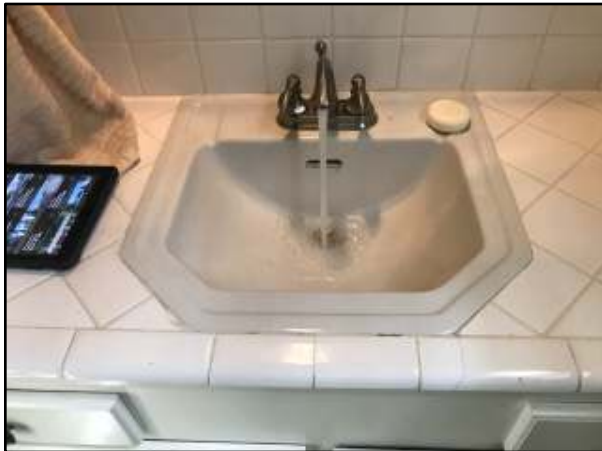
Figure 40-1

All fixtures responded properly when tested. The water pressure to the fixtures is good. Only a slight decrease in pressure was observed when multiple fixtures are operated simultaneously.

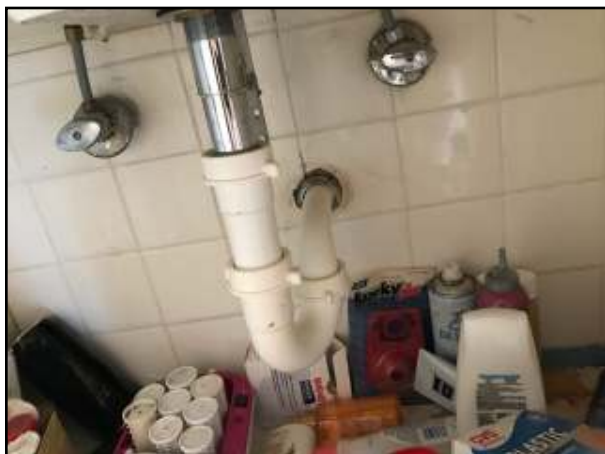
Figure 43-1

All fixtures responded properly when tested. The water pressure to the fixtures is good. Only a slight decrease in pressure was observed when multiple fixtures are operated simultaneously.
